Minnesota Airport System Pavement Evaluation 2011 Update

Ely Municipal Airport (ELO)

Ely, Minnesota

January 2012

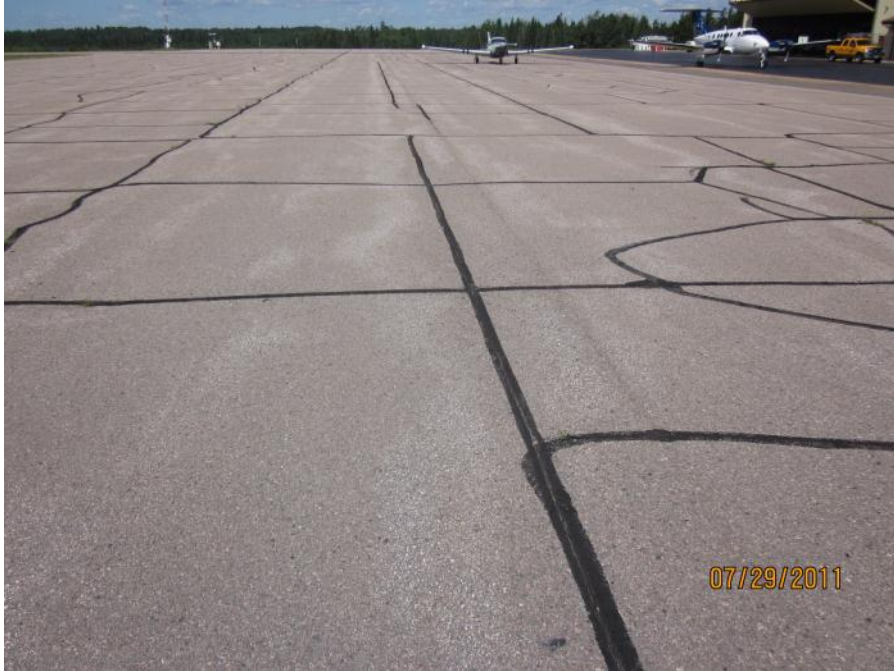
ELO APA 001 (PCI = 54)

Section Comments: crack sealed since 08

Conditions: PCI : 54

43 BLOCK CRACKING M 3,500.00 SqFt Comments:
48 LONGITUDINAL/TRANSVERSE CRACKING L 64.00 Ft Comments:
48 LONGITUDINAL/TRANSVERSE CRACKING M 22.00 Ft Comments:

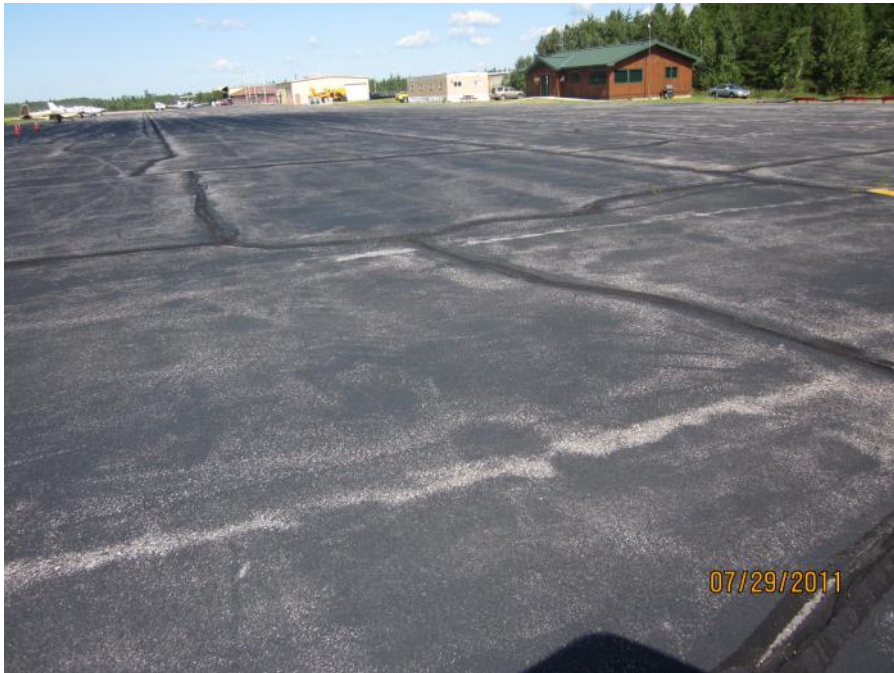
ELO APA 002 (PCI = 72)

Section Comments: crack sealed since 08

Conditions: PCI: 72

48 LONGITUDINAL/TRANSVERSE CRACKING L 421.00 Ft Comments:

48 LONGITUDINAL/TRANSVERSE CRACKING M 171.00 Ft Comments:

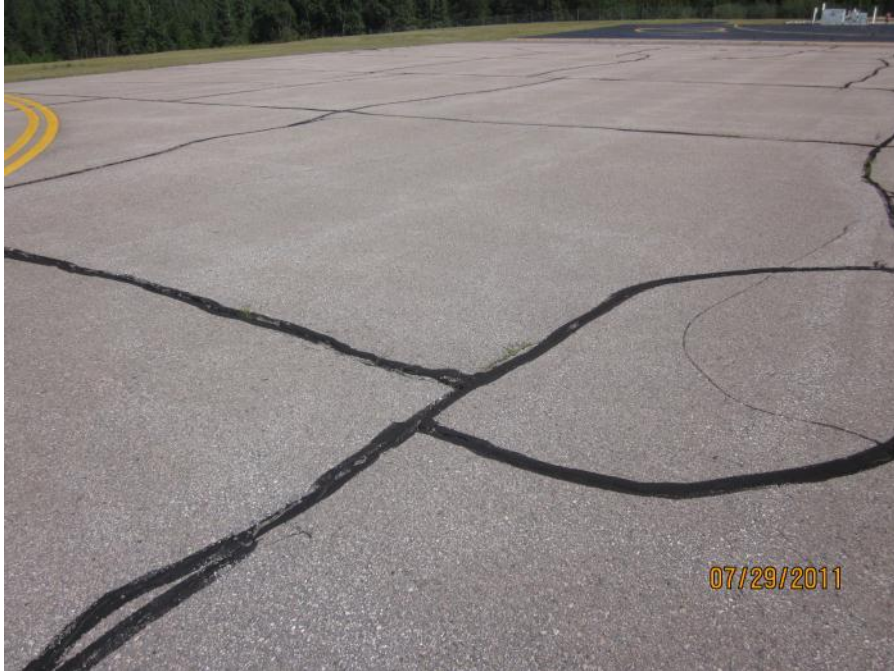
ELO APA 003 (PCI = 71)

Section Comments: crack sealed since 08

Conditions: PCI : 71

48 LONGITUDINAL/TRANSVERSE CRACKING L 381.00 Ft Comments:

48 LONGITUDINAL/TRANSVERSE CRACKING M 204.00 Ft Comments:

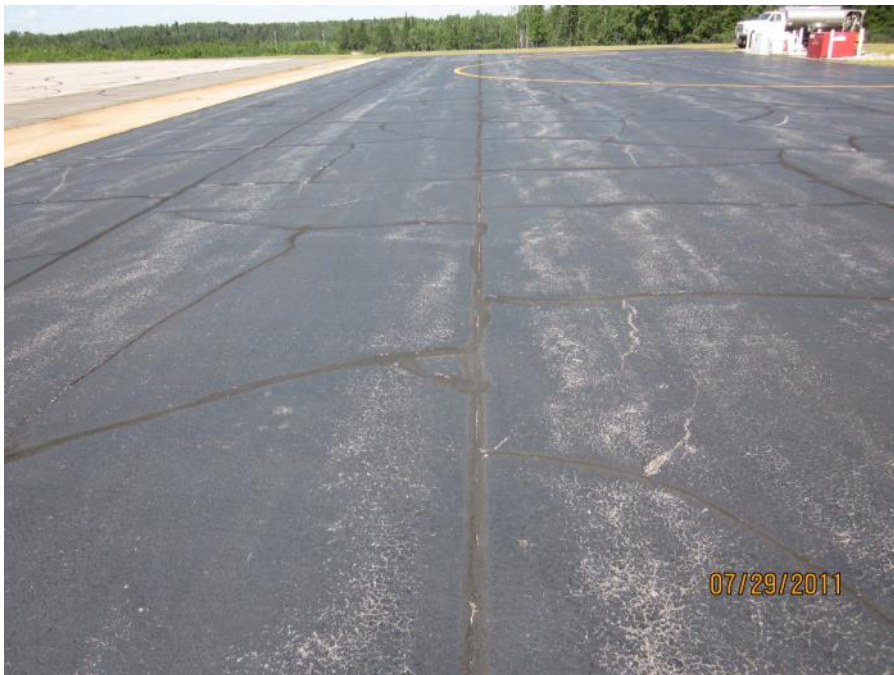
ELO APA 004 (PCI = 47)

Section Comments: crack sealed since 08

Conditions: PCI : 47

Sample Number: 500 Type: R Area: 5,000.00SqFt PCI = 47
Sample Comments:
43 BLOCK CRACKING M 5,000.00 SqFt Comments:

Sample Number: 502 Type: R Area: 5,000.00SqFt PCI = 47
Sample Comments:
43 BLOCK CRACKING M 5,000.00 SqFt Comments:

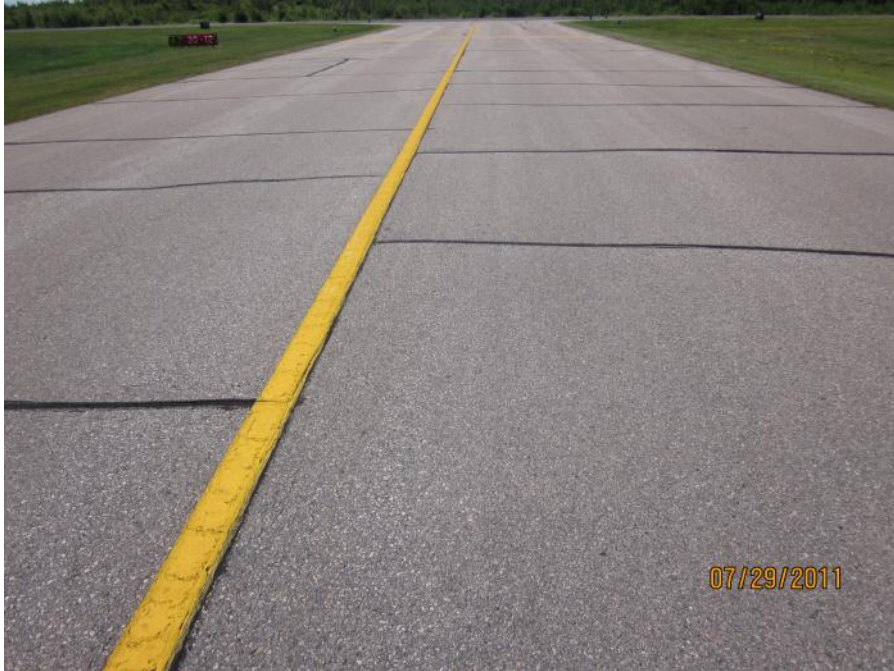
ELO CTA 001 (PCI = 74)

Section Comments: crack sealed since 08

Conditions: PCI: 74

48 LONGITUDINAL/TRANSVERSE CRACKING L 408.00 Ft Comments:

48 LONGITUDINAL/TRANSVERSE CRACKING M 34.00 Ft Comments:

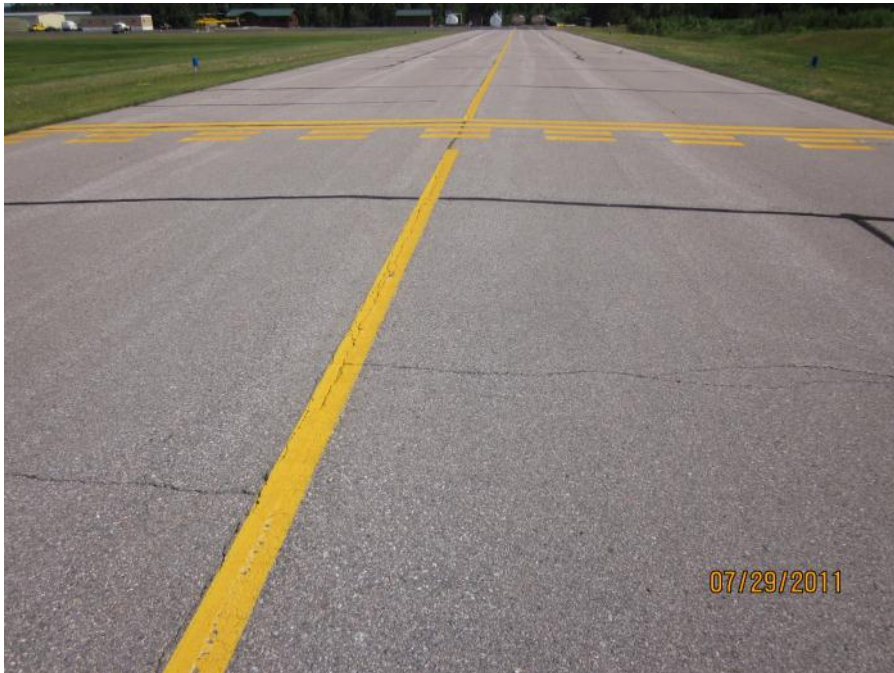
ELO CTB 001 (PCI = 72)

Section Comments: crack sealed since 08

Conditions: PCI: 72

48 LONGITUDINAL/TRANSVERSE CRACKING L 411.00 Ft Comments:
48 LONGITUDINAL/TRANSVERSE CRACKING M 95.00 Ft Comments:

48 LONGITUDINAL/TRANSVERSE CRACKING L 429.00 Ft Comments:
48 LONGITUDINAL/TRANSVERSE CRACKING M 150.00 Ft Comments:
48 LONGITUDINAL/TRANSVERSE CRACKING H 3.00 Ft Comments:

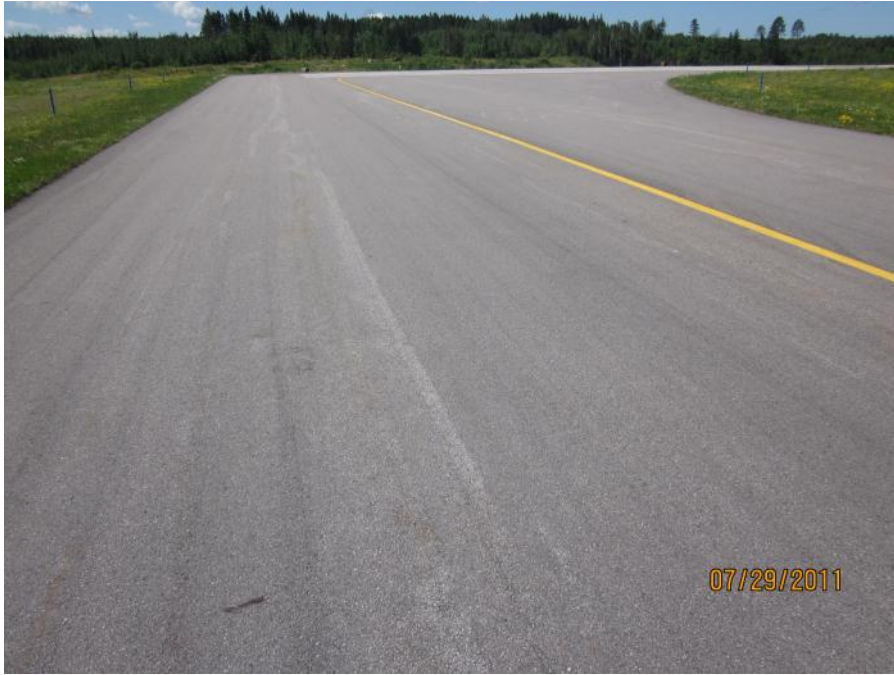
ELO RTA 001 (PCI = 100)

Conditions: PCI: 100

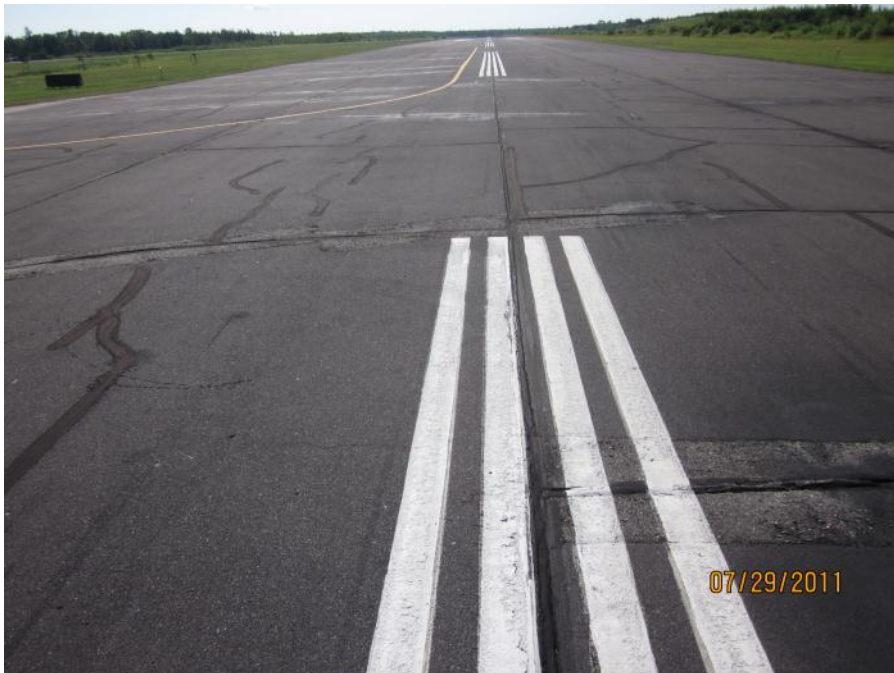
ELO RY1230 001 (PCI = 64)

Section Comments: crack sealed since 08

Conditions: PCI : 64

48 LONGITUDINAL/TRANSVERSE CRACKING L 785.00 Ft Comments:

48 LONGITUDINAL/TRANSVERSE CRACKING M 151.00 Ft Comments:

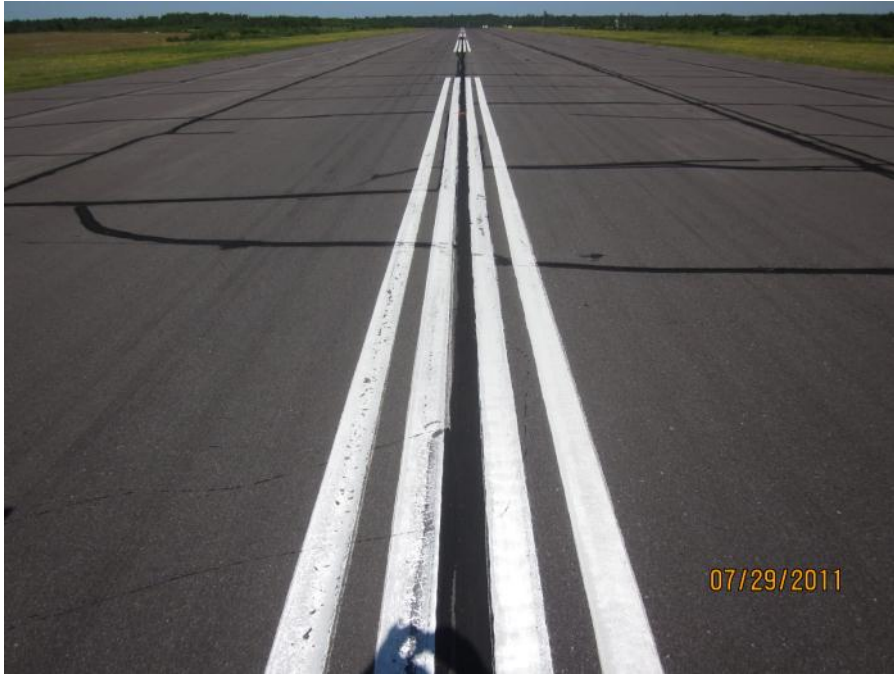
ELO RY1230 002 (PCI = 62)

Section Comments: crack sealed since 08

Conditions: PCI : 62

Sample Number: 128 Type: R Area: 5,000.00SqFt PCI = 64
Sample Comments:
48 LONGITUDINAL/TRANSVERSE CRACKING L 373.00 Ft Comments:
48 LONGITUDINAL/TRANSVERSE CRACKING M 259.00 Ft Comments:
50 PATCHING L 113.00 SqFt Comments:

Sample Number: 138 Type: R Area: 5,000.00SqFt PCI = 66
Sample Comments:
48 LONGITUDINAL/TRANSVERSE CRACKING L 523.00 Ft Comments:
48 LONGITUDINAL/TRANSVERSE CRACKING M 155.00 Ft Comments:
50 PATCHING L 250.00 SqFt Comments:

Sample Number: 148 Type: R Area: 5,000.00SqFt PCI = 63
Sample Comments:
48 LONGITUDINAL/TRANSVERSE CRACKING L 455.00 Ft Comments:
48 LONGITUDINAL/TRANSVERSE CRACKING M 376.00 Ft Comments:

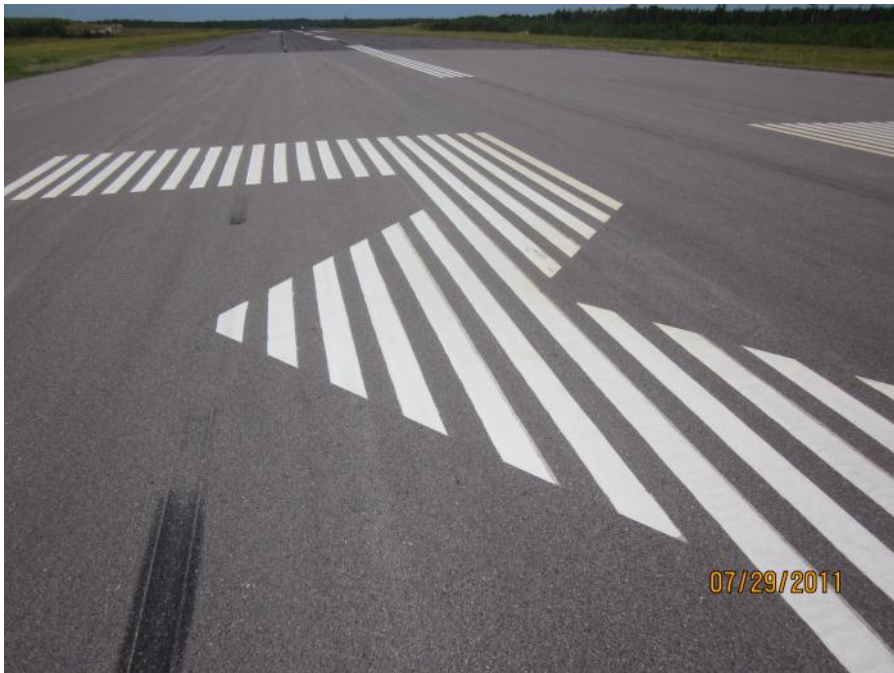
ELO RY1230 003 (PCI = 100)

Conditions: PCI: 100
