Pavement Condition Report

Hallock Municipal Airport (HCO)

December 2014

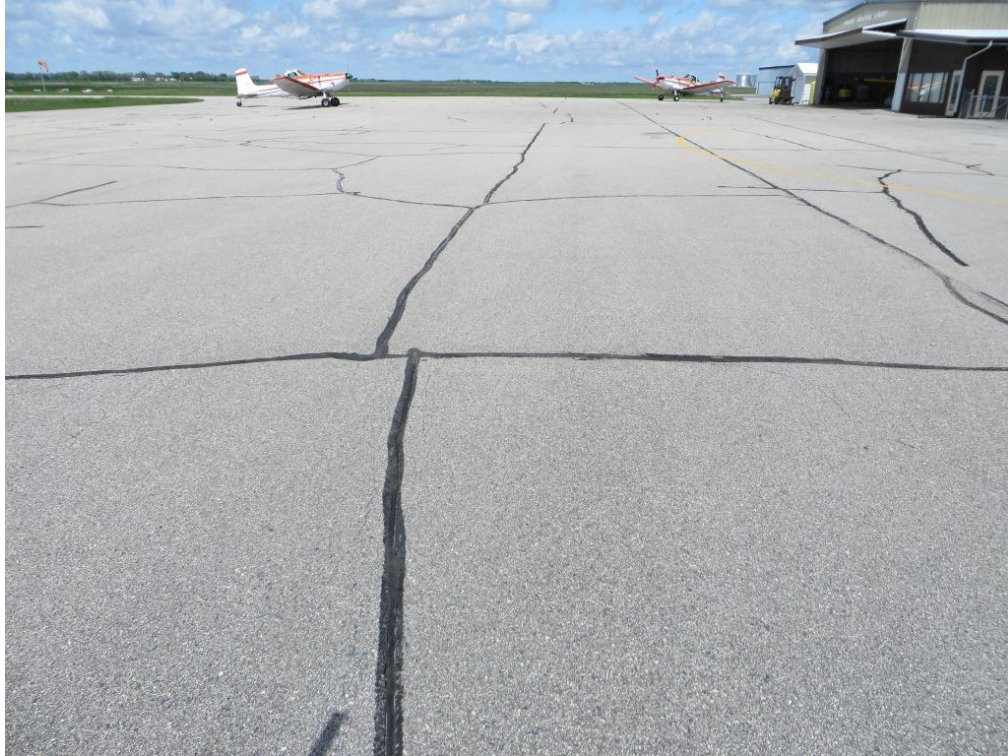
HCO APA 001 (PCI = 69)

Section Comments: crack sealed since 08

Conditions: PCI: 69

48 LONGITUDINAL/TRANSVERSE CRACKING L 486.00 Ft Comments:

48 LONGITUDINAL/TRANSVERSE CRACKING M 87.00 Ft Comments:

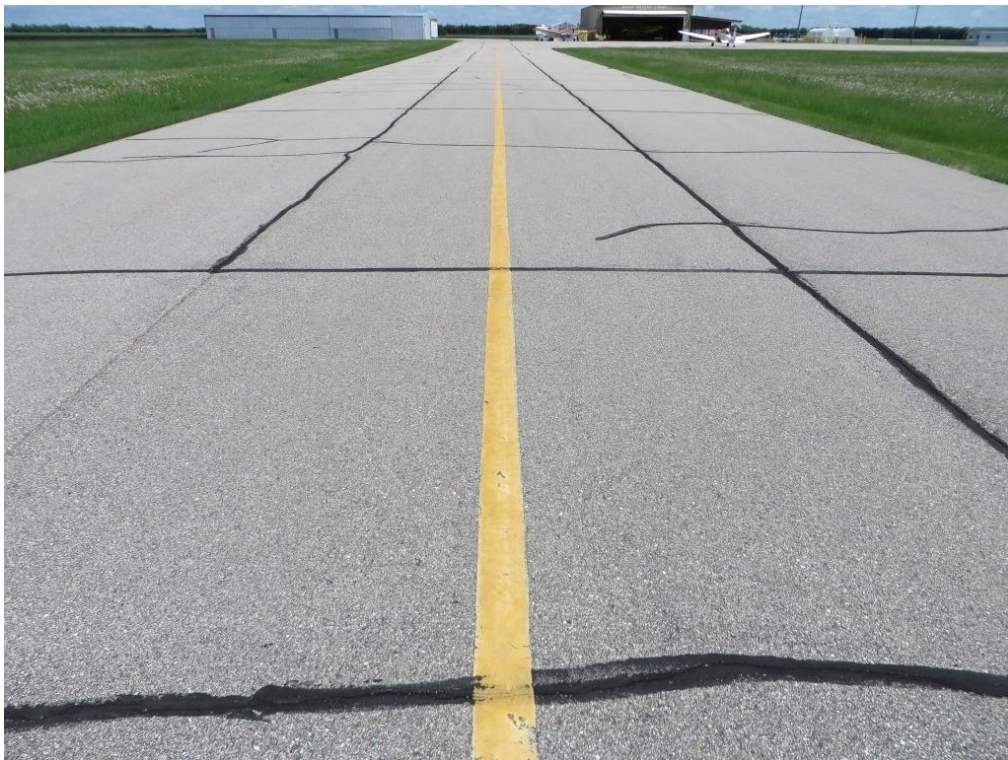
HCO CTA 001 (PCI = 68)

Section Comments: crack sealed since 08

Conditions: PCI : 68

48 LONGITUDINAL/TRANSVERSE CRACKING L 511.00 Ft Comments:
48 LONGITUDINAL/TRANSVERSE CRACKING M 82.00 Ft Comments:

48 LONGITUDINAL/TRANSVERSE CRACKING L 515.00 Ft Comments:
48 LONGITUDINAL/TRANSVERSE CRACKING M 103.00 Ft Comments:

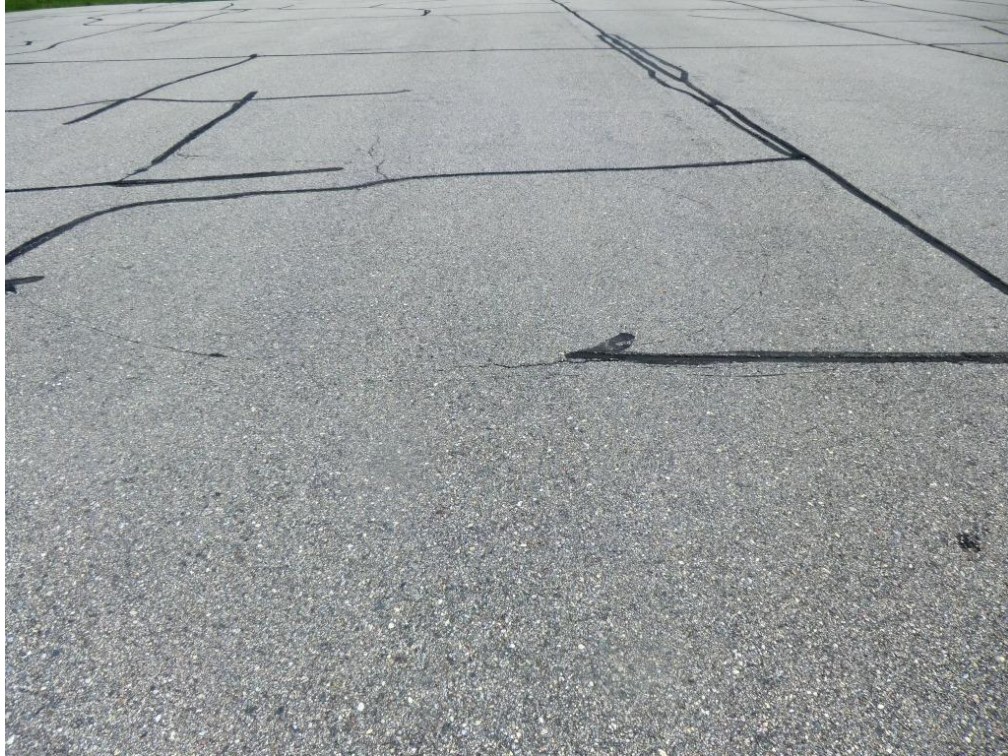
HCO RTA 001 (PCI=63)

Section Comments: crack sealed since 08

Conditions: PCI : 63

48 LONGITUDINAL/TRANSVERSE CRACKING L 675.00 Ft Comments:

48 LONGITUDINAL/TRANSVERSE CRACKING M 47.00 Ft Comments:

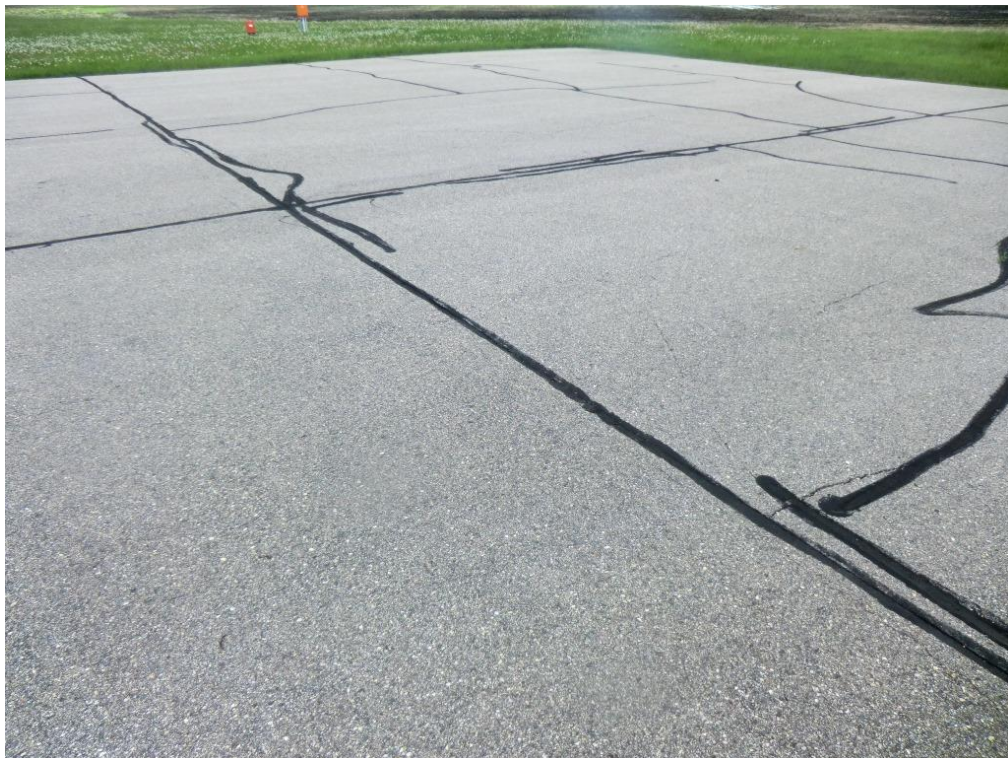
HCO RTA 002 (PCI = 65)

Section Comments: crack sealed since 08

Conditions: PCI : 65

41 ALLIGATOR CRACKING L 9.00 SqFt Comments:

48 LONGITUDINAL/TRANSVERSE CRACKING L 498.00 Ft Comments:

48 LONGITUDINAL/TRANSVERSE CRACKING M 49.00 Ft Comments:

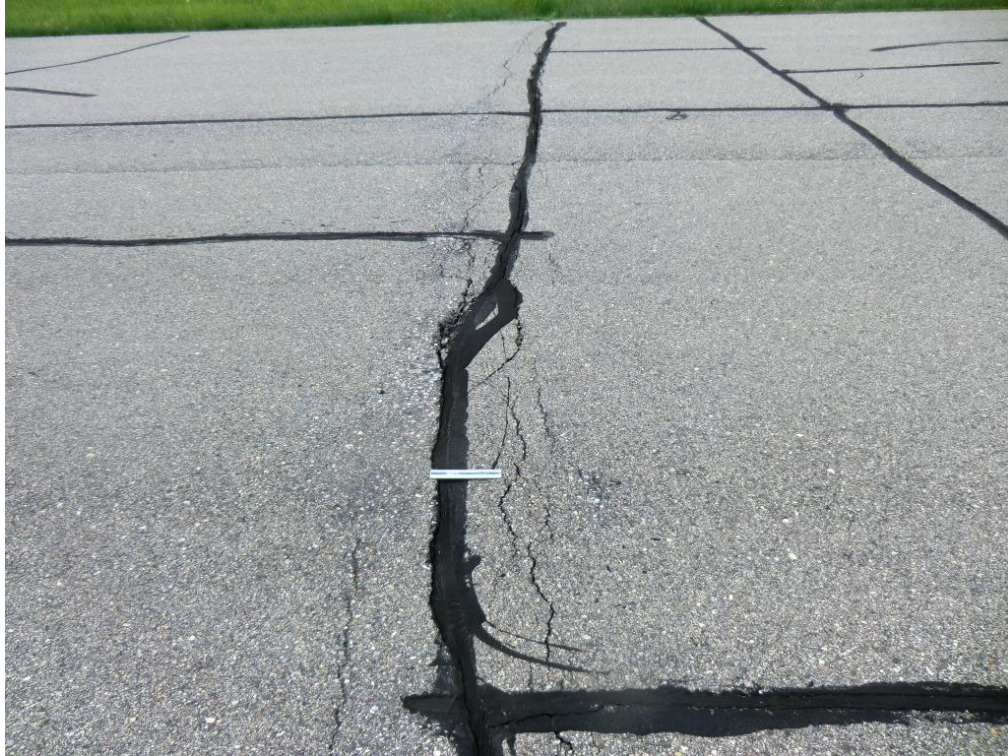
HCO RY1331 001 (PCI = 62)

Section Comments: crack sealed since 08

Conditions: PCI: 62

48 LONGITUDINAL/TRANSVERSE CRACKING L 729.00 Ft Comments:
48 LONGITUDINAL/TRANSVERSE CRACKING M 55.00 Ft Comments:

48 LONGITUDINAL/TRANSVERSE CRACKING L 648.00 Ft Comments:
48 LONGITUDINAL/TRANSVERSE CRACKING M 39.00 Ft Comments:

45 DEPRESSION L 33.00 SqFt Comments:
48 LONGITUDINAL/TRANSVERSE CRACKING L 558.00 Ft Comments:
48 LONGITUDINAL/TRANSVERSE CRACKING M 46.00 Ft Comments:
48 LONGITUDINAL/TRANSVERSE CRACKING H 47.00 Ft Comments:

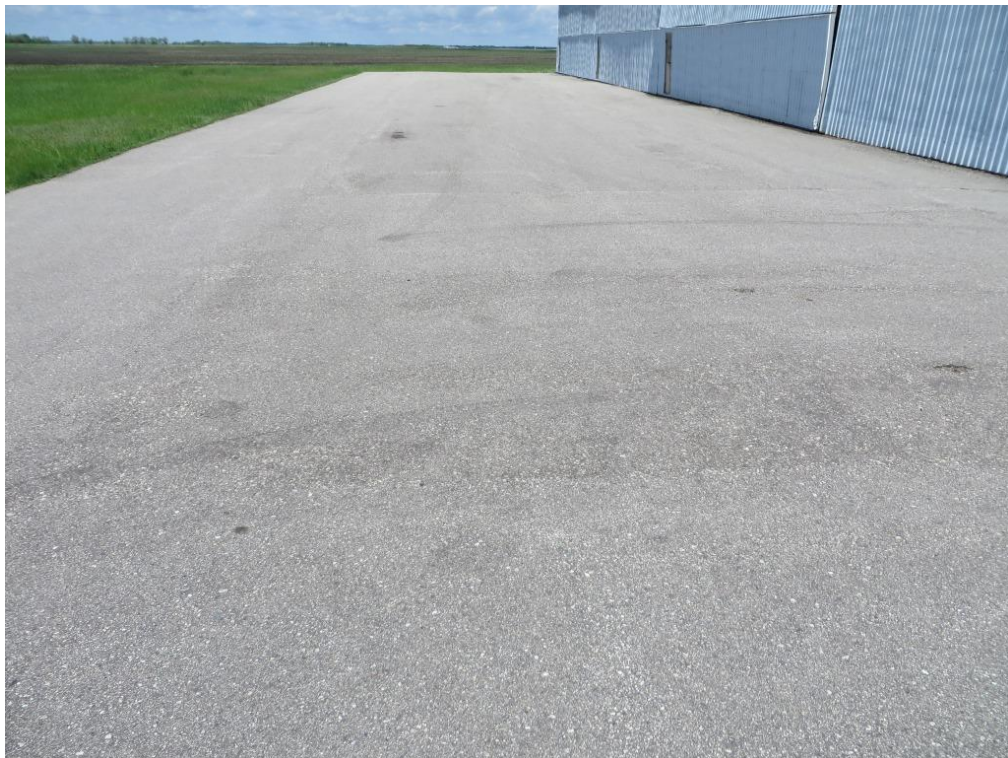
HCO TLA 001 (PCI = 99)

Conditions: PCI: 99

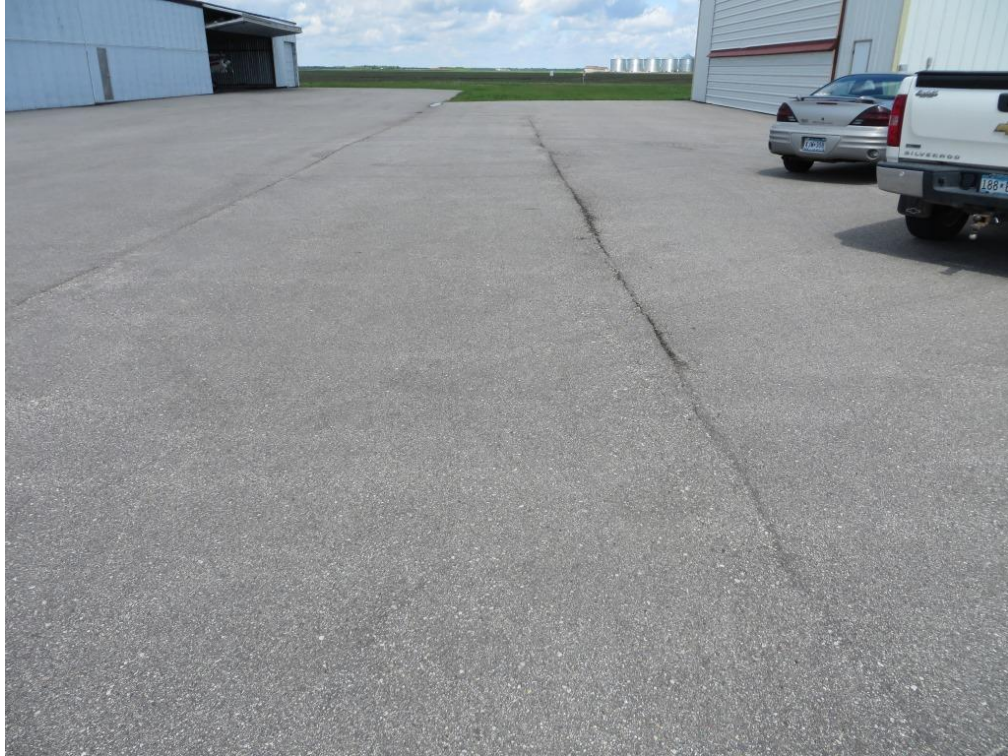
HCO TLA 002 (PCI = 88)

Conditions: PCI : 88

48 LONGITUDINAL/TRANSVERSE CRACKING L 89.00 Ft Comments:
48 LONGITUDINAL/TRANSVERSE CRACKING M 19.00 Ft Comments:
