Pavement Condition Report

Perham Municipal Airport (16D)

December 2016

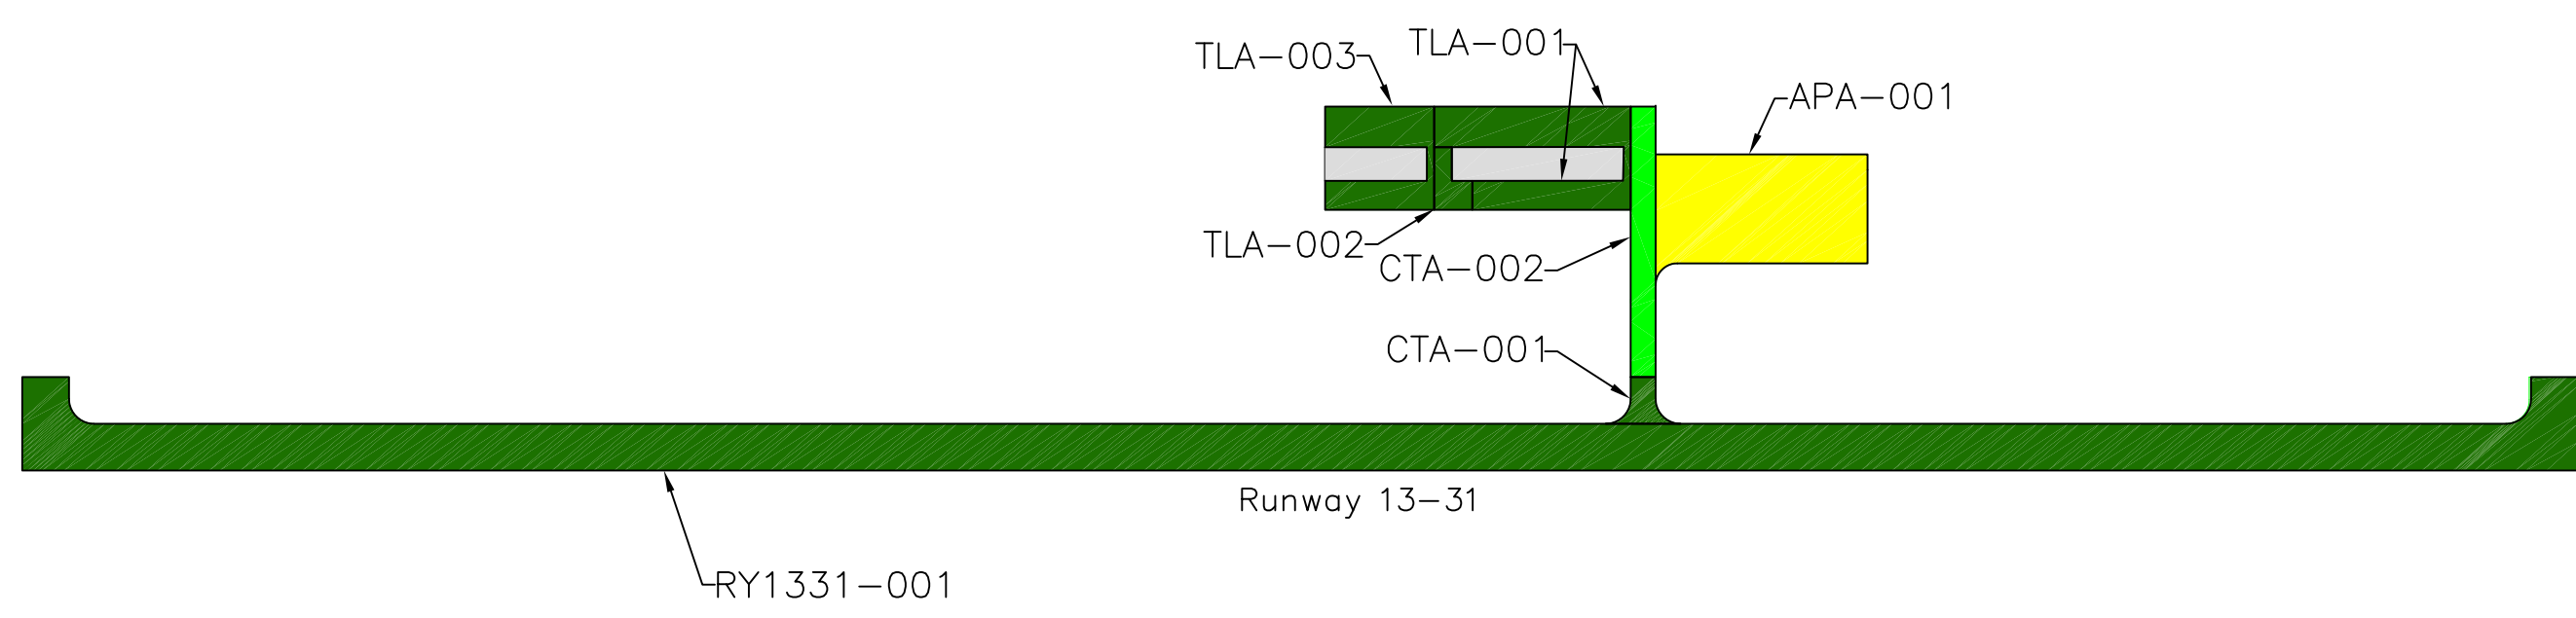
Figure 4. 2016 Pavement Condition Index Rating at Perham Municipal Airport (16D).

Preventive maintenance such as crack sealing and surface treatments were performed at the airport since the last inspection resulting in increased PCI values for some sections.

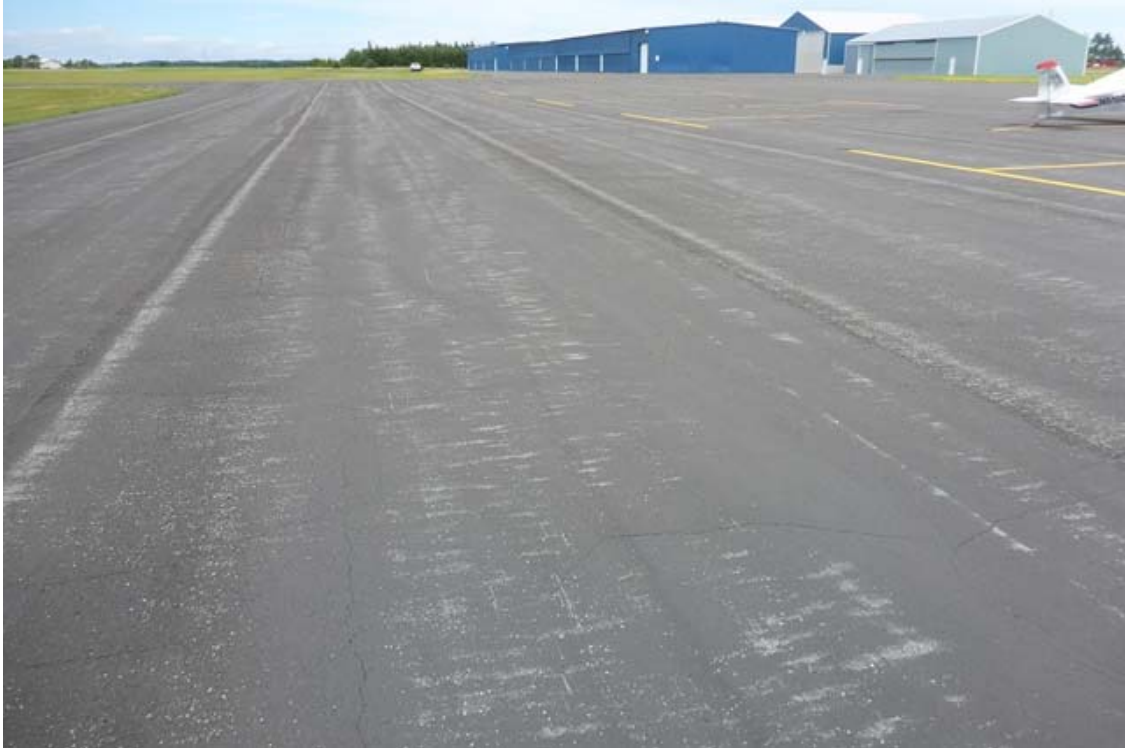
16D APA 001 (PCI = 61)

Network:	16D	Name:	PERHAM						
Branch:	APA	Name:	APRON A	Use:	APRON	Area:	59,760 SqFt		
Section:	001	of 1	From:	100	To:	402	Last Const.:	9/30/1981	
Surface:	AC	Family:	MN2013 Asphalt Aprons	Zone:	W	Category:	3	Rank:	S
Area:	59,760 SqFt	Length:	340 Ft	Width:	175 Ft				
Slabs:		Slab Length:	Ft	Slab Width:	Ft	Joint Length:	Ft		
Shoulder:		Street Type:		Grade:	0	Lanes:	0		
Section Comments:									
Last Insp. Date:	7/10/2016	TotalSamples:	12	Surveyed:	4				
Conditions:	PCI: 61								
Inspection Comments: slurry seal since last inspection									
Sample Number:	100	Type:	R	Area:	5000.00 SqFt	PCI:	60		
Sample Comments:									
43	BLOCK CR	L		4800.00	SqFt				
43	BLOCK CR	M		200.00	SqFt				
Sample Number:	201	Type:	R	Area:	5000.00 SqFt	PCI:	60		
Sample Comments:									
43	BLOCK CR	M		100.00	SqFt				
43	BLOCK CR	L		4900.00	SqFt				
Sample Number:	300	Type:	R	Area:	5000.00 SqFt	PCI:	64		
Sample Comments:

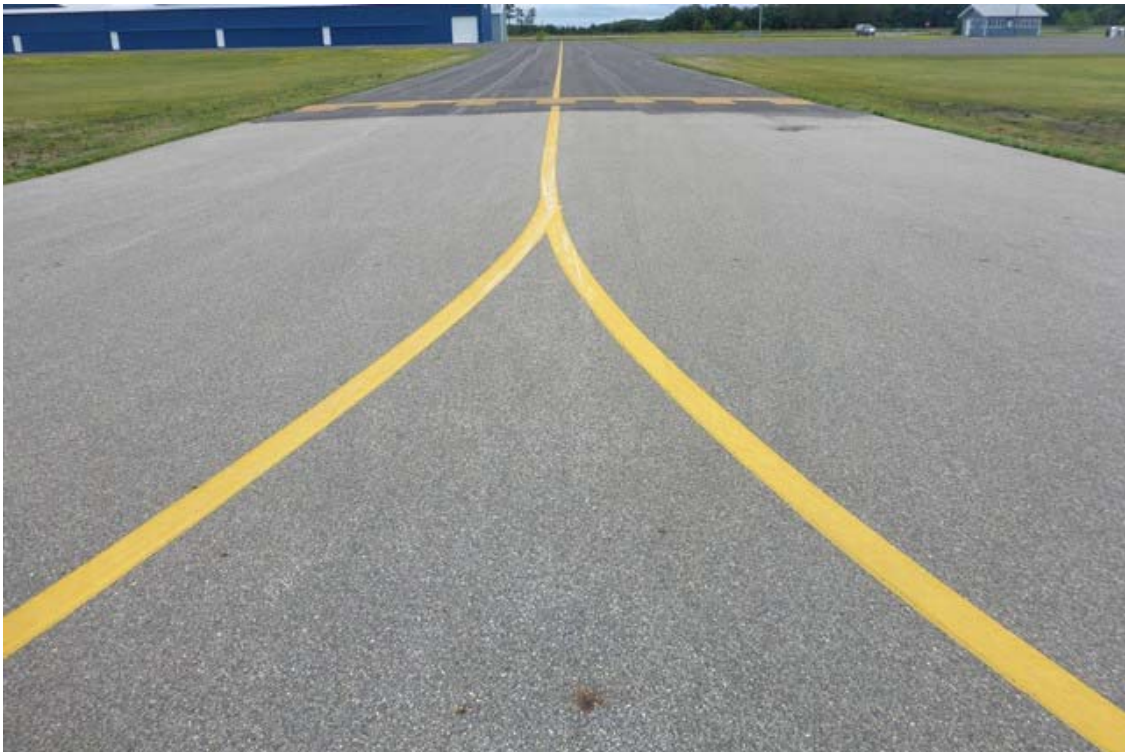
16D CTA 001 (PCI = 88)

Network:	16D	Name:	PERHAM						
Branch:	CTA	Name:	CONNECTING TAXIWAY A	Use:	TAXIWAY	Area:	21,675 SqFt		
Section:	001	of 2	From:	100	To:	101	Last Const.: 9/27/2010		
Surface:	AAC	Family:	MN2013 Asphalt Taxiways	Zone:	W	Category:	3	Rank:	P
Area:	3,675 SqFt	Length:	75 Ft	Width:	40 Ft				
Slabs:		Slab Length:	Ft	Slab Width:	Ft	Joint Length:	Ft		
Shoulder:		Street Type:		Grade:	0	Lanes:	0		
Section Comments:									
Last Insp. Date:	7/10/2016	TotalSamples:	1	Surveyed:	1				
Conditions:	PCI: 88								
Inspection Comments:									
Sample Number:	100	Type:	R	Area:	3675.00 SqFt	PCI:	88		
Sample Comments:									
48	L & T CR	L	143.00	Ft

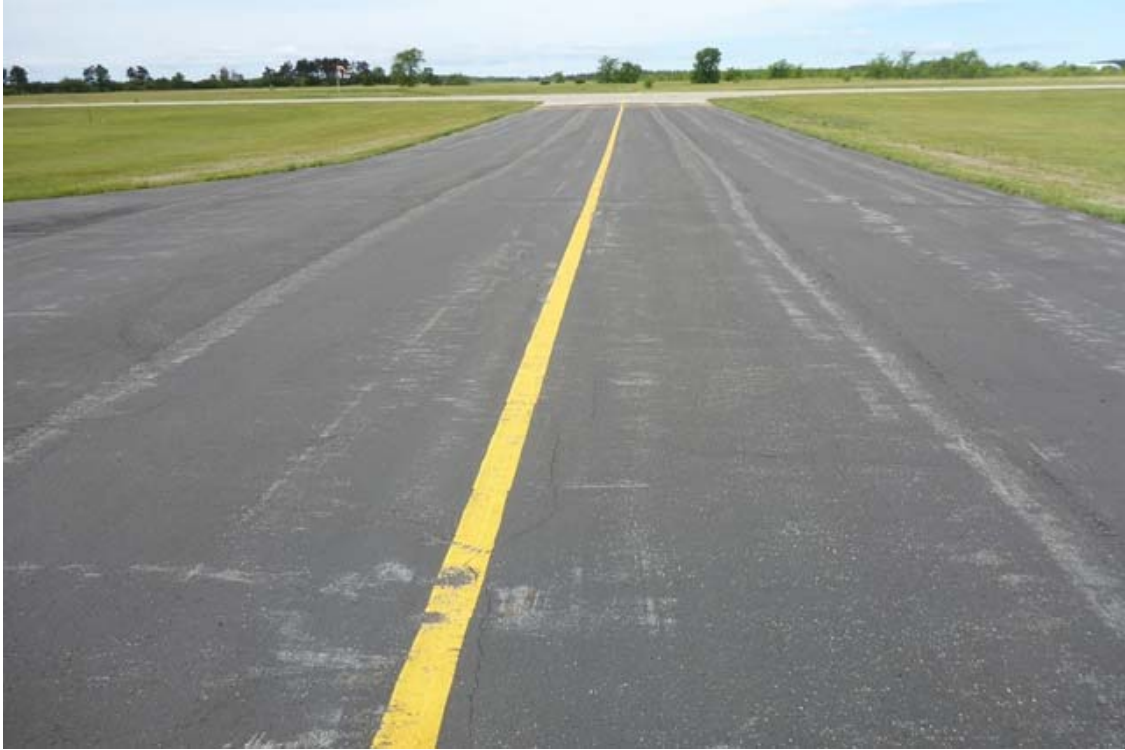
16D CTA 002 (PCI = 72)

Network:	16D	Name:	PERHAM						
Branch:	CTA	Name:	CONNECTING TAXIWAY A	Use:	TAXIWAY	Area:	21,675 SqFt		
Section:	002	of 2	From:	101	To:	104	Last Const.:	9/30/1981	
Surface:	AC	Family:	MN2013 Asphalt Taxiways	Zone:	W	Category:	3	Rank:	P
Area:	18,000 SqFt	Length:	450 Ft	Width:	40 Ft				
Slabs:		Slab Length:	Ft	Slab Width:	Ft	Joint Length:	Ft		
Shoulder:		Street Type:		Grade:	0	Lanes:	0		
Section Comments:									
Last Insp. Date:	7/10/2016	TotalSamples:	4	Surveyed:	1				
Conditions:	PCI: 72								
Inspection Comments: slurry seal est 2014									
Sample Number:	102	Type:	R	Area:	4000.00 SqFt	PCI:	72		
Sample Comments:									
43	BLOCK CR	L	1800.00	SqFt

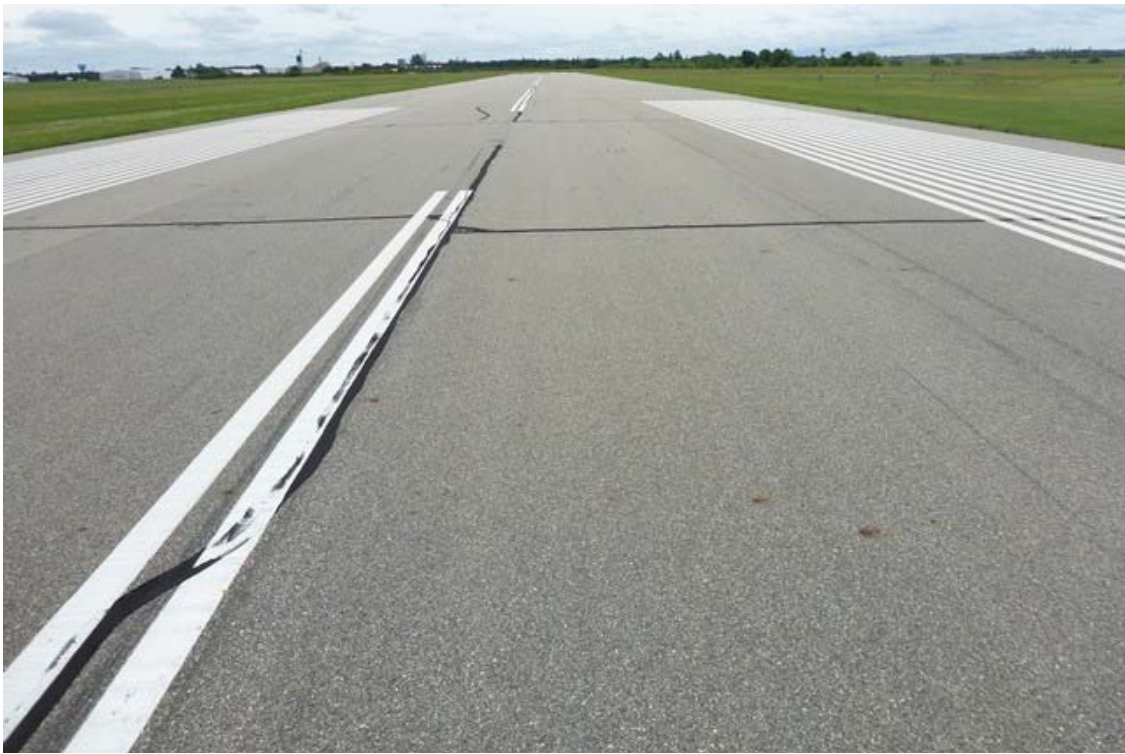
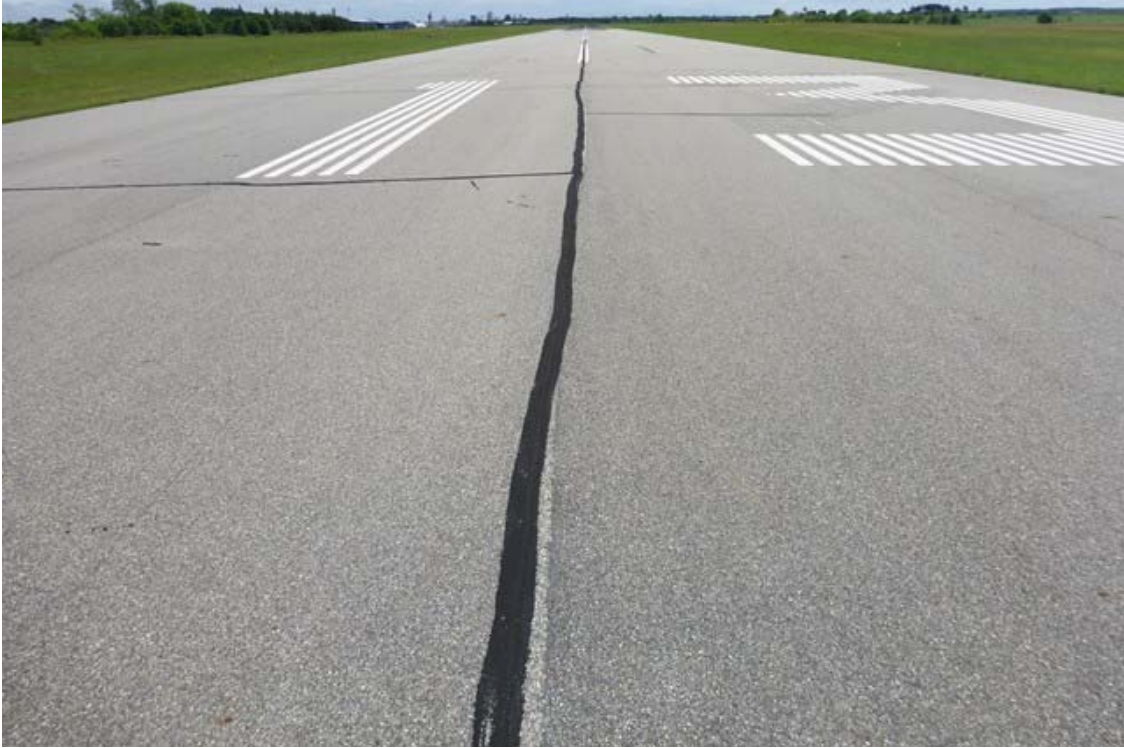
16D RY1331 001 (PCI = 88)

Network:	16D	Name:	PERHAM						
Branch:	RY1331	Name:	RUNWAY 13-31	Use:	RUNWAY	Area:	318,750 SqFt		
Section:	001	of 1	From:	100	To:	181	Last Const.: 9/27/2010		
Surface:	AAC	Family:	MN2013 Asphalt Runways	Zone:	W	Category:	3	Rank:	P
Area:	318,750 SqFt	Length:	4,100 Ft	Width:	75 Ft				
Slabs:		Slab Length:	Ft	Slab Width:	Ft	Joint Length:	Ft		
Shoulder:		Street Type:		Grade:	0	Lanes:	0		
Section Comments:									
Last Insp. Date:	7/10/2016	TotalSamples:	86	Surveyed:	9				
Conditions:	PCI: 88								
Inspection Comments: nes cs since last insp est 2014									
Sample Number:	104	Type:	R	Area:	3750.00 SqFt	PCI:	91		
Sample Comments:									
48	L & T CR	L	98.00	Ft					
Sample Number:	113	Type:	R	Area:	3750.00 SqFt	PCI:	96		
Sample Comments:									
48	L & T CR	L	20.00	Ft					
Sample Number:	122	Type:	R	Area:	3750.00 SqFt	PCI:	85		
Sample Comments:									
48	L & T CR	M	3.00	Ft					
48	L & T CR	L	124.00	Ft

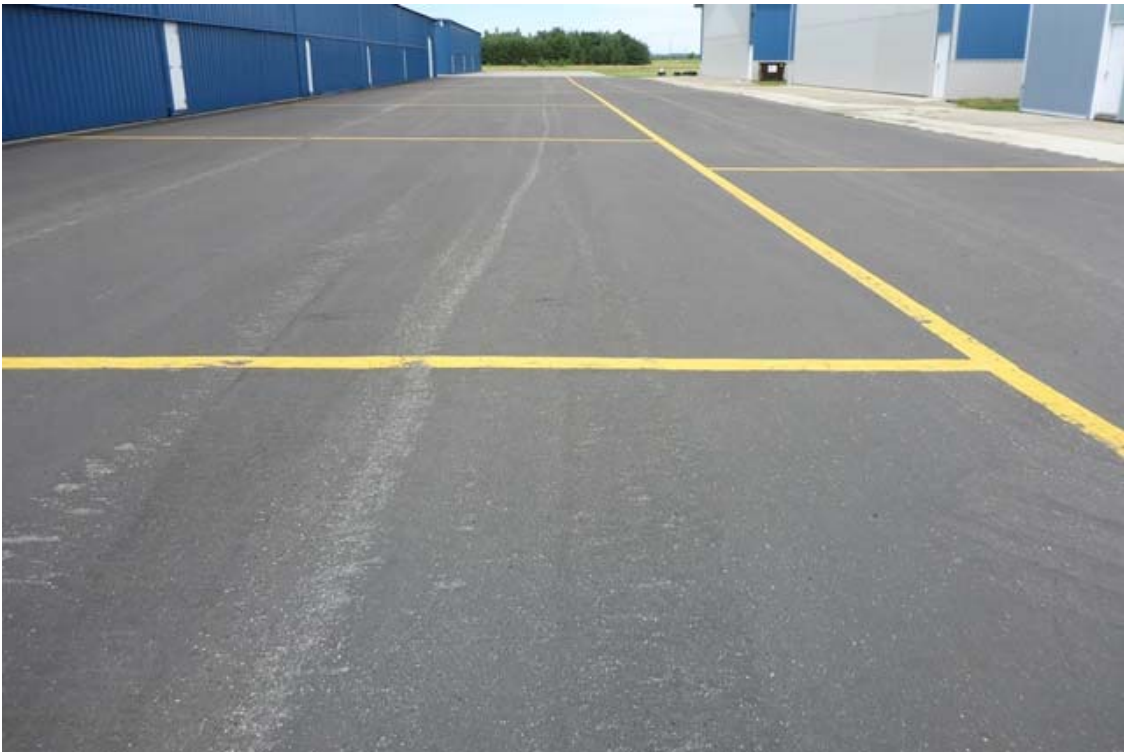
16D TLA 001 (PCI = 94)

Network:	16D	Name:	PERHAM						
Branch:	TLA	Name:	TAXILANE A	Use:	TAXILANE	Area:	57,650 SqFt		
Section:	001	of 3	From:	100	To:	202	Last Const.:	9/1/2007	
Surface:	AAC	Family:	MN2013 Asphalt Taxilanes	Zone:	W	Category:	3	Rank:	T
Area:	33,050 SqFt	Length:	255 Ft	Width:	120 Ft				
Slabs:		Slab Length:	Ft	Slab Width:	Ft	Joint Length:	Ft		
Shoulder:		Street Type:		Grade:	0	Lanes:	0		
Section Comments:									
Last Insp. Date:	7/10/2016	TotalSamples:	6	Surveyed:	2				
Conditions:	PCI: 94								
Inspection Comments:									
Sample Number:	101	Type:	R	Area:	5000.00 SqFt	PCI:	91		
Sample Comments:									
48	L & T CR	L	133.00	Ft					
Sample Number:	201	Type:	R	Area:	7000.00 SqFt	PCI:	96		
Sample Comments:									
48	L & T CR	L	41.00	Ft

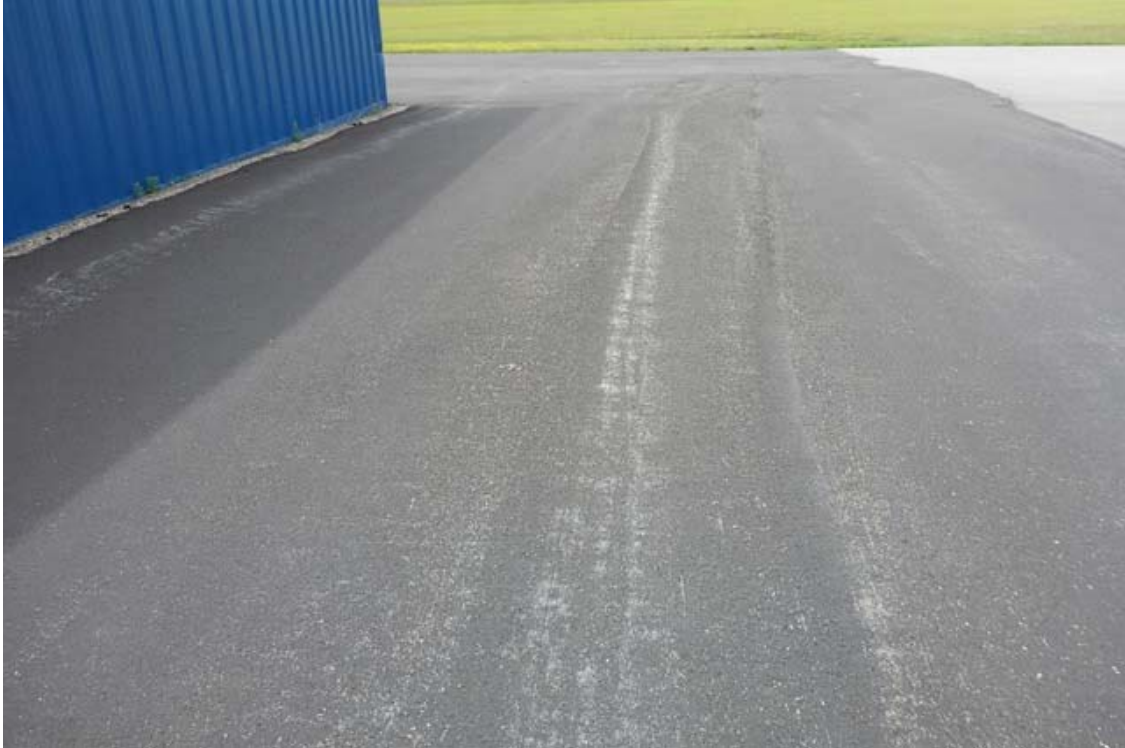
16D TLA 002 (PCI = 88)

Network:	16D	Name:	PERHAM						
Branch:	TLA	Name:	TAXILANE A	Use:	TAXILANE	Area:	57,650 SqFt		
Section:	002	of 3	From:	100	To:	100	Last Const.:	10/1/2014	
Surface:	AC	Family:	MN2013 Asphalt Taxilanes	Zone:	W	Category:	3	Rank:	T
Area:	4,400 SqFt	Length:	100 Ft	Width:	30 Ft				
Slabs:		Slab Length:	Ft	Slab Width:	Ft	Joint Length:	Ft		
Shoulder:		Street Type:		Grade:	0	Lanes:	0		
Section Comments:									
Last Insp. Date:	7/10/2016	TotalSamples:	1	Surveyed:	1				
Conditions:	PCI: 88								
Inspection Comments: section is only 25 ft wide									
Sample Number:	100	Type:	R	Area:	2500.00 SqFt	PCI:	88		
Sample Comments:									
48	L & T CR	L	96.00	Ft

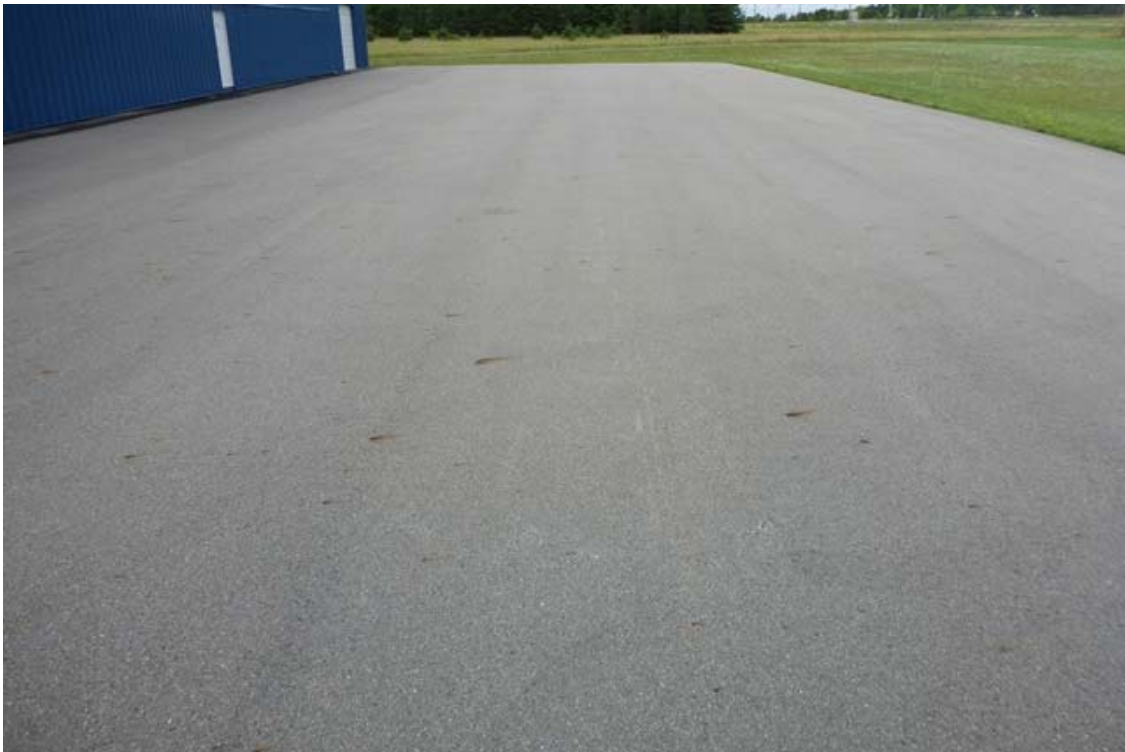
16D TLA 003 (PCI = 94)

Network:	16D	Name:	PERHAM					
Branch:	TLA	Name:	TAXILANE A	Use:	TAXILANE	Area:	57,650 SqFt	
Section:	003	of 3	From:	A	To:	B	Last Const.:	10/1/2014
Surface:	AC	Family:	MN2013 Asphalt Taxilanes	Zone:		Category:	Rank:	T
Area:	20,200 SqFt	Length:	175 Ft	Width:	100 Ft			
Slabs:		Slab Length:	Ft	Slab Width:	Ft	Joint Length:	Ft	
Shoulder:		Street Type:		Grade:	0	Lanes:	0	
Section Comments:								
Last Insp. Date:	7/10/2016	TotalSamples:	4	Surveyed:	2			
Conditions:	PCI: 94							
Inspection Comments: new section								
Sample Number:	103	Type:	R	Area:	5000.00 SqFt	PCI:	94	
Sample Comments:								
48	L & T CR	L	75.00	Ft				
Sample Number:	203	Type:	R	Area:	5000.00 SqFt	PCI:	94	
Sample Comments:								
48	L & T CR	L	77.00	Ft
