# Pavement Condition Report

## Mora Municipal Airport (JMR)

**December 2017**

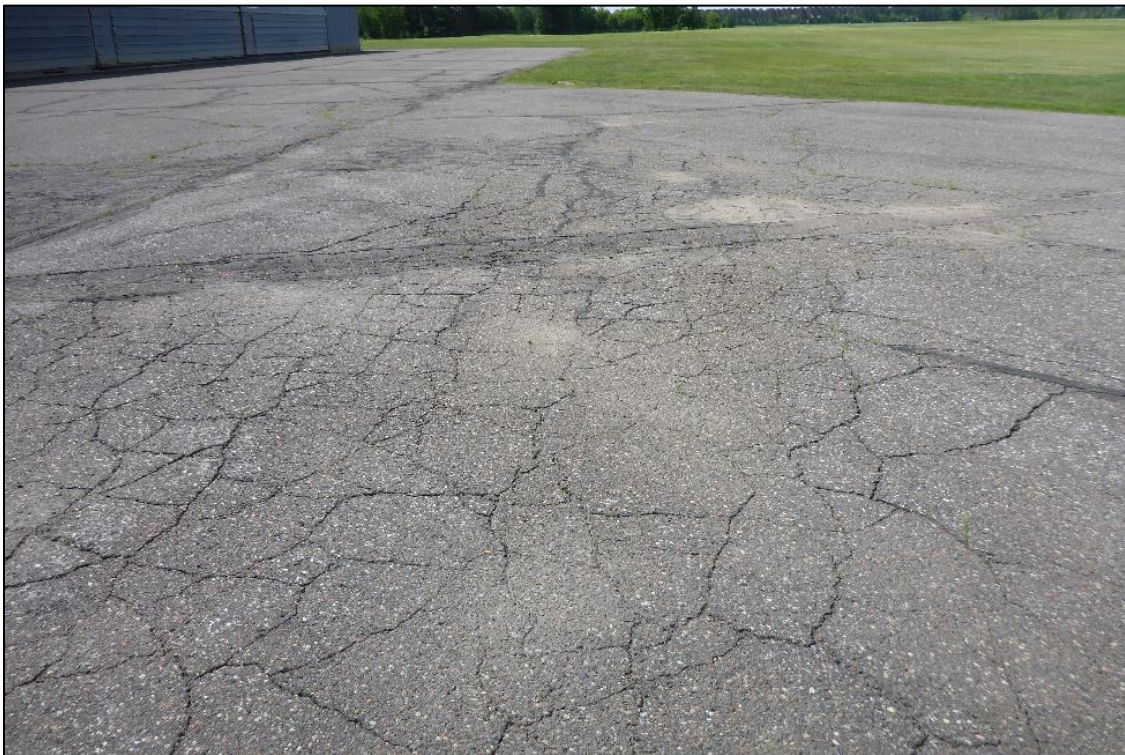
JMR APA 002 (PCI = 16)

**Conditions:** PCI: 16

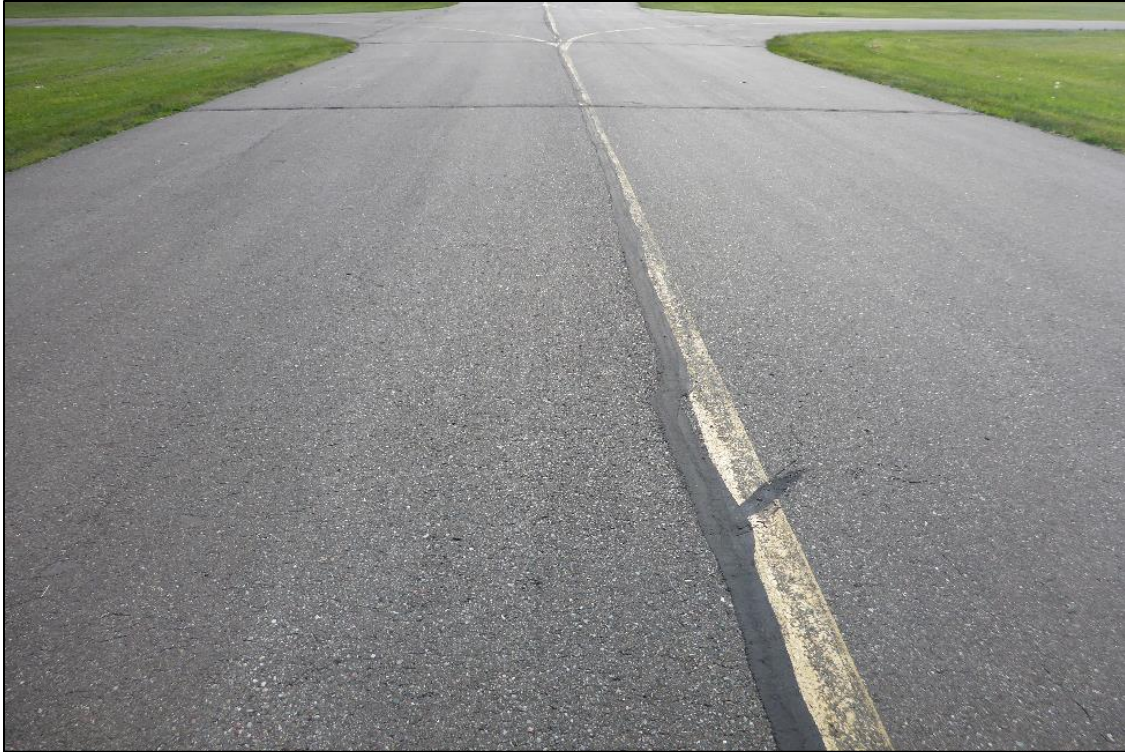
JMR CTA 001 (PCI = 76)

**Conditions:** PCI: 76

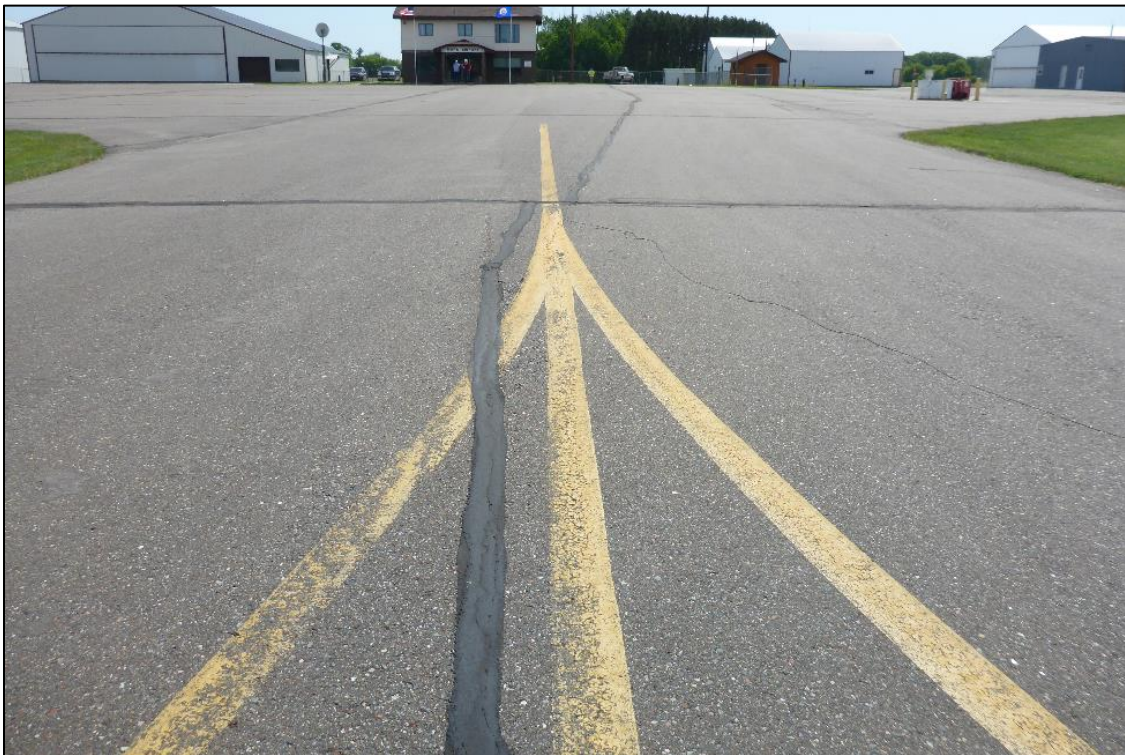
JMR CTAX 001 (PCI = 75)

**Conditions:** PCI: 75

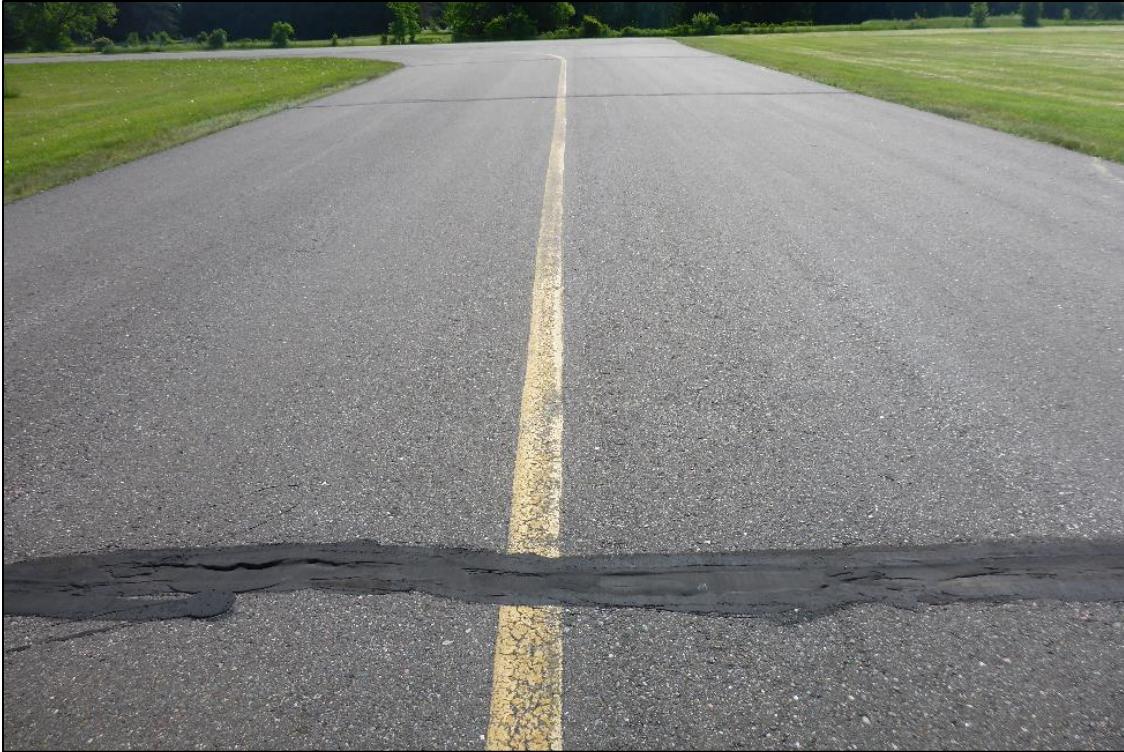
JMR CTB 001 (PCI = 77)

**Conditions:** PCI: 77

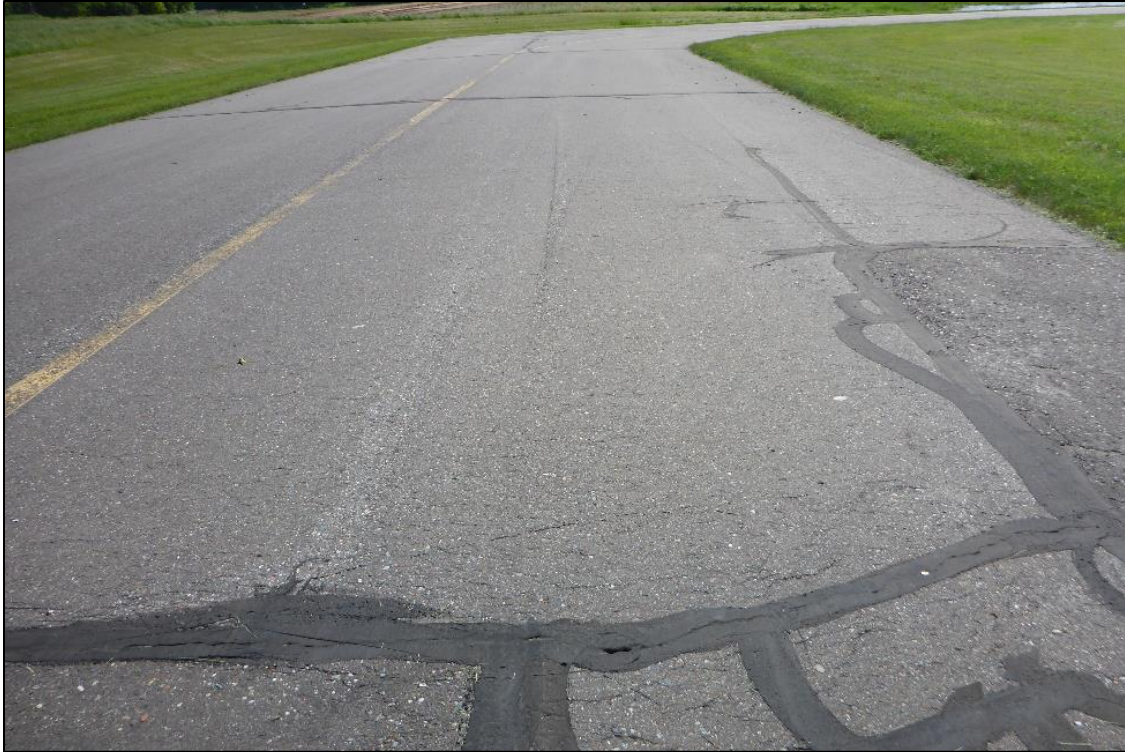
JMR CTD 001 (PCI = 73)

**Conditions:** PCI: 73

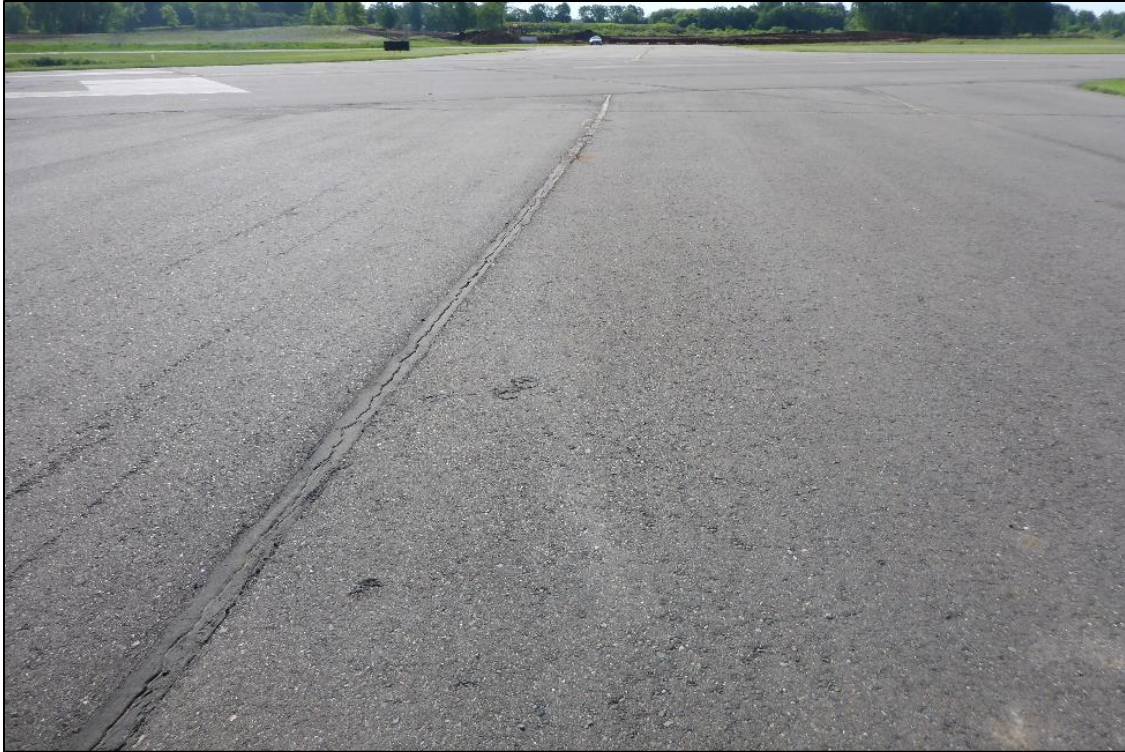
JMR RY1129 001 (PCI = 94)

**Conditions:** **PCI:** 94

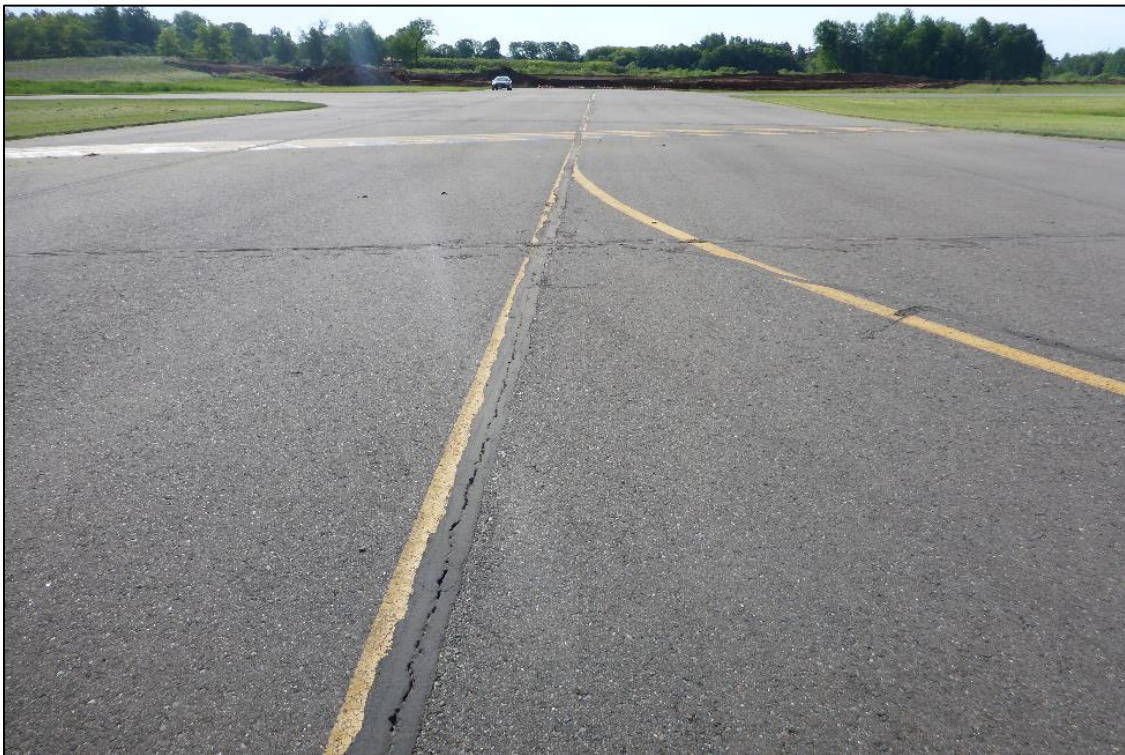
JMR RY1129 002 (PCI = 86)

**Conditions:** **PCI:** 86

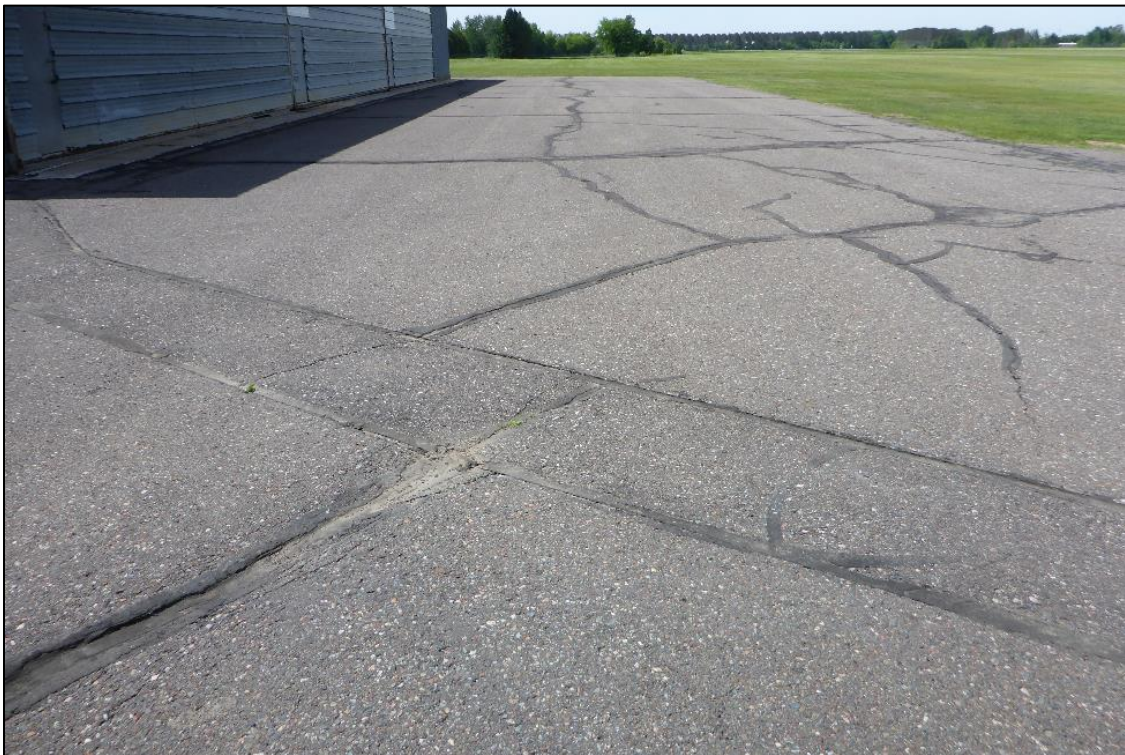
JMR TLA 001 (PCI = 44)

**Conditions:** PCI: 44

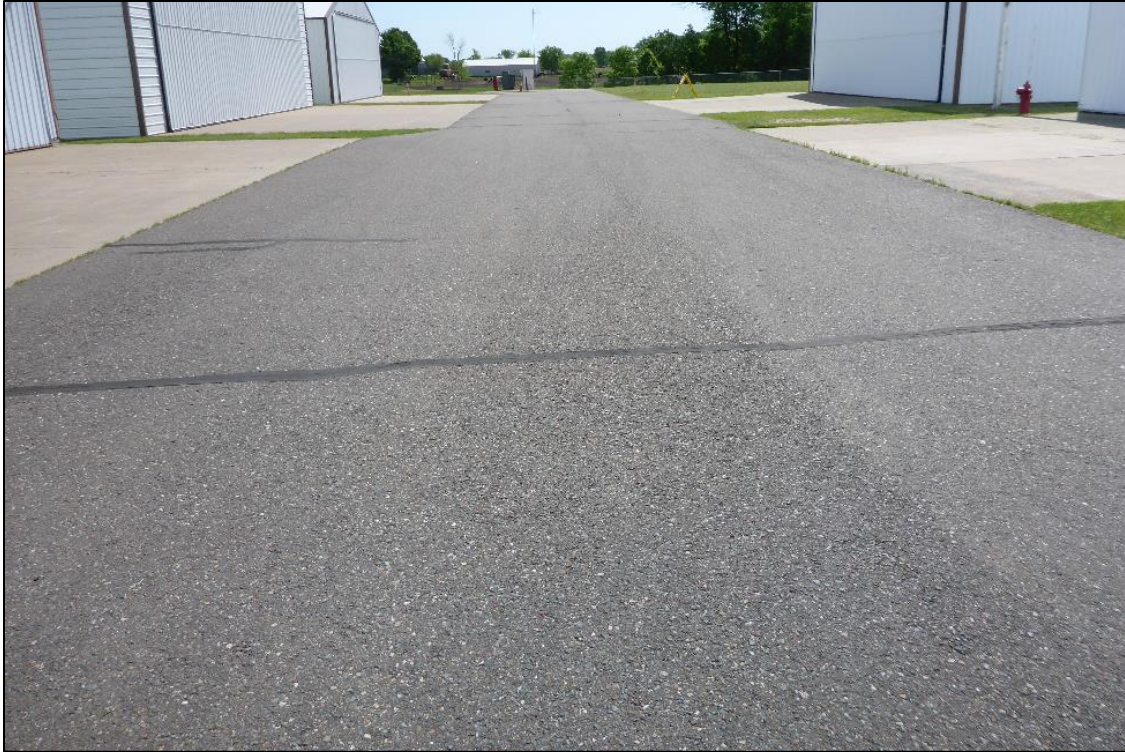
JMR TLB 001 (PCI = 83)

**Conditions:** PCI: 83

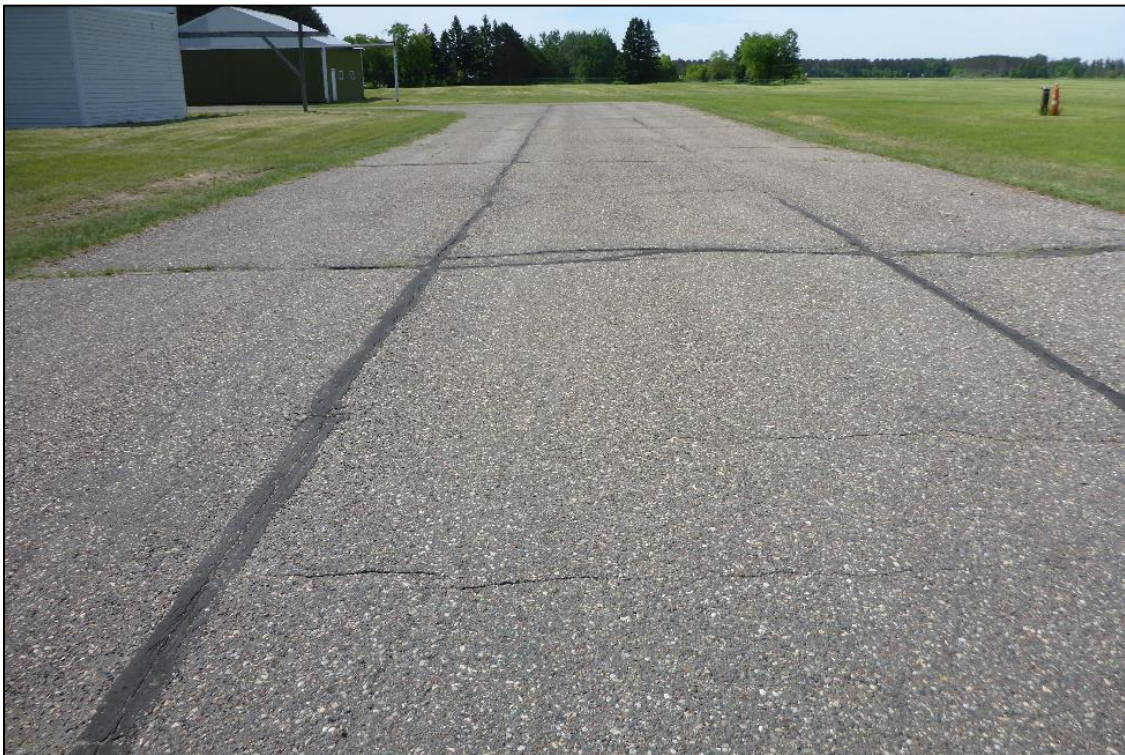
JMR TLC 001 (PCI = 10)

**Conditions:** PCI: 10

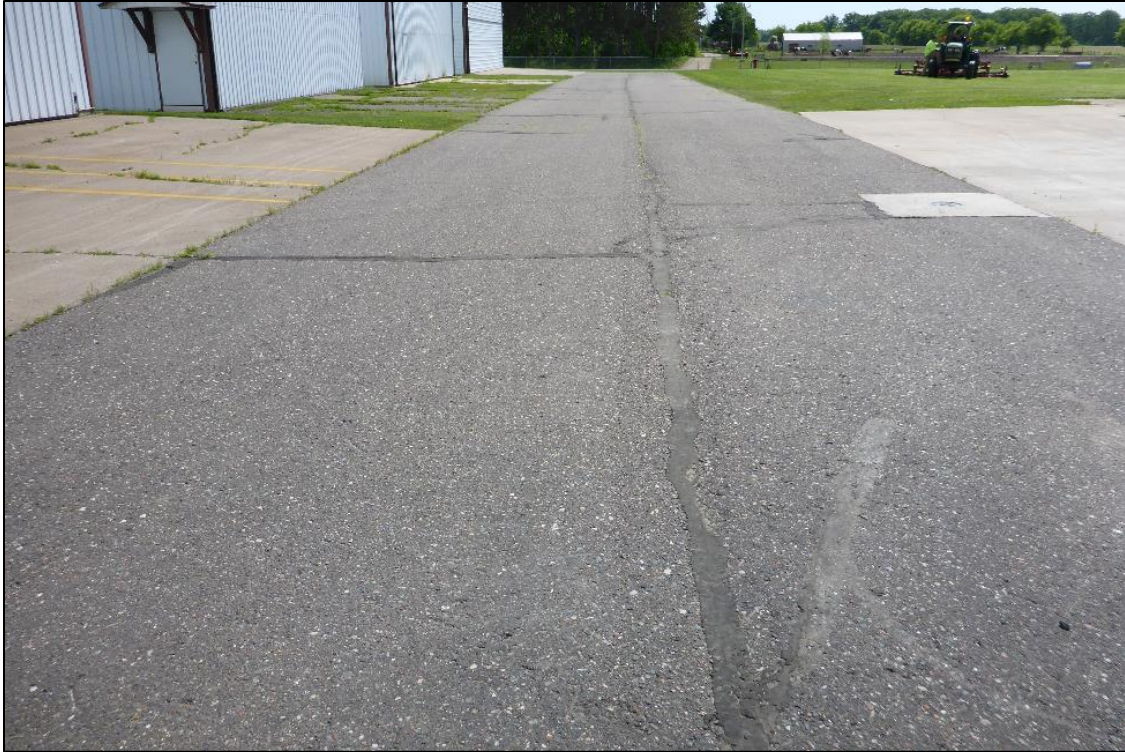
JMR TLD 001 (PCI = 54)

**Conditions:** PCI: 54
