Pavement Condition Report

McGregor-Isedor Iverson Airport (HZX)

December 2018

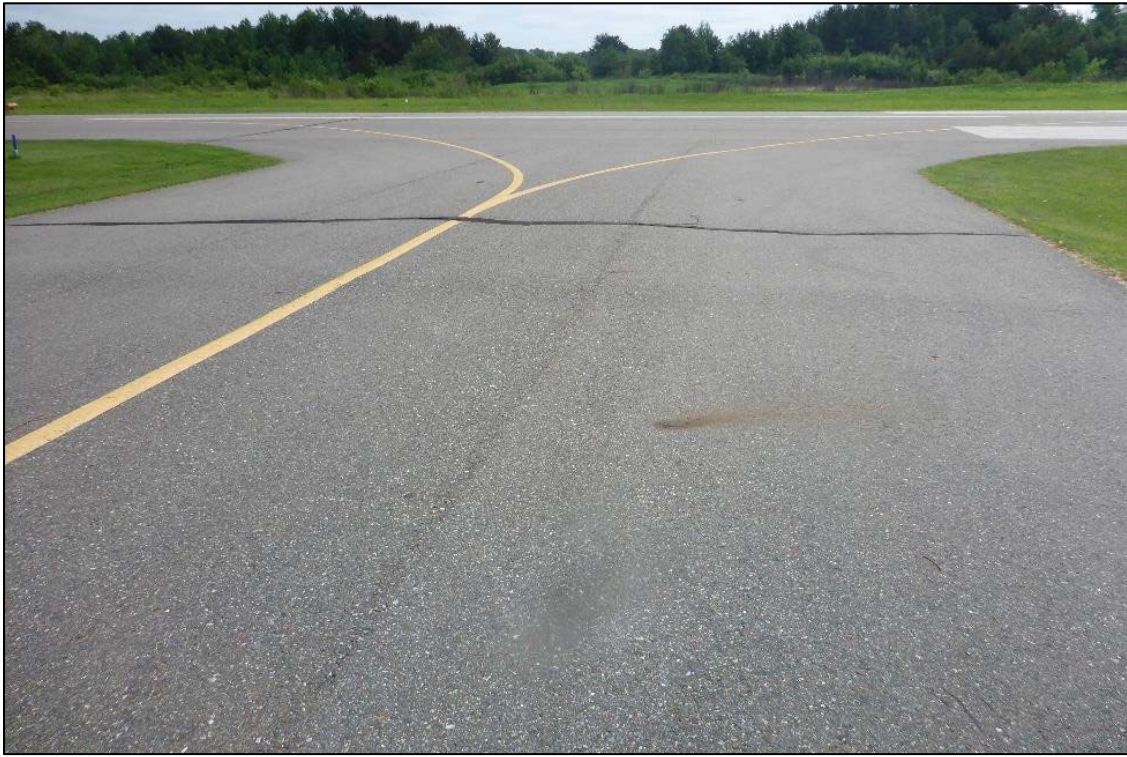
HZX CTA 001 (PCI = 77)

Network:	HZX		Name:	MCGREGOR					
Branch:	CTA	Name:	CONNECTING TXWY A	Use:	TAXIWAY	Area:	10,320 SqFt		
Section:	001	of 1	From:	100	To:	102	Last Const.:	8/1/2012	
Surface:	AC	Family:	MN2018 Asphalt Runway- Taxiways	Zone:	E	Category:	2	Rank:	P
Area:	10,320 SqFt	Length:	258 Ft	Width:	40 Ft				
Slabs:		Slab Length:	Ft	Slab Width:	Ft	Joint Length:	Ft		
Shoulder:		Street Type:		Grade:	0	Lanes:	0		
Section Comments:	overlaid Aug 2012 (PCI was 11)								
Last Insp. Date:	6/10/2018		TotalSamples:	3		Surveyed:	2		
Conditions:	PCI: 77								
Inspection Comments:									
Sample Number:	100	Type:	R	Area:	4000.00 SqFt	PCI:	71		
Sample Comments:									
57	WEATHERING	L	1800.00	SqFt					
48	L & T CR	M	21.00	Ft					
56	SWELLING	L	160.00	SqFt					
48	L & T CR	L	22.00	Ft					
48	L & T CR	H	19.00	Ft					
Sample Number:	101	Type:	R	Area:	4000.00 SqFt	PCI:	83		
Sample Comments:									
48	L & T CR	M	18.00	Ft					
57	WEATHERING	L	1500.00	SqFt

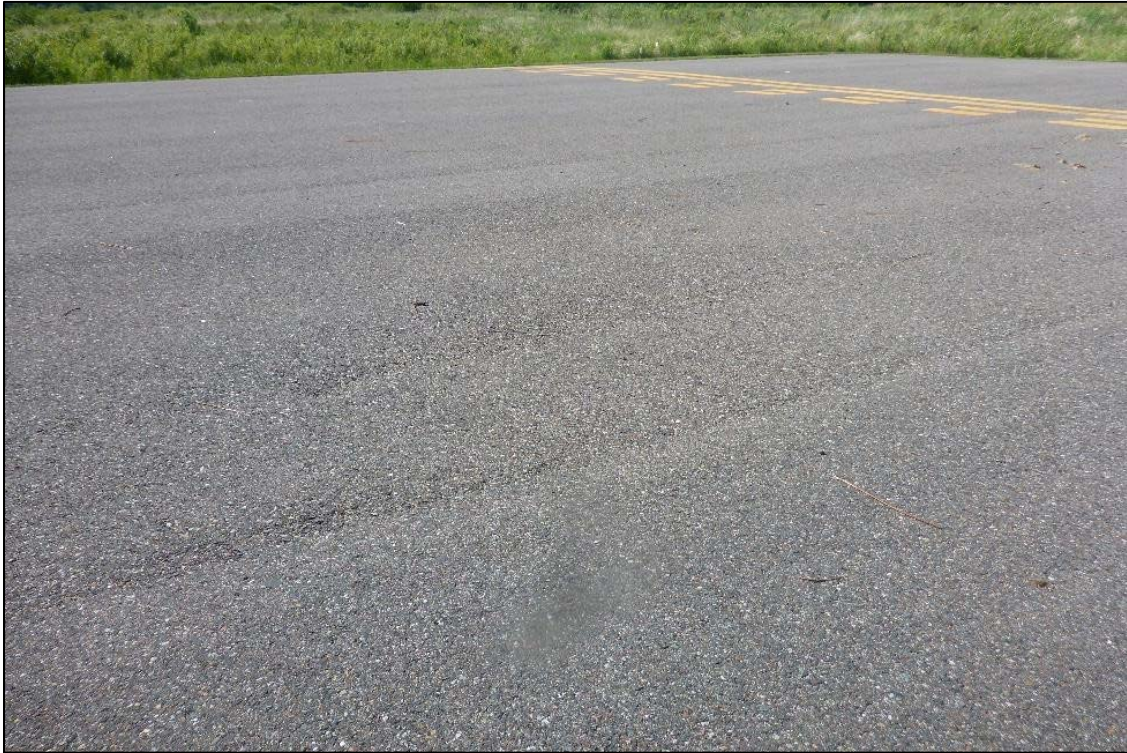
HZX RTA 001 (PCI = 92)

Network:	HZX		Name:	MCGREGOR					
Branch:	RTA	Name:	RTA	Use:	TAXIWAY	Area:	21,661 SqFt		
Section:	001	of 2	From:	200	To:	201	Last Const.:	8/1/2012	
Surface:	AC	Family:	MN2018 Asphalt Runway-Taxiways	Zone:	E	Category:	2	Rank:	S
Area:	10,736 SqFt	Length:	130 Ft	Width:	80 Ft				
Slabs:		Slab Length:	Ft	Slab Width:	Ft	Joint Length:	Ft		
Shoulder:		Street Type:		Grade:	0	Lanes:	0		
Section Comments:	removed/replaced asphalt (PCI was 71)								
Last Insp. Date:	6/10/2018	TotalSamples:	2	Surveyed:	1				
Conditions:	PCI: 92								
Inspection Comments:									
Sample Number:	201	Type:	R	Area:	5535.00 SqFt	PCI:	92		
Sample Comments:									
57	WEATHERING	L	1500.00 SqFt						
48	L & T CR	L	36.00 Ft

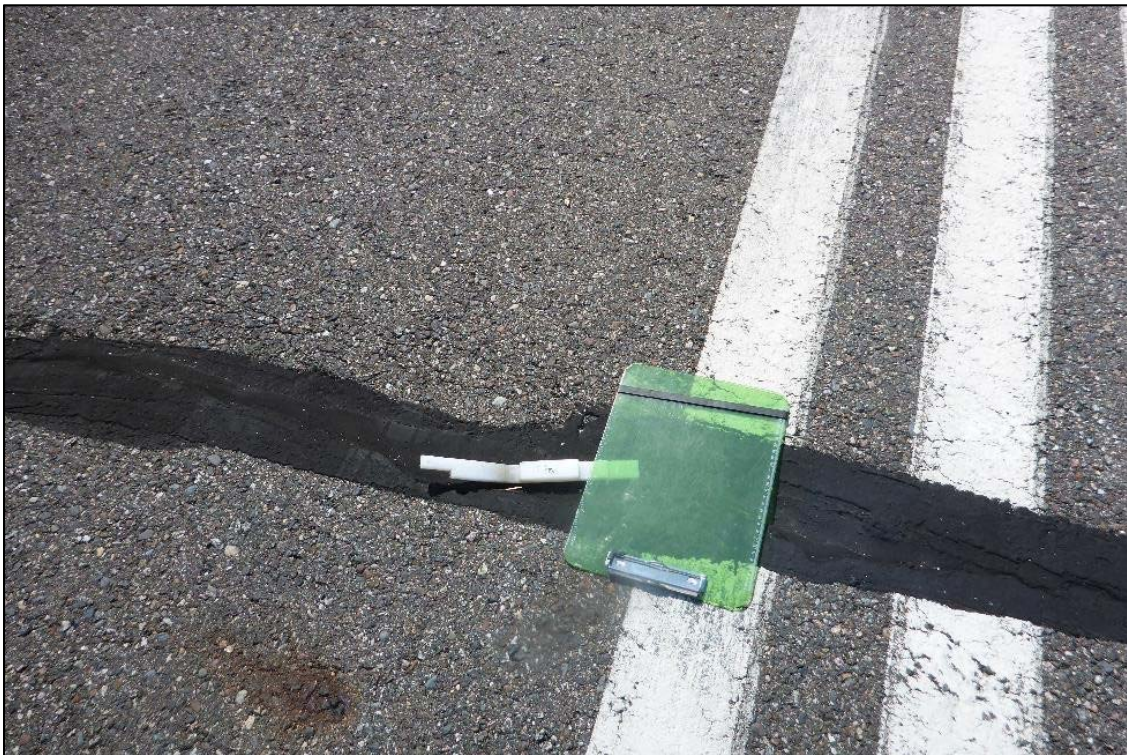
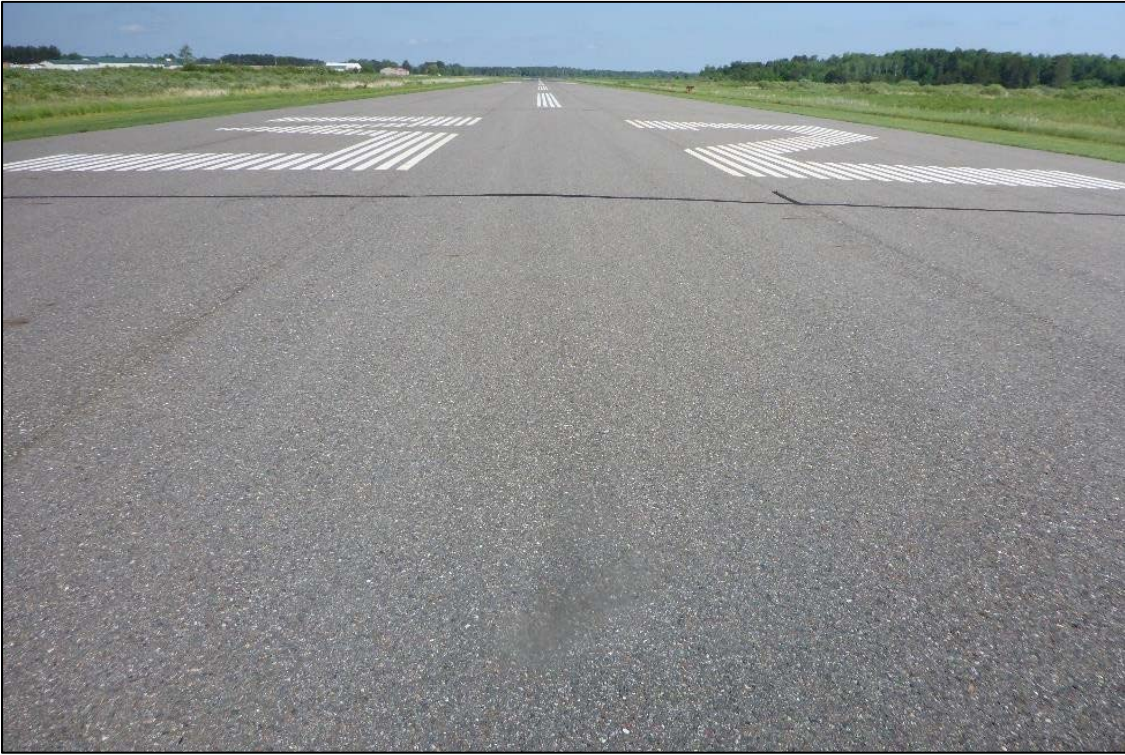
HZX RY1432 001 (PCI = 78)

Network:	HZX		Name:	MCGREGOR					
Branch:	RY1432	Name:	RUNWAY 14-32	Use:	RUNWAY	Area:	255,000 SqFt		
Section:	001	of 1	From:	100	To:	167	Last Const.:	8/1/2012	
Surface:	AC	Family:	MN2018 Asphalt Runway- Taxiways	Zone:	E	Category:	2	Rank:	P
Area:	255,000 SqFt	Length:	3,400 Ft	Width:	75 Ft				
Slabs:		Slab Length:	Ft	Slab Width:	Ft	Joint Length:	Ft		
Shoulder:		Street Type:		Grade:	0	Lanes:	0		
Section Comments:	removed/replaced asphalt (PCI was 13 and 41)								
Last Insp. Date:	6/10/2018		TotalSamples:	49		Surveyed:	8		
Conditions:	PCI: 78								
Inspection Comments:									
Sample Number:	105	Type:	R	Area:	3750.00 SqFt	PCI:	91		
Sample Comments:									
57	WEATHERING	L		1800.00	SqFt				
48	L & T CR	L		27.00	Ft				
Sample Number:	109	Type:	R	Area:	3750.00 SqFt	PCI:	76		
Sample Comments:									
57	WEATHERING	M		1500.00	SqFt				
48	L & T CR	L		58.00	Ft				
48	L & T CR	M		17.00	Ft				
Sample Number:	114	Type:	R	Area:	3750.00 SqFt	PCI:	86

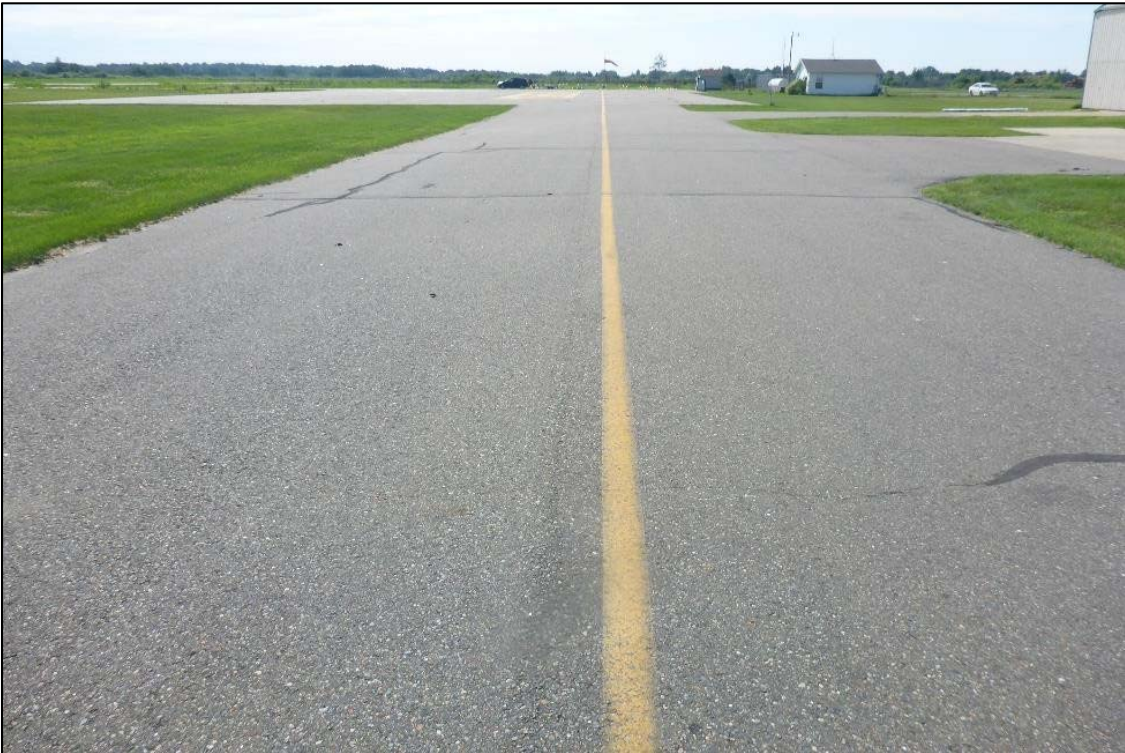
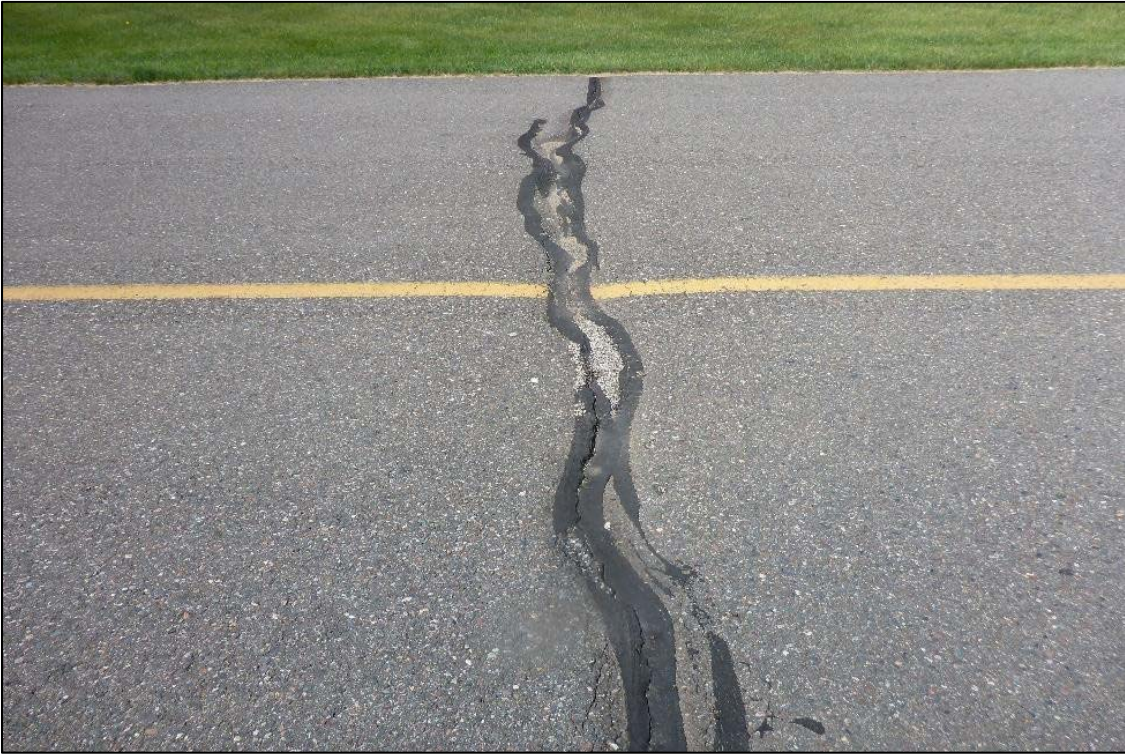
HZX TLA 001 (PCI = 78)

Network:	HZX		Name:	MCGREGOR					
Branch:	TLA	Name:	Taxilane A	Use:	TAXILANE	Area:	24,500 SqFt		
Section:	001	of 2	From:	100	To:	102	Last Const.:	8/1/2012	
Surface:	AC	Family:	MN2018 Asphalt Taxilanes	Zone:	E	Category:	2	Rank:	T
Area:	9,000 SqFt	Length:	300 Ft	Width:	30 Ft	Joint Length:	Ft		
Slabs:		Slab Length:	Ft	Slab Width:	Ft	Joint Length:	Ft		
Shoulder:		Street Type:		Grade:	0	Lanes:	0		
Section Comments:	overlaid in Aug 2012								
Last Insp. Date:	6/10/2018		TotalSamples:	3		Surveyed:	2		
Conditions:	PCI: 78								
Inspection Comments:									
Sample Number:	101	Type:	R	Area:	3000.00 SqFt	PCI:	80		
Sample Comments:									
57	WEATHERING	L		1500.00	SqFt				
48	L & T CR	L		163.00	Ft				
Sample Number:	102	Type:	A	Area:	3000.00 SqFt	PCI:	75		
Sample Comments:									
48	L & T CR	H		25.00	Ft				
48	L & T CR	M		5.00	Ft				
48	L & T CR	L		105.00	Ft

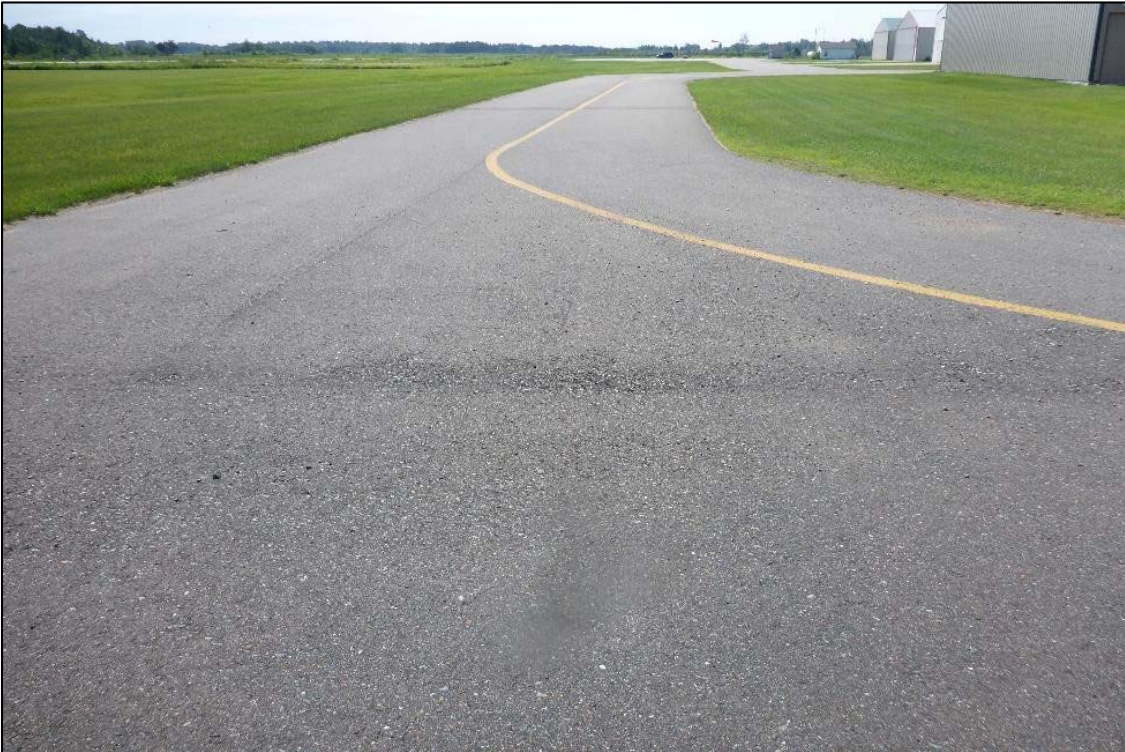
HZX TLA 002 (PCI = 85)

Network:	HZX		Name:	MCGREGOR					
Branch:	TLA	Name:	Taxilane A	Use:	TAXILANE	Area:	24,500 SqFt		
Section:	002	of 2	From:	100	To:	103	Last Const.:	6/1/2008	
Surface:	AC	Family:	MN2018 Asphalt Taxilanes	Zone:	E	Category:	2	Rank:	T
Area:	15,500 SqFt	Length:	725 Ft	Width:	20 Ft				
Slabs:		Slab Length:	Ft	Slab Width:	Ft	Joint Length:	Ft		
Shoulder:		Street Type:		Grade:	0	Lanes:	0		
Section Comments:									
Last Insp. Date:	6/10/2018	TotalSamples:	4	Surveyed:	2				
Conditions:	PCI: 85								
Inspection Comments:									
Sample Number:	100	Type:	R	Area:	4500.00 SqFt	PCI:	90		
Sample Comments:									
48	L & T CR	L	67.00	Ft					
48	L & T CR	M	6.00	Ft					
Sample Number:	101	Type:	A	Area:	3600.00 SqFt	PCI:	70		
Sample Comments:									
45	DEPRESSION	M	60.00	SqFt					
57	WEATHERING	M	800.00	SqFt					
48	L & T CR	M	20.00	Ft
