Pavement Condition Report

Worthington Municipal Airport (OTG)

December 2018

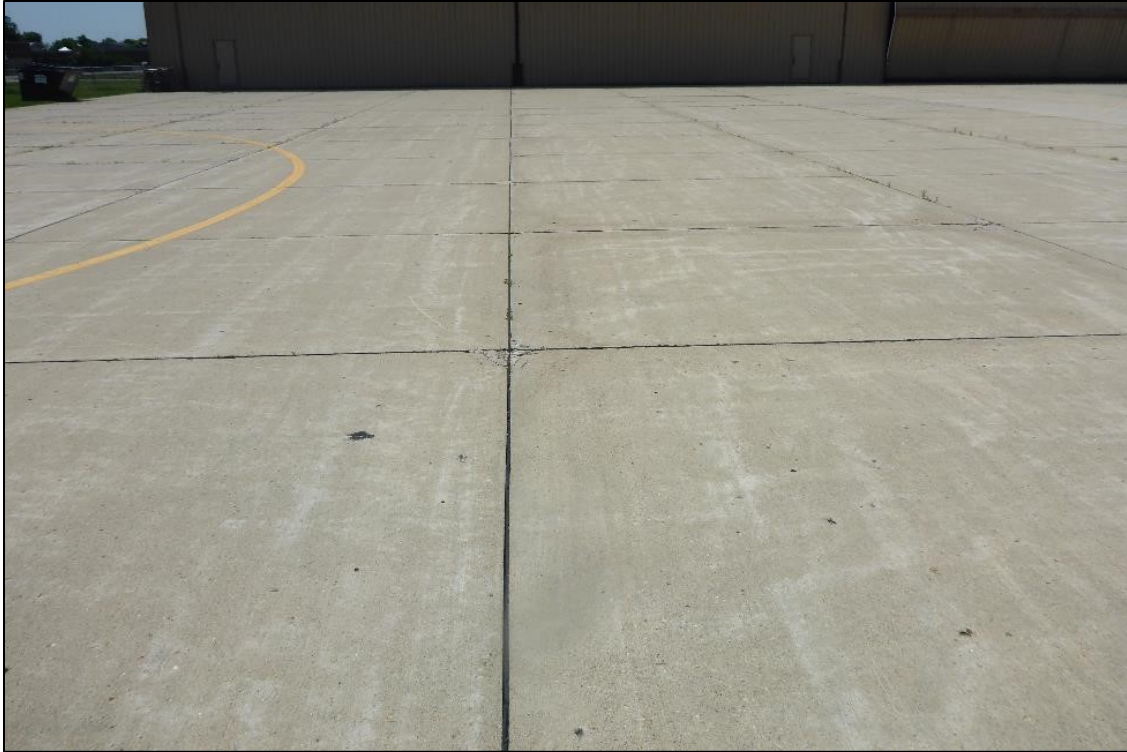
OTG APA 003 (PCI = 43)

Network: OTG						Name: WORTHINGTON
Branch: APA	Name: APRON A	Use: APRON	Area: 205,417 SqFt			
Section: 003	of 4	From: 403	To: 704	Last Const.: 9/30/1979		
Surface: PCC	Family: MN2018 PCC	Zone: S	Category: 2	Rank: S		
Area: 28,610 SqFt	Length: 135 Ft	Width: 230 Ft				
Slabs: 166	Slab Length: 15 Ft	Slab Width: 13 Ft	Joint Length: 4,189 Ft			
Shoulder:	Street Type:	Grade: 0	Lanes: 0			
Last Insp. Date: 6/6/2018	TotalSamples: 10	Surveyed: 3				
Conditions: PCI: 43						
Sample Number: 503	Type: R	Area: 16.00 Slabs	PCI: 40			
75 CORNER SPALL	M	2.00 Slabs				
75 CORNER SPALL	L	1.00 Slabs				
65 JT SEAL DMG	H	16.00 Slabs				
63 LINEAR CR	L	1.00 Slabs				
64 DURABIL. CR	L	10.00 Slabs				
64 DURABIL. CR	M	6.00 Slabs				
Sample Number: 604	Type: R	Area: 20.00 Slabs	PCI: 40			
67 LARGE PATCH	L	1.00 Slabs				
65 JT SEAL DMG	H	20.00 Slabs				
75 CORNER SPALL	H	1.00 Slabs				
64 DURABIL. CR	M	9.00 Slabs				
62 CORNER BREAK	M	1.00 Slabs

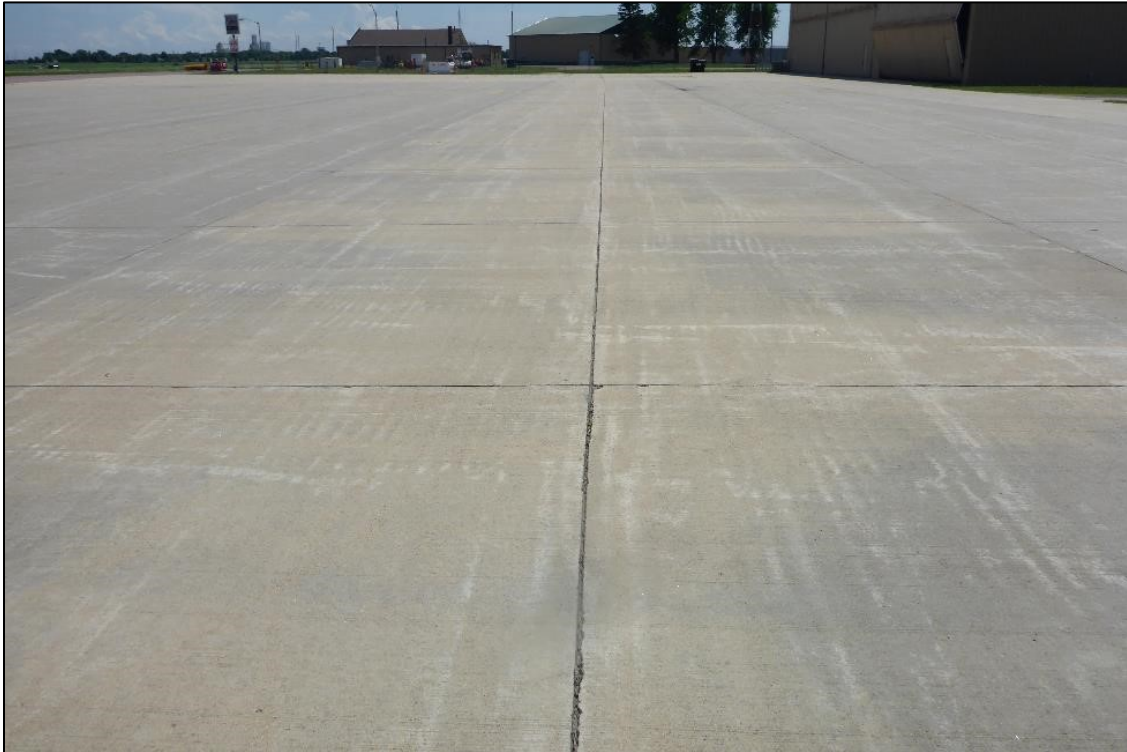
OTG APA 004 (PCI = 95)

Network:	OTG	Name:	WORTHINGTON						
Branch:	APA	Name:	APRON A	Use:	APRON	Area:	205,417 SqFt		
Section:	004	of 4	From:	405	To:	708	Last Const.: 6/1/2004		
Surface:	PCC	Family:	MN2018 PCC	Zone:	S	Category:	2	Rank:	S
Area:	60,230 SqFt	Length:	300 Ft	Width:	215 Ft				
Slabs:	344	Slab Length:	15 Ft	Slab Width:	13 Ft	Joint Length:	8,945 Ft		
Shoulder:		Street Type:		Grade:	0	Lanes:	0		
Last Insp. Date:	6/6/2018	TotalSamples:	16	Surveyed:	4				
Conditions:	PCI: 95								
Sample Number:	405	Type:	R	Area:	20.00 Slabs	PCI:	97		
73	SHRINKAGE CR		N	1.00	Slabs				
65	JT SEAL DMG		L	20.00	Slabs				
Sample Number:	506	Type:	R	Area:	20.00 Slabs	PCI:	98		
65	JT SEAL DMG		L	20.00	Slabs				
Sample Number:	607	Type:	R	Area:	20.00 Slabs	PCI:	93		
65	JT SEAL DMG		M	20.00	Slabs				
Sample Number:	708	Type:	R	Area:	20.00 Slabs	PCI:	93		
63	LINEAR CR		L	1.00	Slabs				
65	JT SEAL DMG		L	20.00	Slabs

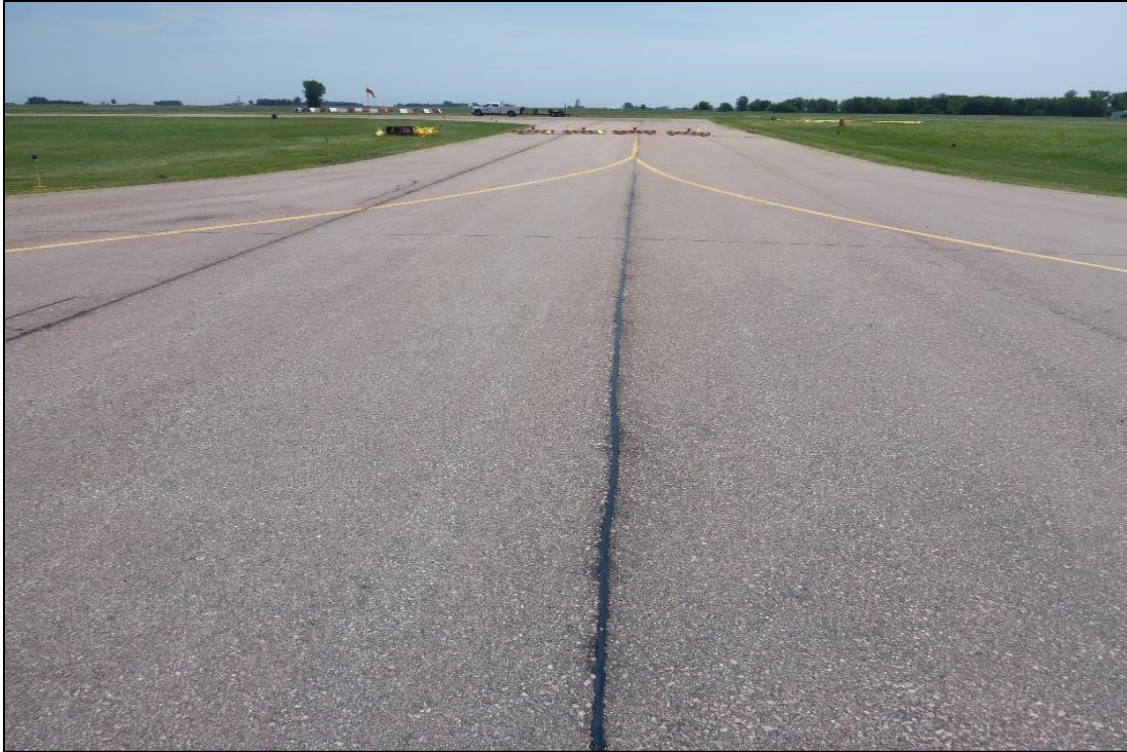
OTG CTA 001 (PCI = 78)

Network:	OTG	Name:	WORTHINGTON						
Branch:	CTA	Name:	CONNECTING TXWY A	Use:	TAXIWAY	Area:	23,260 SqFt		
Section:	001	of 1	From:	100	To:	102	Last Const.: 10/1/2009		
Surface:	AC	Family:	MN2018 Asphalt Runway- Taxiways	Zone:	S	Category:	2	Rank:	P
Area:	23,260 SqFt	Length:	335 Ft	Width:	50 Ft				
Slabs:		Slab Length:	Ft	Slab Width:	Ft	Joint Length:	Ft		
Shoulder:		Street Type:		Grade:	0	Lanes:	0		
Last Insp. Date:	6/6/2018	TotalSamples:	3	Surveyed:	1				
Conditions:	PCI: 78								
Sample Number:	101	Type:	R	Area:	5000.00 SqFt	PCI:	78		
48	L & T CR		L	308.00	Ft				
48	L & T CR		M	32.00	Ft

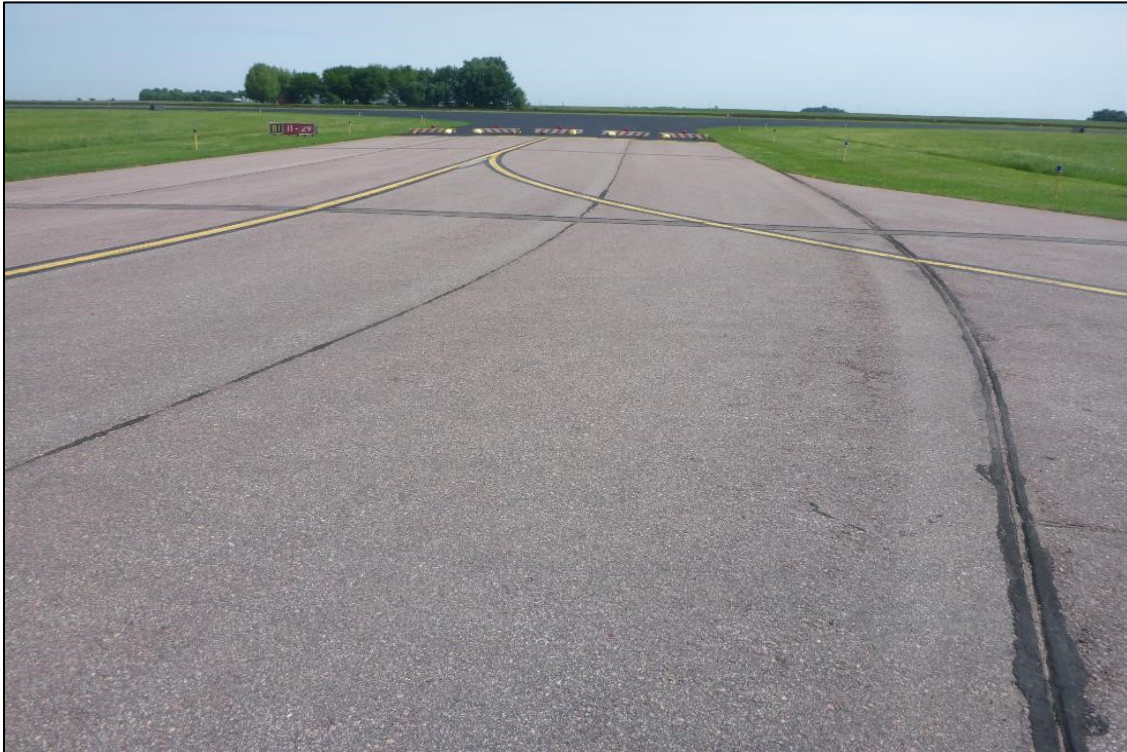
OTG CTB 001 (PCI = 75)

Network:	OTG	Name:		WORTHINGTON		
Branch:	CTB	Name:	CONNECTING TAXIWAY B	Use:	TAXIWAY	Area: 128,505 SqFt
Section:	001	of 2	From: 100	To: 116+24	Last Const.: 9/30/2001	
Surface:	AC	Family: MN2018 Asphalt Runway- Taxiways	Zone: S	Category: 2	Rank: S	
Area:	88,855 SqFt	Length:	1,624 Ft	Width:	50 Ft	
Slabs:		Slab Length:	Ft	Slab Width:	Ft	Joint Length: Ft
Shoulder:		Street Type:		Grade: 0	Lanes: 0	
Last Insp. Date:	6/6/2018	TotalSamples:	16	Surveyed:	3	
Conditions:	PCI: 75					
Sample Number:	102	Type:	R	Area:	5000.00 SqFt	PCI: 75
48	L & T CR		L	254.00	Ft	
48	L & T CR		M	69.00	Ft	
50	PATCHING		L	75.00	SqFt	
Sample Number:	108	Type:	R	Area:	5000.00 SqFt	PCI: 75
48	L & T CR		L	202.00	Ft	
48	L & T CR		M	95.00	Ft	
50	PATCHING		L	75.00	SqFt	
Sample Number:	114	Type:	R	Area:	5000.00 SqFt	PCI: 75
50	PATCHING		L	50.00	SqFt	
57	WEATHERING		L	100.00	SqFt	
48	L & T CR		L	222.00	Ft	
50	PATCHING		M	25.00	SqFt	
48	L & T CR		M	89.00	Ft

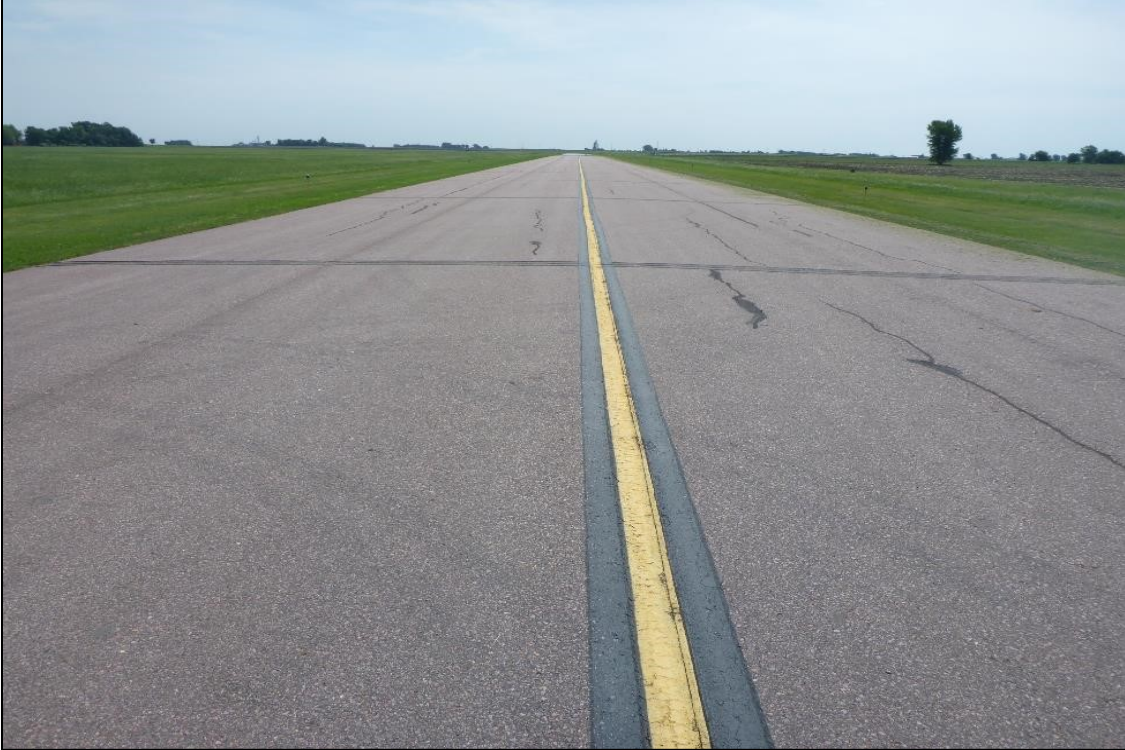
OTG CTB 002 (PCI = 70)

Network:	OTG	Name:	WORTHINGTON						
Branch:	CTB	Name:	CONNECTING TAXIWAY B	Use:	TAXIWAY	Area:	128,505 SqFt		
Section:	002	of 2	From:	116+45	To:	124+44	Last Const.:	9/30/2000	
Surface:	AC	Family:	MN2018 Asphalt Runway- Taxiways	Zone:	S	Category:	2	Rank:	S
Area:	39,650 SqFt	Length:	800 Ft	Width:	50 Ft				
Slabs:		Slab Length:	Ft	Slab Width:	Ft	Joint Length:	Ft		
Shoulder:		Street Type:		Grade:	0	Lanes:	0		
Last Insp. Date:	6/6/2018	TotalSamples:	8	Surveyed:	2				
Conditions:	PCI: 70								
Sample Number:	118	Type:	R	Area:	5000.00 SqFt	PCI:	72		
48	L & T CR	L		341.00	Ft				
48	L & T CR	M		14.00	Ft				
50	PATCHING	L		150.00	SqFt				
Sample Number:	123	Type:	R	Area:	5000.00 SqFt	PCI:	68		
50	PATCHING	L		75.00	SqFt				
57	WEATHERING	L		500.00	SqFt				
48	L & T CR	L		410.00	Ft				
48	L & T CR	M		19.00	Ft

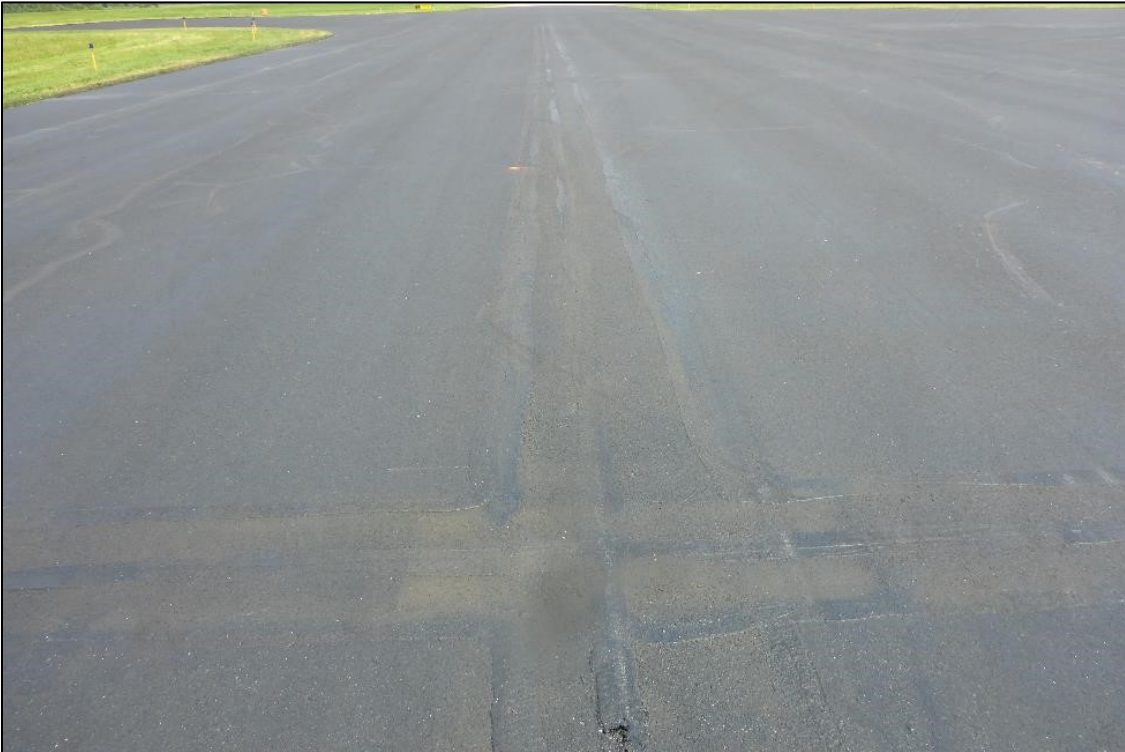
OTG PTC 002 (PCI = 78)

⁷Increase in PCI on PTC-002 due to crack seal and emulsion seal done in 2018

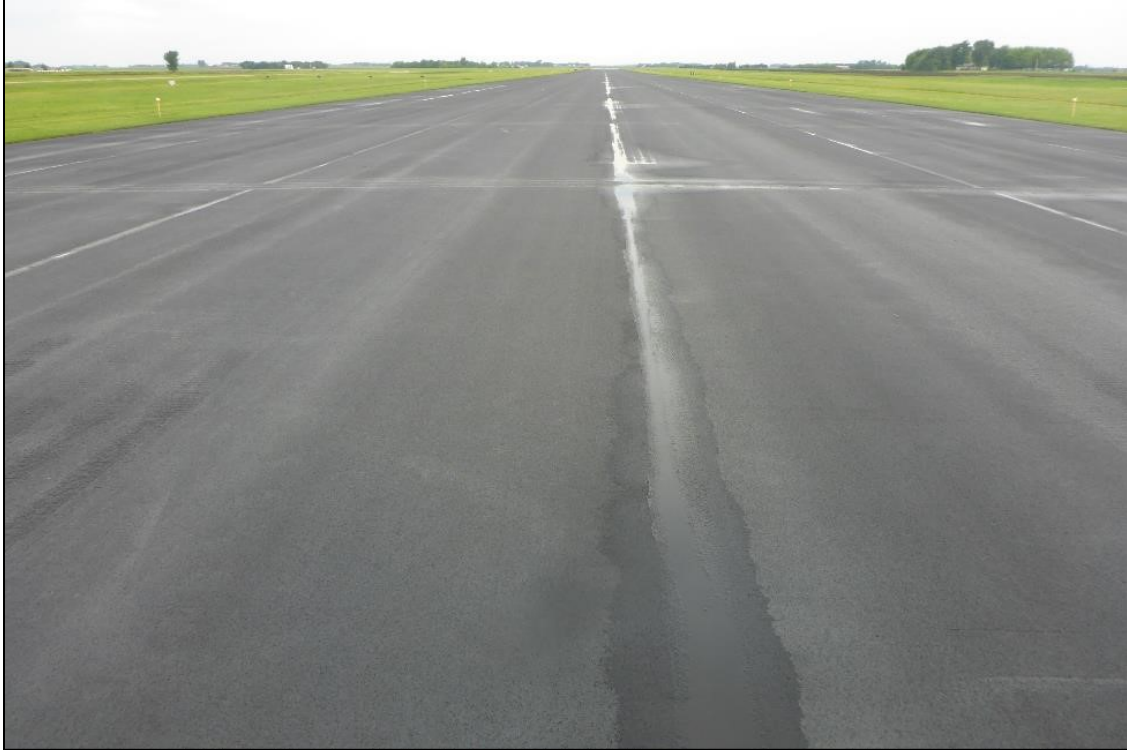
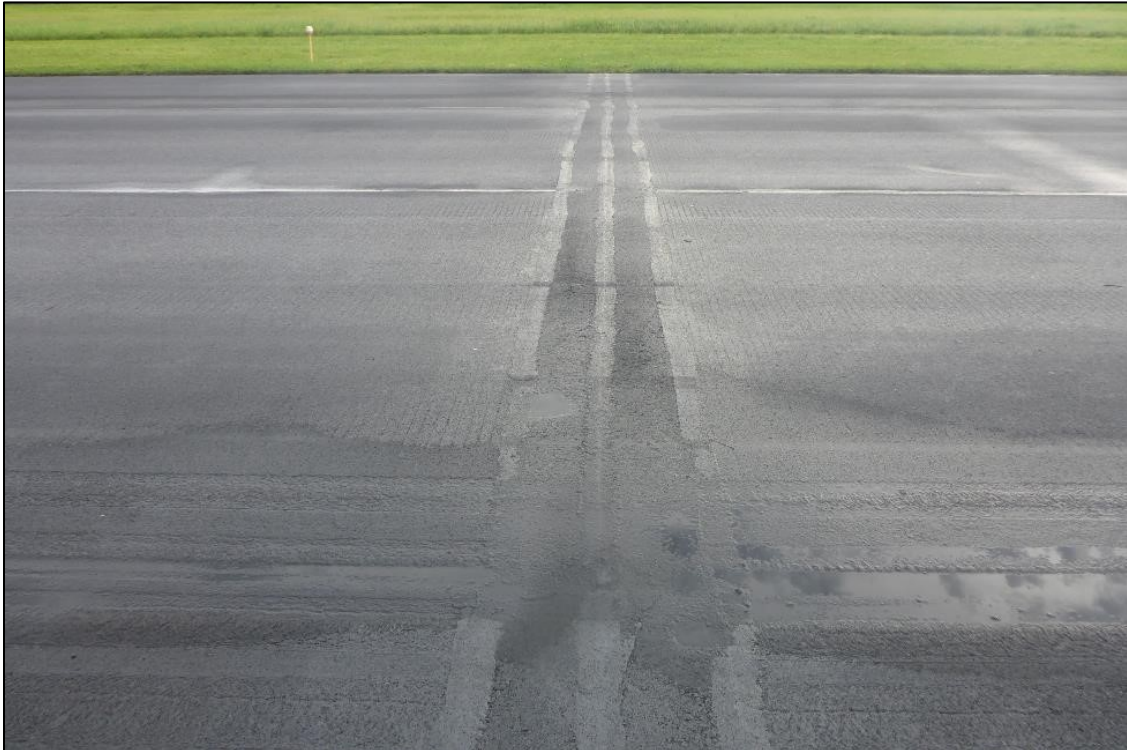
OTG RY1129 001 (PCI = 75)

⁹Increase in PCI on RY1129-001, RY1836-002, and RY1836-003 due to crack seal and emulsion seal done in 2018
