Pavement Condition Report

Redwood Falls Municipal Airport (RWF)

December 2018

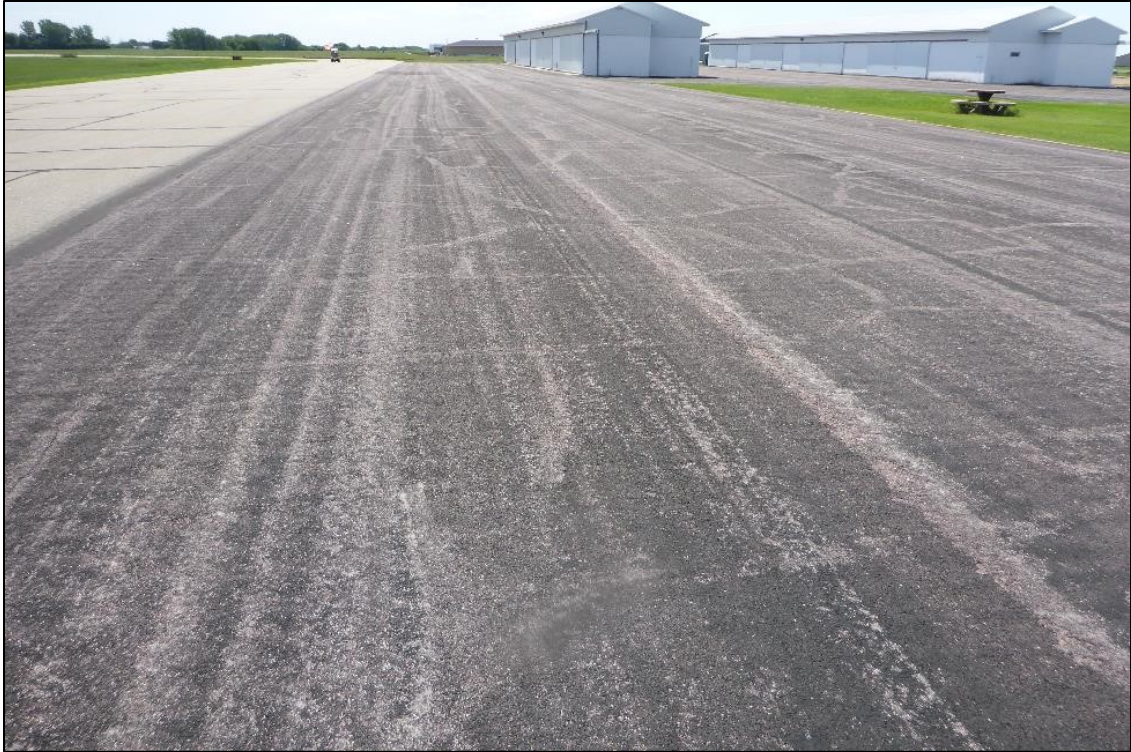
RWF APA 001 (PCI = 64)

Network:	RWF	Name:	REDWOOD FALLS						
Branch:	APA	Name:	APRON A	Use:	APRON	Area:	167,850 SqFt		
Section:	001	of 6	From:	204	To:	206	Last Const.:	9/30/1996	
Surface:	AC	Family:	MN2018 Asphalt Aprons	Zone:	S	Category:	2	Rank:	S
Area:	12,150 SqFt	Length:	270 Ft	Width:	45 Ft				
Slabs:	Slab Length:	Ft	Slab Width:	Ft	Joint Length:	Ft			
Shoulder:	Street Type:		Grade:	0	Lanes:	0			
Section Comments:	maint. R&E (crack seal)								
Last Insp. Date:	6/4/2018	TotalSamples:	3	Surveyed:	1				
Conditions:	PCI:	64							
Inspection Comments:	new slurry seal								
Sample Number:	205	Type:	R	Area:	4500.00 SqFt	PCI:	64		
Sample Comments:									
43	BLOCK CR	L	4500.00	SqFt

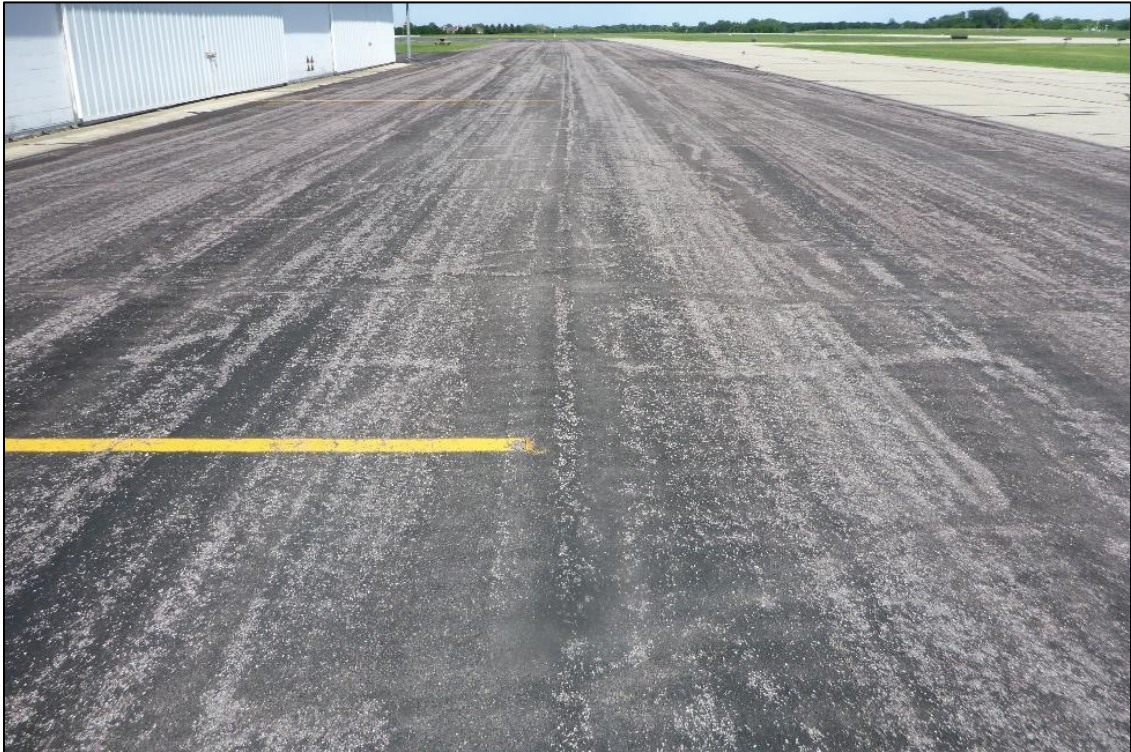
RWF APA 002 (PCI = 61)

Section Comments: maint. R&E (crack seal)

Conditions: PCI: 61

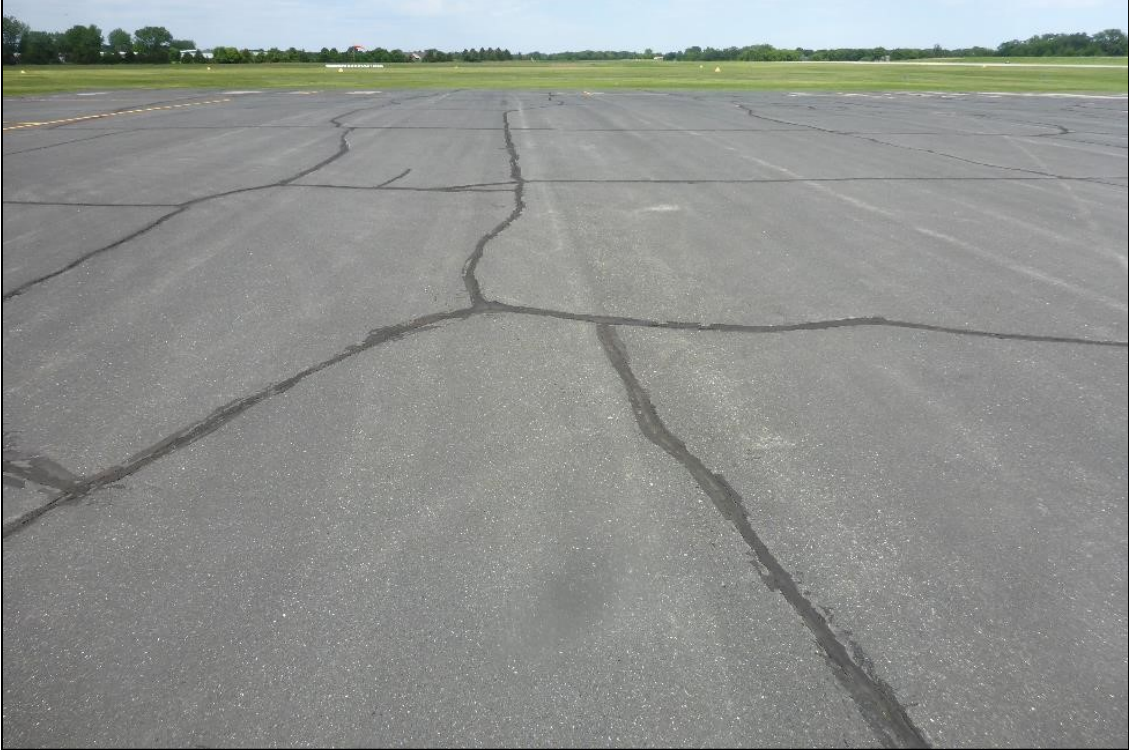
RWF APA 003 (PCI = 68)

Network:	RWF	Name:	REDWOOD FALLS						
Branch:	APA	Name:	APRON A	Use:	APRON	Area:	167,850 SqFt		
Section:	003	of 6	From:	100	To:	503	Last Const.:	9/30/1996	
Surface:	AC	Family:	MN2018 Asphalt Aprons	Zone:	S	Category:	2	Rank:	S
Area:	87,660 SqFt	Length:	400 Ft	Width:	220 Ft				
Slabs:	Slab Length:	Ft	Slab Width:	Ft	Joint Length:	Ft			
Shoulder:	Street Type:		Grade:	0	Lanes:	0			
Section Comments:	maint. R&E (slurry seal)								
Last Insp. Date:	6/4/2018	TotalSamples:	16	Surveyed:	4				
Conditions:	PCI:	68							
Inspection Comments:									
Sample Number:	201	Type:	R	Area:	5000.00 SqFt	PCI:	68		
Sample Comments:									
48	L & T CR	M	73.00	Ft					
48	L & T CR	H	8.00	Ft					
48	L & T CR	L	535.00	Ft					
Sample Number:	300	Type:	R	Area:	5000.00 SqFt	PCI:	65		
Sample Comments:									
48	L & T CR	M	78.00	Ft					
48	L & T CR	H	10.00	Ft					
48	L & T CR	L	695.00	Ft					
Sample Number:	302	Type:	R	Area:	5000.00 SqFt	PCI:	66

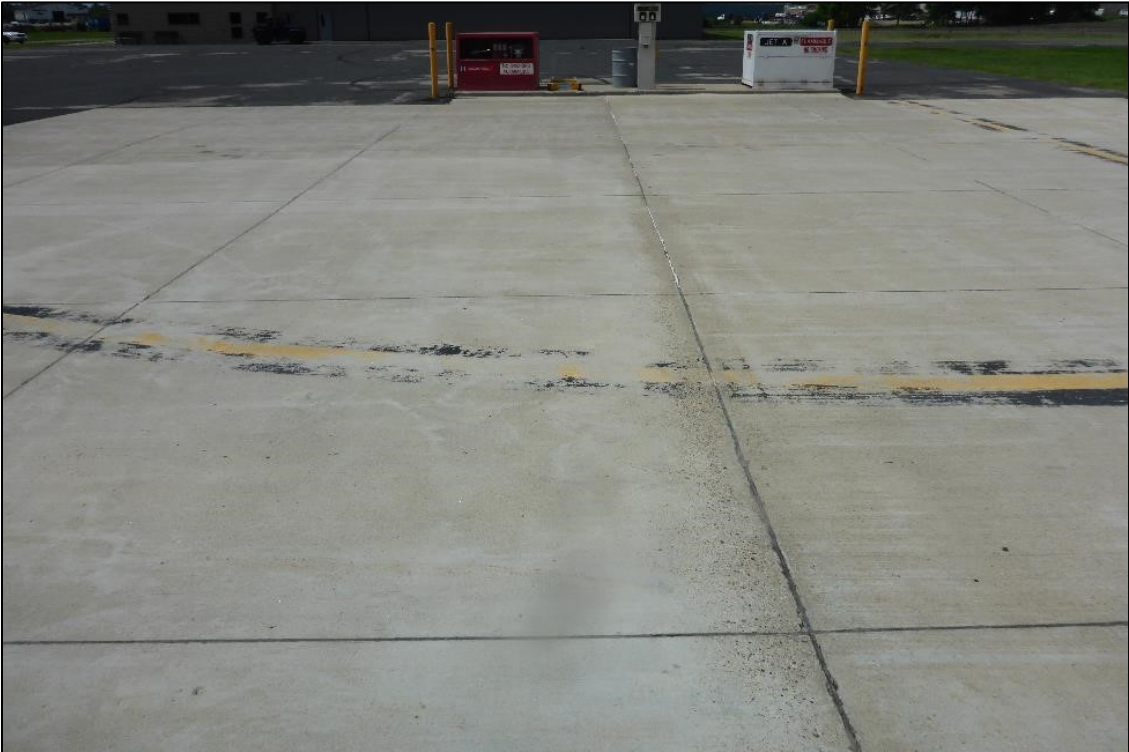
RWF APA 004 (PCI = 93)

Network:	RWF	Name:	REDWOOD FALLS				
Branch:	APA	Name:	APRON A	Use:	APRON	Area:	167,850 SqFt
Section:	004	of 6	From:	-	To:	-	Last Const.: 6/1/2007
Surface:	PCC	Family:	MN2018 PCC	Zone:	S	Category:	2
Area:	3,600 SqFt	Length:	60 Ft	Width:	60 Ft	Rank:	S
Slabs:	36	Slab Length:	10 Ft	Slab Width:	10 Ft	Joint Length:	600 Ft
Shoulder:		Street Type:		Grade:	0	Lanes:	0
Section Comments:	estimated LCD						
Last Insp. Date:	6/4/2018	TotalSamples:	2	Surveyed:	1		
Conditions:	PCI:	93					
Inspection Comments:							
Sample Number:	502	Type:	R	Area:	18.00 Slabs	PCI:	93
Sample Comments:							
65	JT SEAL DMG	M	18.00 Slabs

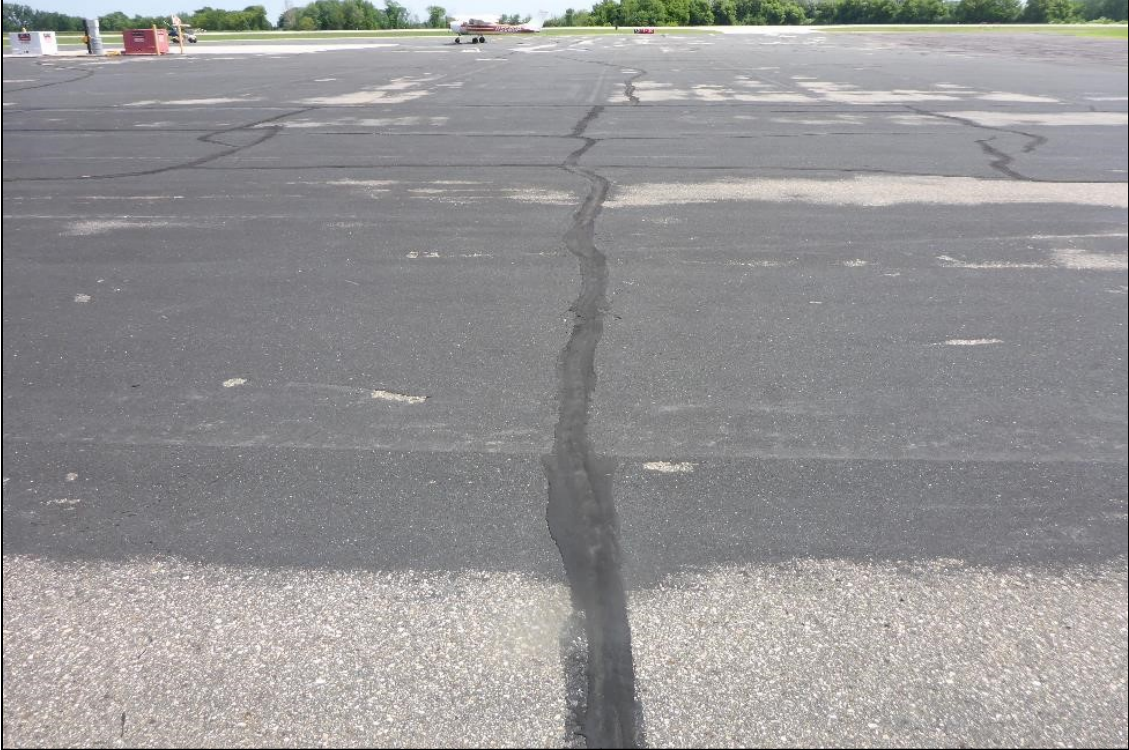
RWF APA 005 (PCI = 85)

Network:	RWF	Name:	REDWOOD FALLS						
Branch:	APA	Name:	APRON A	Use:	APRON	Area:	167,850 SqFt		
Section:	005	of 6	From:	600	To:	901	Last Const.:	6/1/2005	
Surface:	AC	Family:	MN2018 Asphalt Aprons	Zone:	S	Category:	2	Rank:	S
Area:	34,000 SqFt	Length:	200 Ft	Width:	165 Ft				
Slabs:	Slab Length:	Ft	Slab Width:	Ft	Joint Length:	Ft			
Shoulder:	Street Type:		Grade:	0	Lanes:	0			
Section Comments:	estimated LCD; maint. R&E (slurry seal)								
Last Insp. Date:	6/4/2018	TotalSamples:	8	Surveyed:	3				
Conditions:	PCI:	85							
Inspection Comments:									
Sample Number:	700	Type:	R	Area:	5000.00 SqFt	PCI:	92		
Sample Comments:									
57	WEATHERING	L	650.00	SqFt					
48	L & T CR	L	74.00	Ft					
Sample Number:	701	Type:	R	Area:	3500.00 SqFt	PCI:	89		
Sample Comments:									
48	L & T CR	L	94.00	Ft					
57	WEATHERING	L	280.00	SqFt					
Sample Number:	801	Type:	R	Area:	3500.00 SqFt	PCI:	70		
Sample Comments:

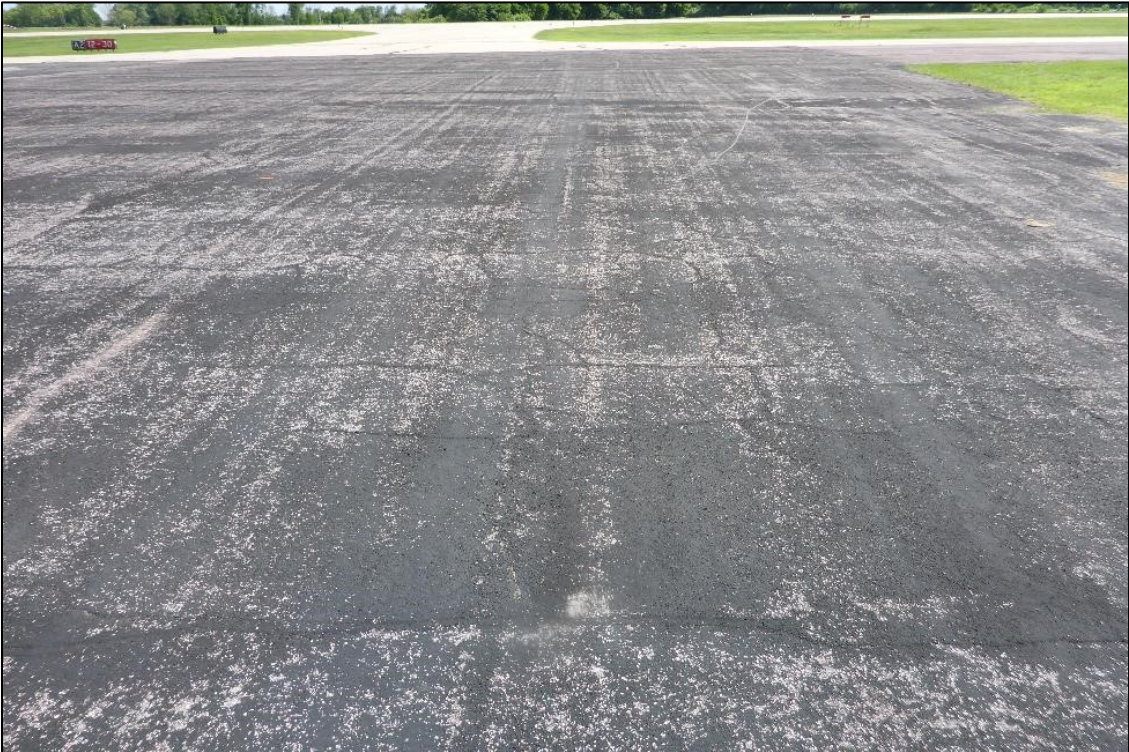
RWF APA 006 (PCI = 22)

Network:	RWF	Name:	REDWOOD FALLS				
Branch:	APA	Name:	APRON A	Use:	APRON	Area:	167,850 SqFt
Section:	006	of 6	From:	-	To:	-	Last Const.: 9/30/1996
Surface:	AAC	Family:	MN2018 Asphalt Aprons	Zone:		Category:	Rank: S
Area:	13,440 SqFt	Length:	290 Ft	Width:	70 Ft		
Slabs:		Slab Length:	Ft	Slab Width:	Ft	Joint Length:	Ft
Shoulder:		Street Type:		Grade:	0	Lanes:	0
Section Comments:	maint. R&E (slurry seal)						
Last Insp. Date:	6/4/2018	TotalSamples:	3	Surveyed:	1		
Conditions:	PCI: 22						
Inspection Comments:							
Sample Number:	404	Type:	R	Area:	3200.00 SqFt	PCI:	22
Sample Comments:							
41	ALLIGATOR CR	M	30.00	SqFt			
48	L & T CR	L	180.00	Ft			
43	BLOCK CR	H	1400.00	SqFt			
48	L & T CR	M	15.00	Ft

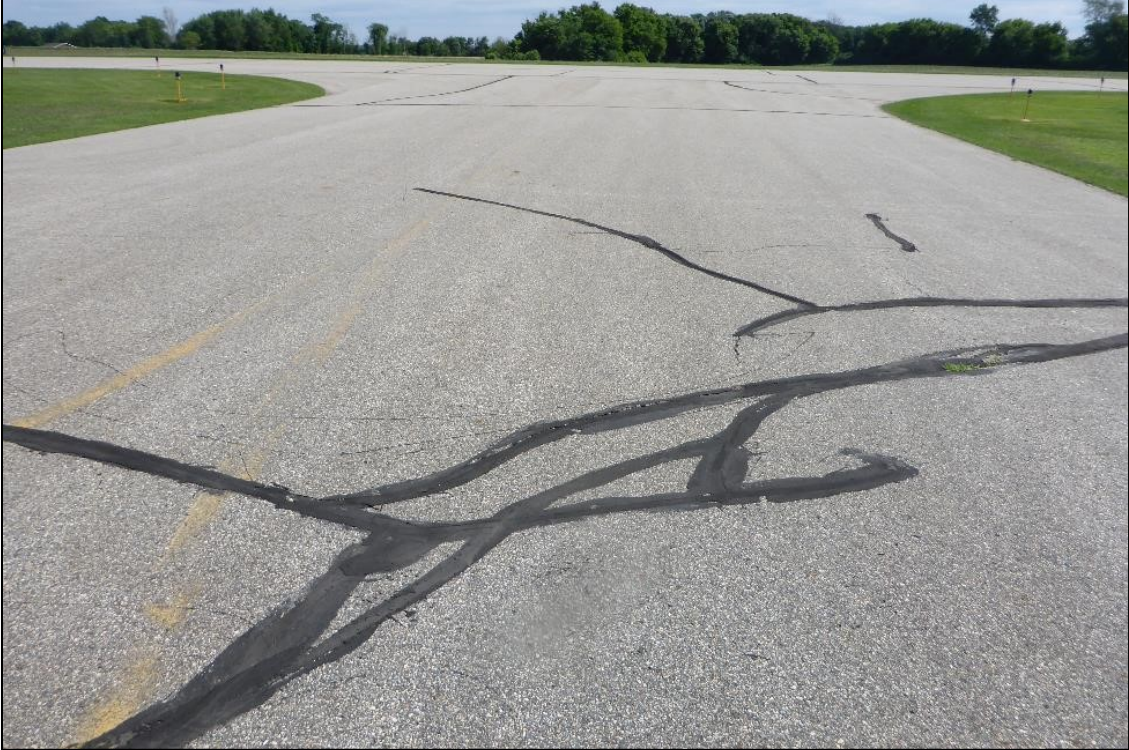
RWF CTA2 001 (PCI = 81)

Network:	RWF	Name:	REDWOOD FALLS						
Branch:	CTA2	Name:	CONNECTING TAXIWAY A2	Use:	TAXIWAY	Area:	12,430 SqFt		
Section:	001	of 1	From:	201	To:	202	Last Const.: 6/1/2009		
Surface:	AC	Family:	MN2018 Asphalt Runway- Taxiways	Zone:	S	Category:	2	Rank:	P
Area:	12,430 SqFt	Length:	175 Ft	Width:	40 Ft				
Slabs:		Slab Length:	Ft	Slab Width:	Ft	Joint Length:	Ft		
Shoulder:		Street Type:		Grade:	0	Lanes:	0		
Section Comments:	maint. R&E (crack seal)								
Last Insp. Date:	6/4/2018	TotalSamples:	2	Surveyed:	1				
Conditions:	PCI:	81							
Inspection Comments:	check width length and area								
Sample Number:	201	Type:	R	Area:	5675.00 SqFt	PCI:	81		
Sample Comments:									
48	L & T CR	L	137.00 Ft						
48	L & T CR	M	35.00 Ft						
57	WEATHERING	L	2800.00 SqFt

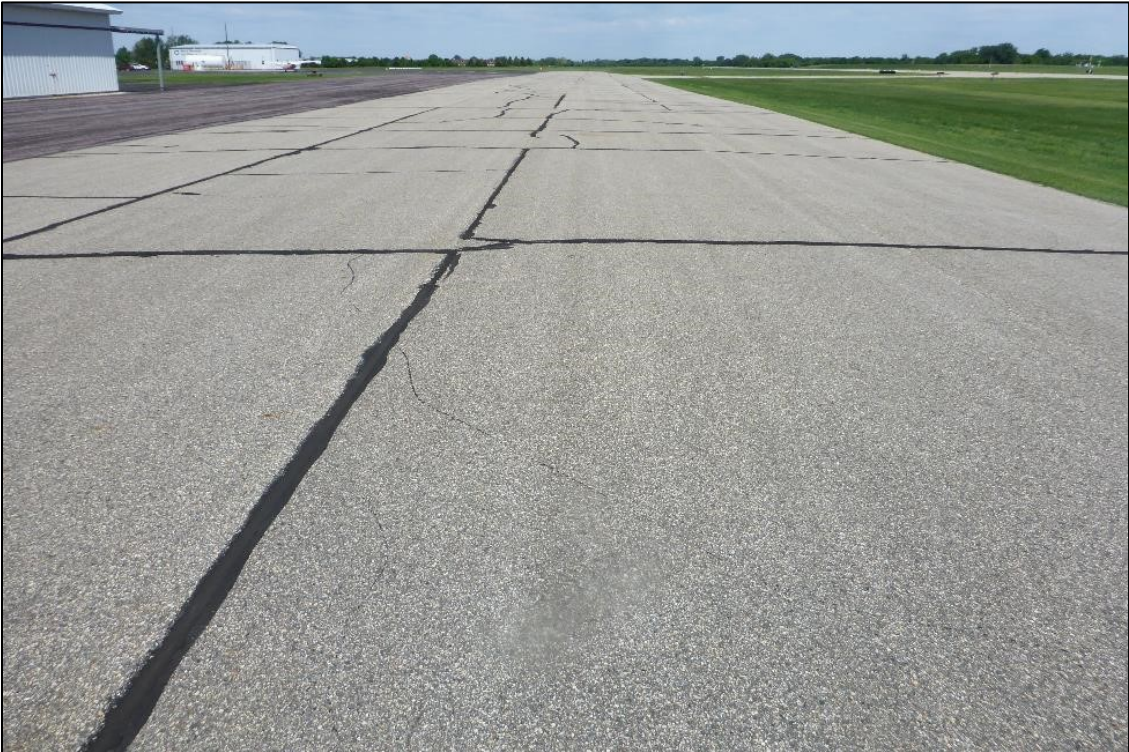
RWF PPTA 001 (PCI = 70)

Network:	RWF	Name:	REDWOOD FALLS						
Branch:	PPTA	Name:	Partial Parallel TW A	Use:	TAXIWAY	Area:	66,540 SqFt		
Section:	001	of 1	From:	100	To:	113	Last Const.: 6/1/2009		
Surface:	AC	Family:	MN2018 Asphalt Runway- Taxiways	Zone:	S	Category:	2	Rank:	P
Area:	66,540 SqFt	Length:	1,375 Ft	Width:	50 Ft				
Slabs:		Slab Length:	Ft	Slab Width:	Ft	Joint Length:	Ft		
Shoulder:		Street Type:		Grade:	0	Lanes:	0		
Section Comments:									
Last Insp. Date:	6/4/2018	TotalSamples:	14	Surveyed:	5				
Conditions:	PCI: 70								
Inspection Comments:									
Sample Number:	100	Type:	R	Area:	5000.00 SqFt	PCI:	71		
Sample Comments:									
48	L & T CR	M	15.00	Ft					
48	L & T CR	L	363.00	Ft					
57	WEATHERING	L	2500.00	SqFt					
Sample Number:	103	Type:	R	Area:	5000.00 SqFt	PCI:	69		
Sample Comments:									
48	L & T CR	L	429.00	Ft					
57	WEATHERING	L	2500.00	SqFt					
48	L & T CR	M	47.00	Ft					
Sample Number:	106	Type:	R	Area:	5000.00 SqFt	PCI:	68

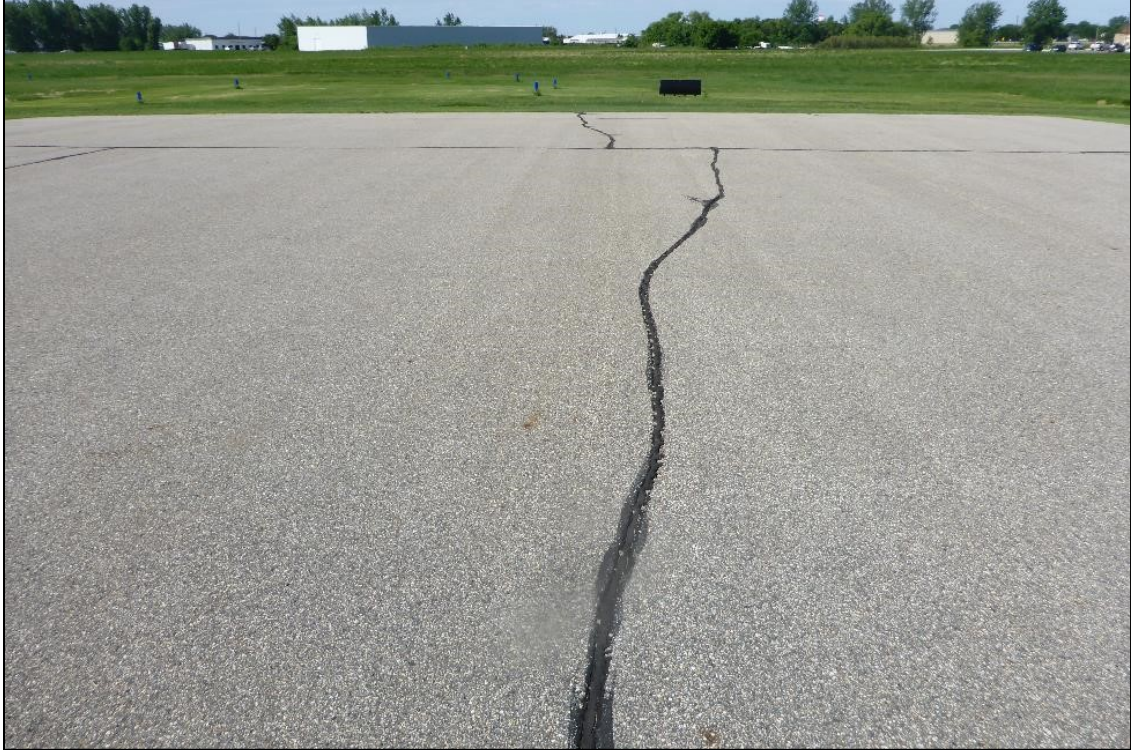
RWF RTA 001 (PCI = 78)

Conditions: PCI: 78
