Pavement Condition Report

Owatonna Degner Regional Airport (OWA)

December 2019

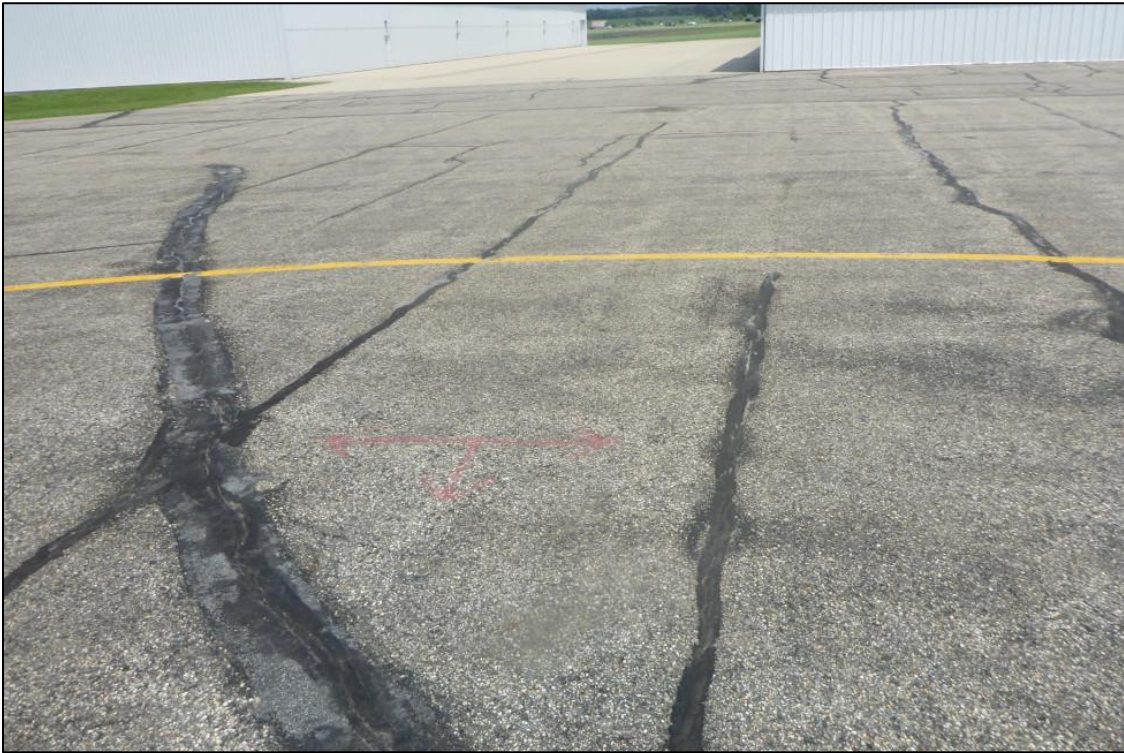
OWA APA 002 (PCI = 61)

Sample Comments: crack fill since 2016...look at photos for fog seal crack filler with gravel p909,910

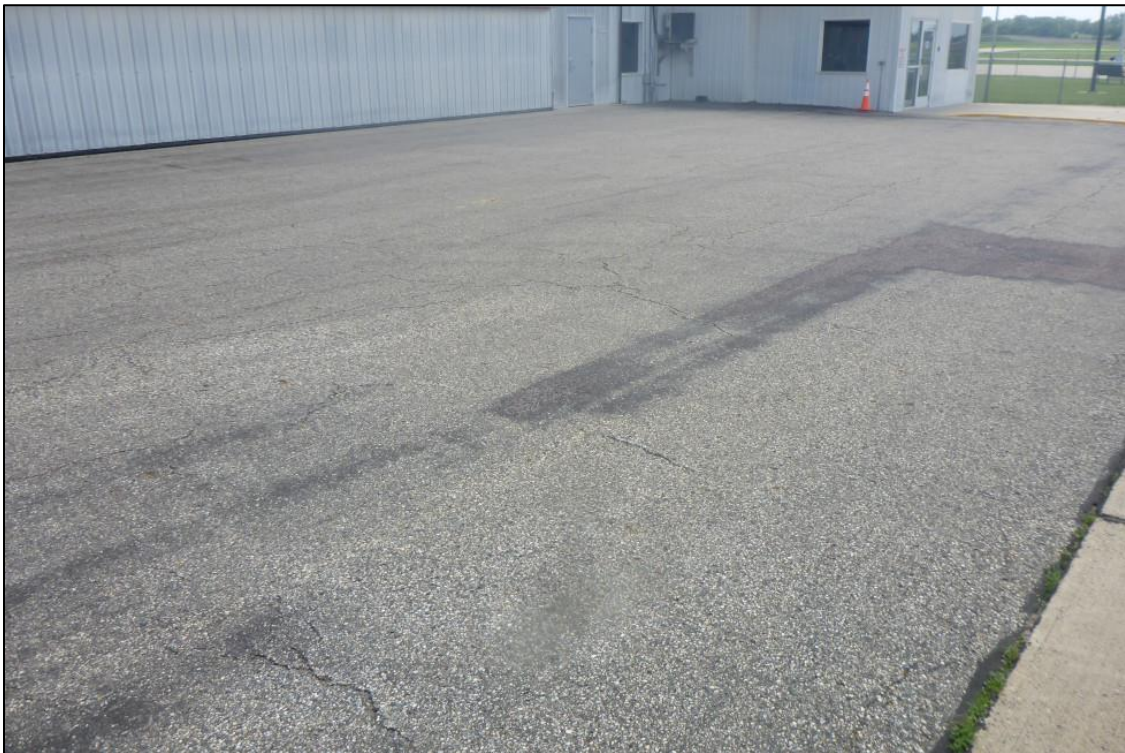
OWA APA 005 (PCI = 66)

Network:	OWA		Name:	OWATONNA					
Branch:	APA	Name:	Apron A	Use:	APRON	Area:	243,879 SqFt		
Section:	005	of 4	From:	100	To:	100	Last Const.:	9/26/1998	
Surface:	AC	Family:	MN2018 Asphalt Aprons	Zone:	S	Category:	3	Rank:	S
Area:	5,076 SqFt	Length:	108 Ft	Width:	47 Ft				
Slabs:	Slab Length:	Ft	Slab Width:	Ft	Joint Length:	Ft			
Shoulder:	Street Type:		Grade:	0	Lanes:	0			
Section Comments:									
Last Insp. Date:	6/11/2019	TotalSamples:	1	Surveyed:	1				
Conditions:	PCI: 66								
Inspection Comments:									
Sample Number:	100	Type:	R	Area:	5076.00 SqFt	PCI:	66		
Sample Comments:									
48	L & T CR	L	167.00	Ft					
48	L & T CR	M	219.00	Ft					
57	WEATHERING	L	3000.00	SqFt

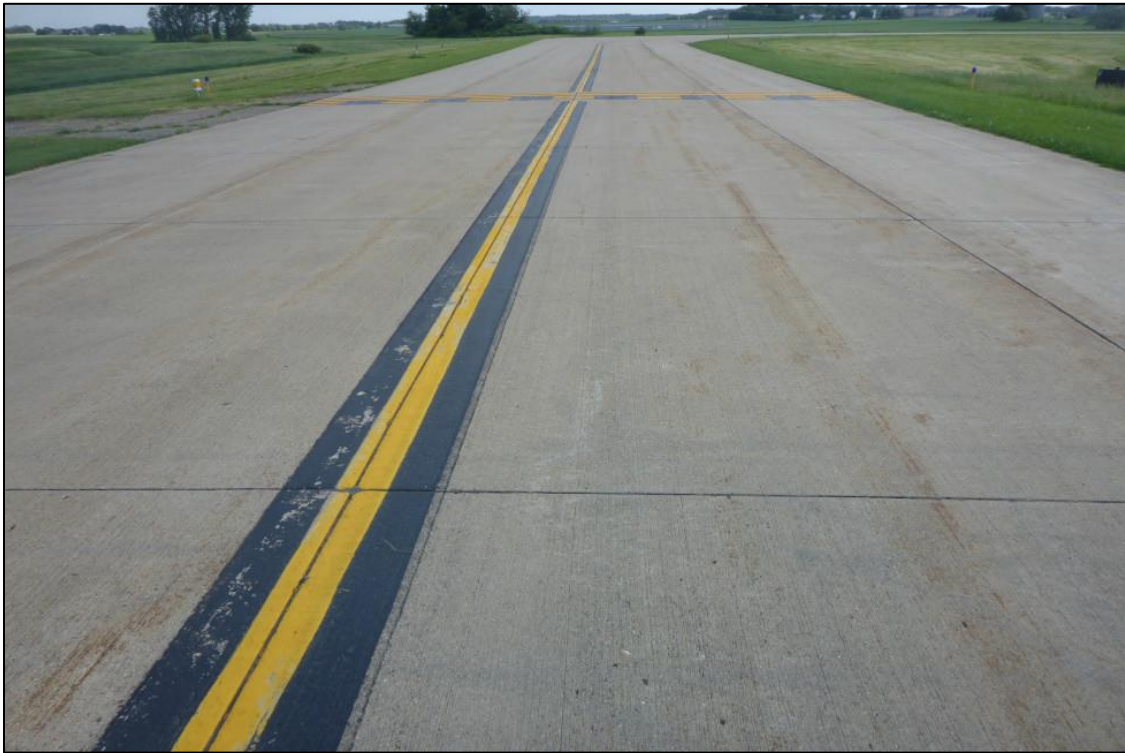
OWA CTA1 001 (PCI = 99)

Network:	OWA		Name:	OWATONNA					
Branch:	CTA1	Name:	Connecting Taxiway A1	Use:	TAXIWAY	Area:	17,500 SqFt		
Section:	001	of 2	From:	100+40	To:	105	Last Const.:	9/27/1996	
Surface:	PCC	Family:	MN2018 PCC	Zone:	S	Category:	3	Rank:	P
Area:	15,650 SqFt	Length:	385 Ft	Width:	40 Ft				
Slabs:	104	Slab Length:	15 Ft	Slab Width:	10 Ft	Joint Length:	2,142 Ft		
Shoulder:		Street Type:		Grade:	0	Lanes:	0		
Section Comments:	Maint. (R&E) JSR								
Last Insp. Date:	6/11/2019		TotalSamples:	5		Surveyed:	2		
Conditions:	PCI: 99								
Inspection Comments:									
Sample Number:	102	Type:	R	Area:	20.00 Slabs	PCI:	100		
Sample Comments:	p329								
<No Distress>									
Sample Number:	104	Type:	R	Area:	20.00 Slabs	PCI:	99		
Sample Comments:									
73	SHRINKAGE CR	N	1.00	Slabs

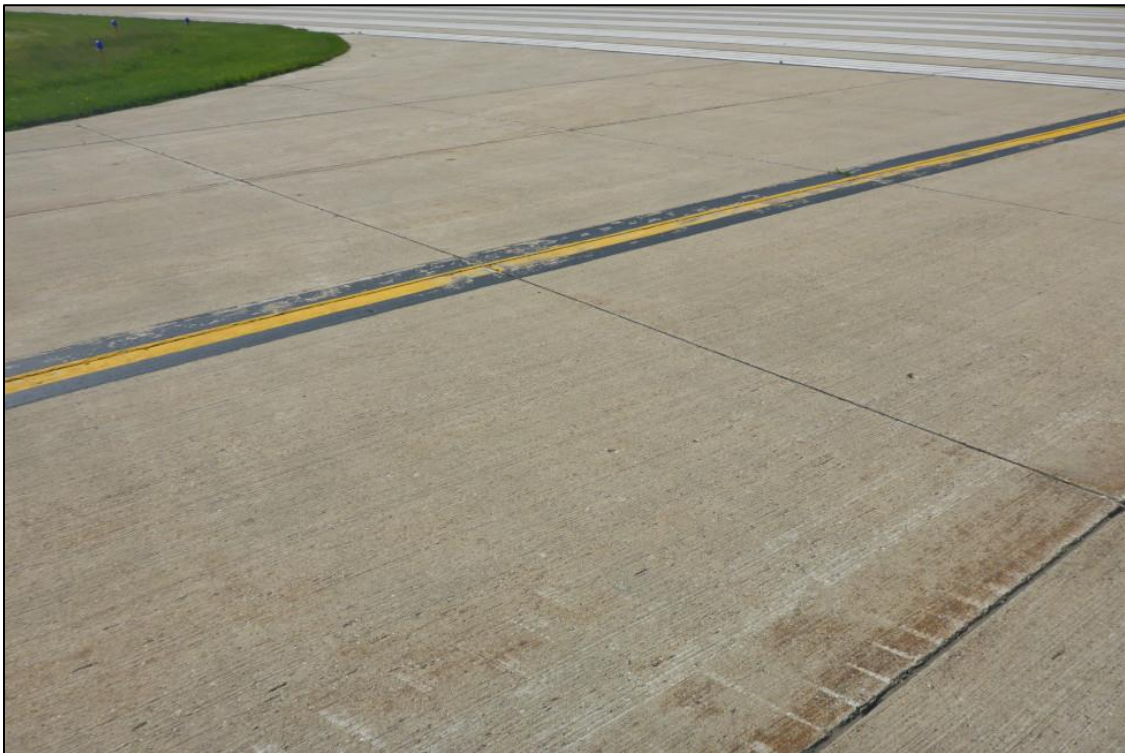
OWA CTA1 002 (PCI = 95)

Network:	OWA		Name:	OWATONNA					
Branch:	CTA1	Name:	Connecting Taxiway A1	Use:	TAXIWAY	Area:	17,500 SqFt		
Section:	002	of 2	From:	100	To:	100+40	Last Const.:	9/28/1997	
Surface:	PCC	Family:	MN2018 PCC	Zone:	S	Category:	3	Rank:	P
Area:	1,850 SqFt	Length:	40 Ft	Width:	40 Ft				
Slabs:	19	Slab Length:	10 Ft	Slab Width:	10 Ft	Joint Length:	240 Ft		
Shoulder:	Street Type:		Grade:	0	Lanes:		0		
Section Comments:	Maint. (R&E) JSR								
Last Insp. Date:	6/11/2019	TotalSamples:	1	Surveyed:	1				
Conditions:	PCI: 95								
Inspection Comments:									
Sample Number:	100	Type:	R	Area:	16.00 Slabs	PCI:	95		
Sample Comments:	p328								
62	CORNER BREAK	L	1.00	Slabs

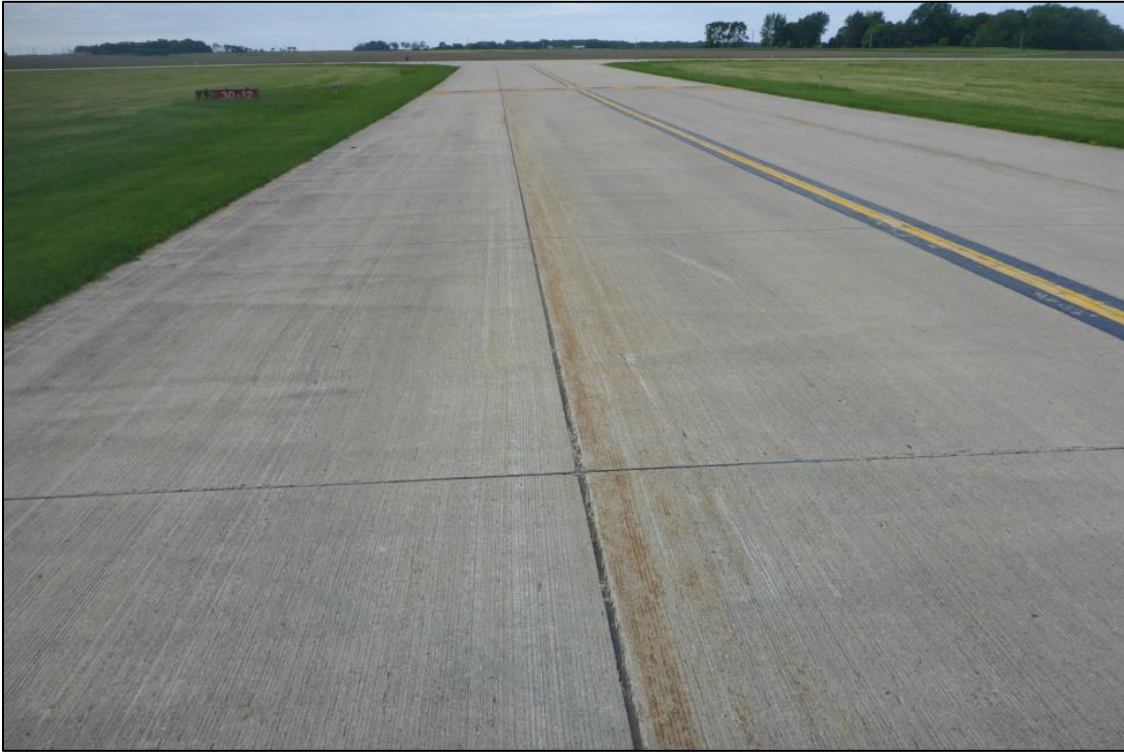
OWA CTA2 001 (PCI = 100)

Network:	OWA	Name:	OWATONNA						
Branch:	CTA2	Name:	Connecting Taxiway A2	Use:	TAXIWAY	Area:	18,000 SqFt		
Section:	001	of 2	From:	102+05	To:	105	Last Const.:	9/27/1996	
Surface:	PCC	Family:	MN2018 PCC	Zone:	S	Category:	3	Rank:	S
Area:	9,300 SqFt	Length:	220 Ft	Width:	40 Ft				
Slabs:	62	Slab Length:	15 Ft	Slab Width:	10 Ft	Joint Length:	1,207 Ft		
Shoulder:		Street Type:		Grade:	0	Lanes:	0		
Section Comments:	Maint. (R&E) JSR								
Last Insp. Date:	6/11/2019	TotalSamples:	3	Surveyed:	1				
Conditions:	PCI: 100								
Inspection Comments:									
Sample Number:	104	Type:	R	Area:	20.00 Slabs	PCI:	100		
Sample Comments:	p332								
<No Distress>

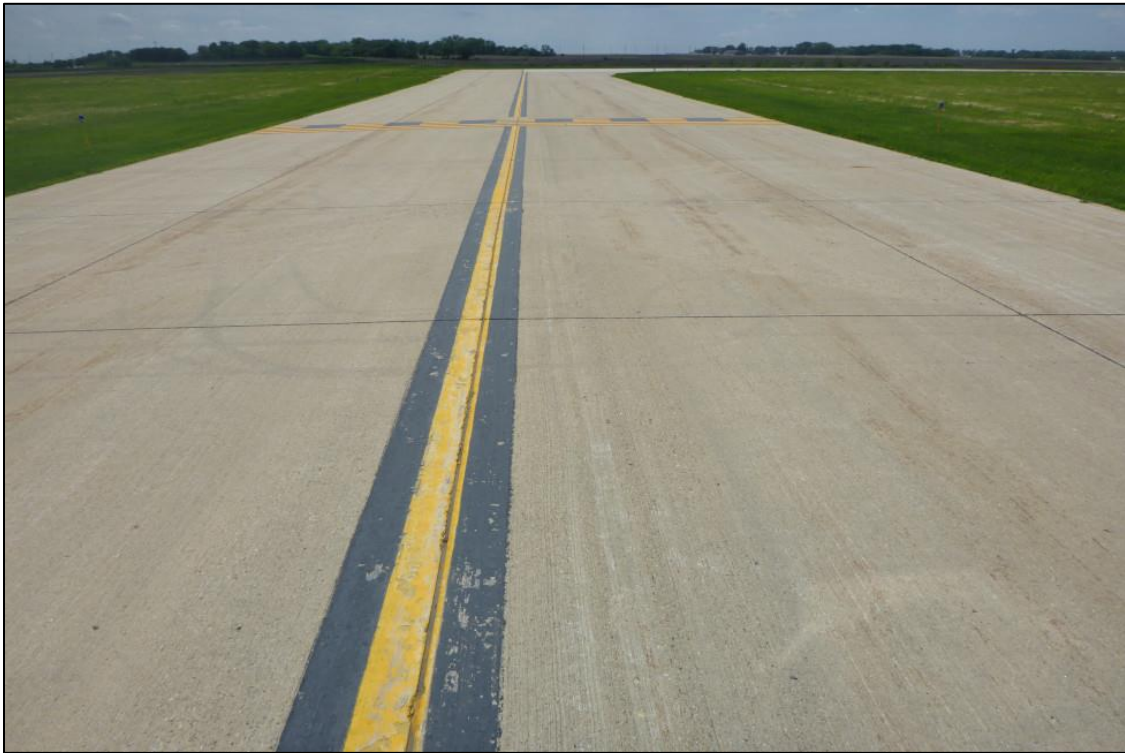
OWA CTA3 001 (PCI = 100)

Network:	OWA	Name:	OWATONNA						
Branch:	CTA3	Name:	Connecting Taxiway A3	Use:	TAXIWAY	Area:	17,500 SqFt		
Section:	001	of 2	From:	100+85	To:	105	Last Const.:	9/27/1996	
Surface:	PCC	Family:	MN2018 PCC	Zone:	S	Category:	3	Rank:	P
Area:	13,850 SqFt	Length:	340 Ft	Width:	40 Ft				
Slabs:	92	Slab Length:	15 Ft	Slab Width:	10 Ft	Joint Length:	1,887 Ft		
Shoulder:	Street Type:		Grade:	0	Lanes:		0		
Section Comments:	Maint. (R&E) JSR								
Last Insp. Date:	6/11/2019	TotalSamples:	4	Surveyed:	1				
Conditions:	PCI: 100								
Inspection Comments:									
Sample Number:	103	Type:	R	Area:	20.00 Slabs	PCI:	100		
Sample Comments:	p341								
<No Distress>

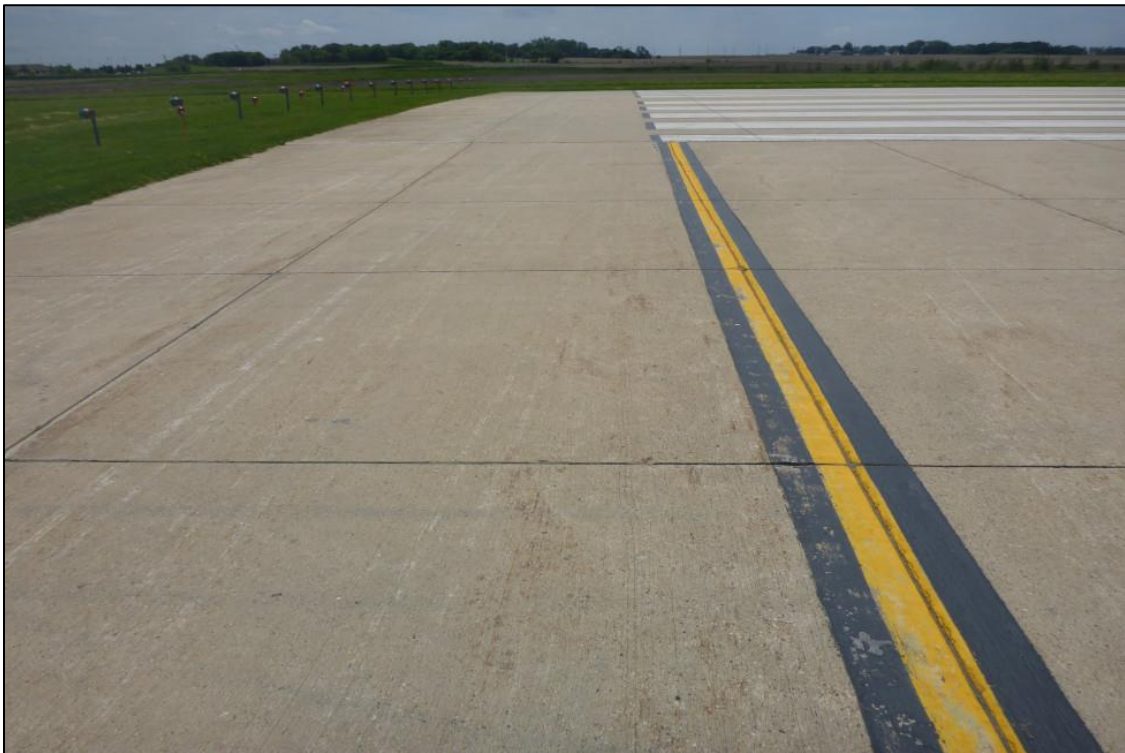
OWA CTA3 002 (PCI = 100)

Network:	OWA		Name:	OWATONNA					
Branch:	CTA3	Name:	Connecting Taxiway A3	Use:	TAXIWAY	Area:	17,500 SqFt		
Section:	002	of 2	From:	100	To:	100+85	Last Const.:	9/28/1997	
Surface:	PCC	Family:	MN2018 PCC	Zone:	S	Category:	3	Rank:	P
Area:	3,650 SqFt	Length:	85 Ft	Width:	40 Ft				
Slabs:	24	Slab Length:	15 Ft	Slab Width:	10 Ft	Joint Length:	442 Ft		
Shoulder:		Street Type:		Grade:	0	Lanes:	0		
Section Comments:	Maint. (R&E) JSR								
Last Insp. Date:	6/11/2019	TotalSamples:	2	Surveyed:	1				
Conditions:	PCI: 100								
Inspection Comments:									
Sample Number:	100	Type:	R	Area:	20.00 Slabs	PCI:	100		
Sample Comments:	p342								
<No Distress>
