# **WRI Research Related to the Optimal Timing of Preventive Maintenance for Addressing Environmental Aging**

*Kickoff Meeting*

**Fred Turner**  
**Western Research Institute**

**MnROAD Research Facility**

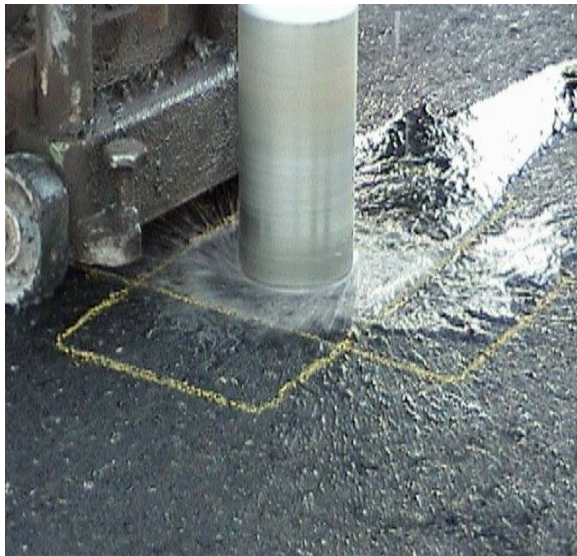
# Aging at the Arizona Validation Site

Constructed Nov. 2001  
Shoulder cored Nov. 2005

2 – 63 mm lifts, 19-mm NMS dense graded  
aggregate, 4.7% AC)

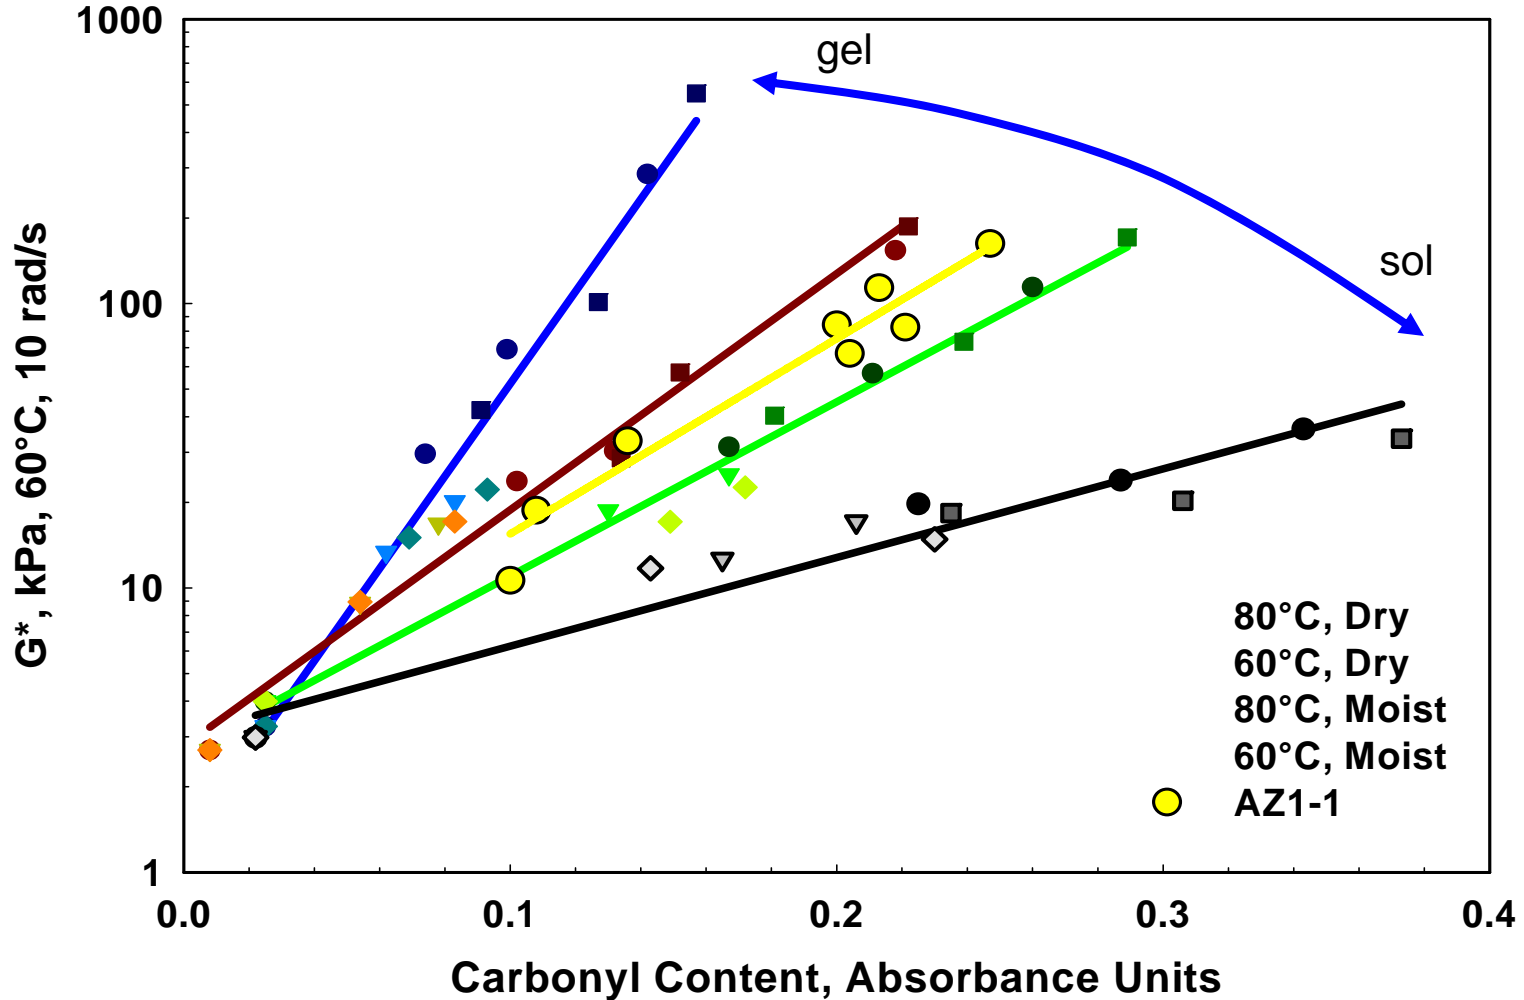
# Asphalt Hardening: Laboratory and Field Aging

Relationship between carbonyl content and complex modulus of asphalts

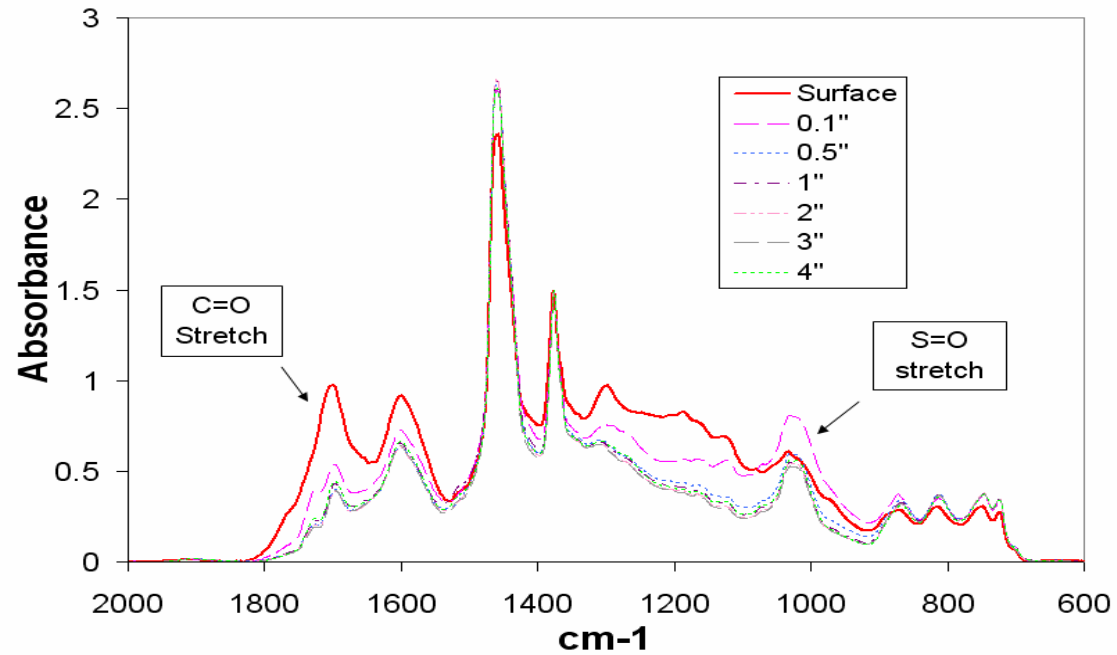
# Infrared Spectra From Each Layer

AZ1-3b core

Spectra normalized to CH<sub>3</sub> umbrella bending mode at 1376 cm<sup>-1</sup>

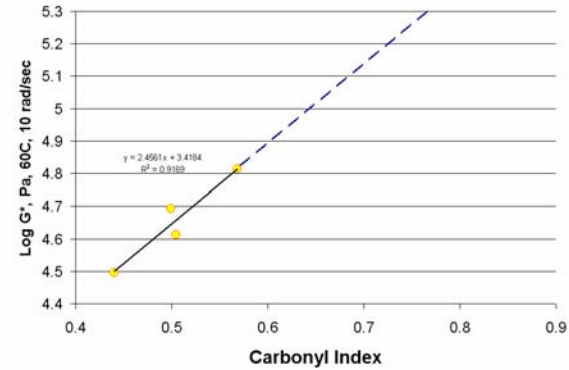
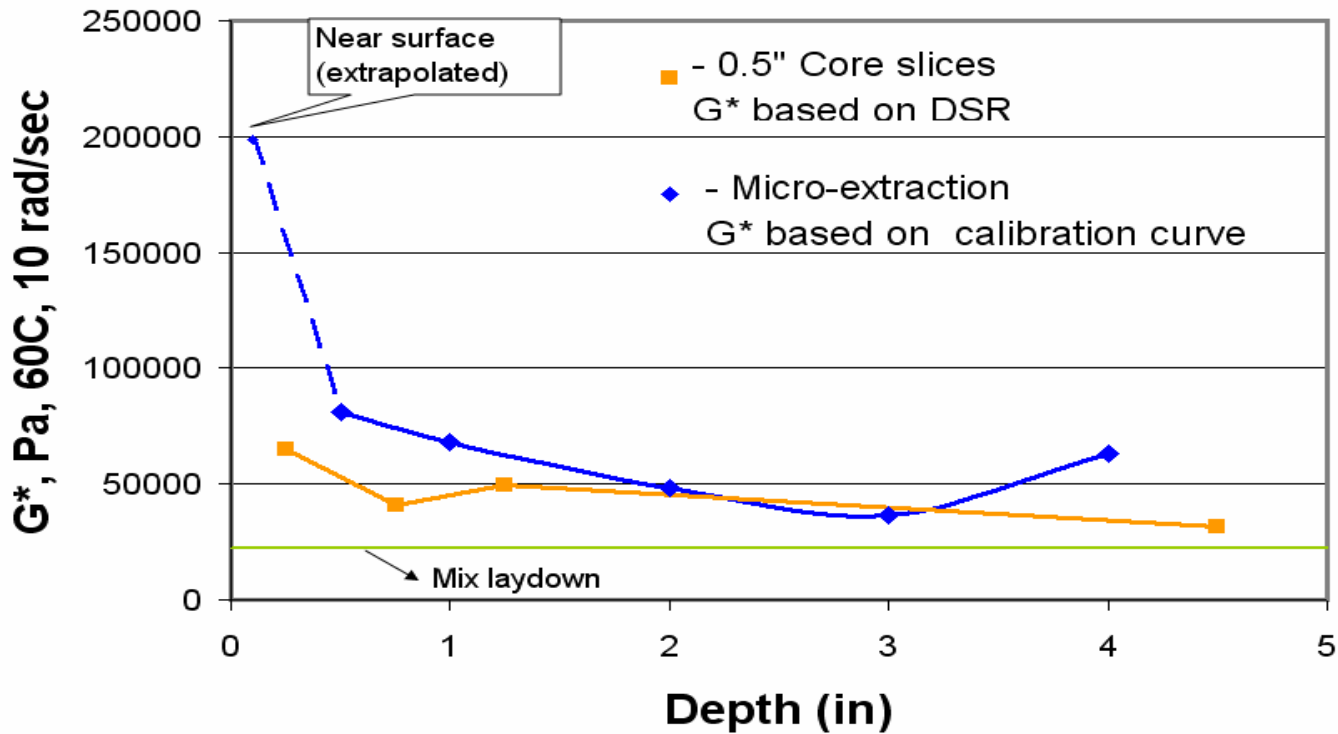
Functional group  
depth gradients

*G\* gradient - Arizona validation site at year four*

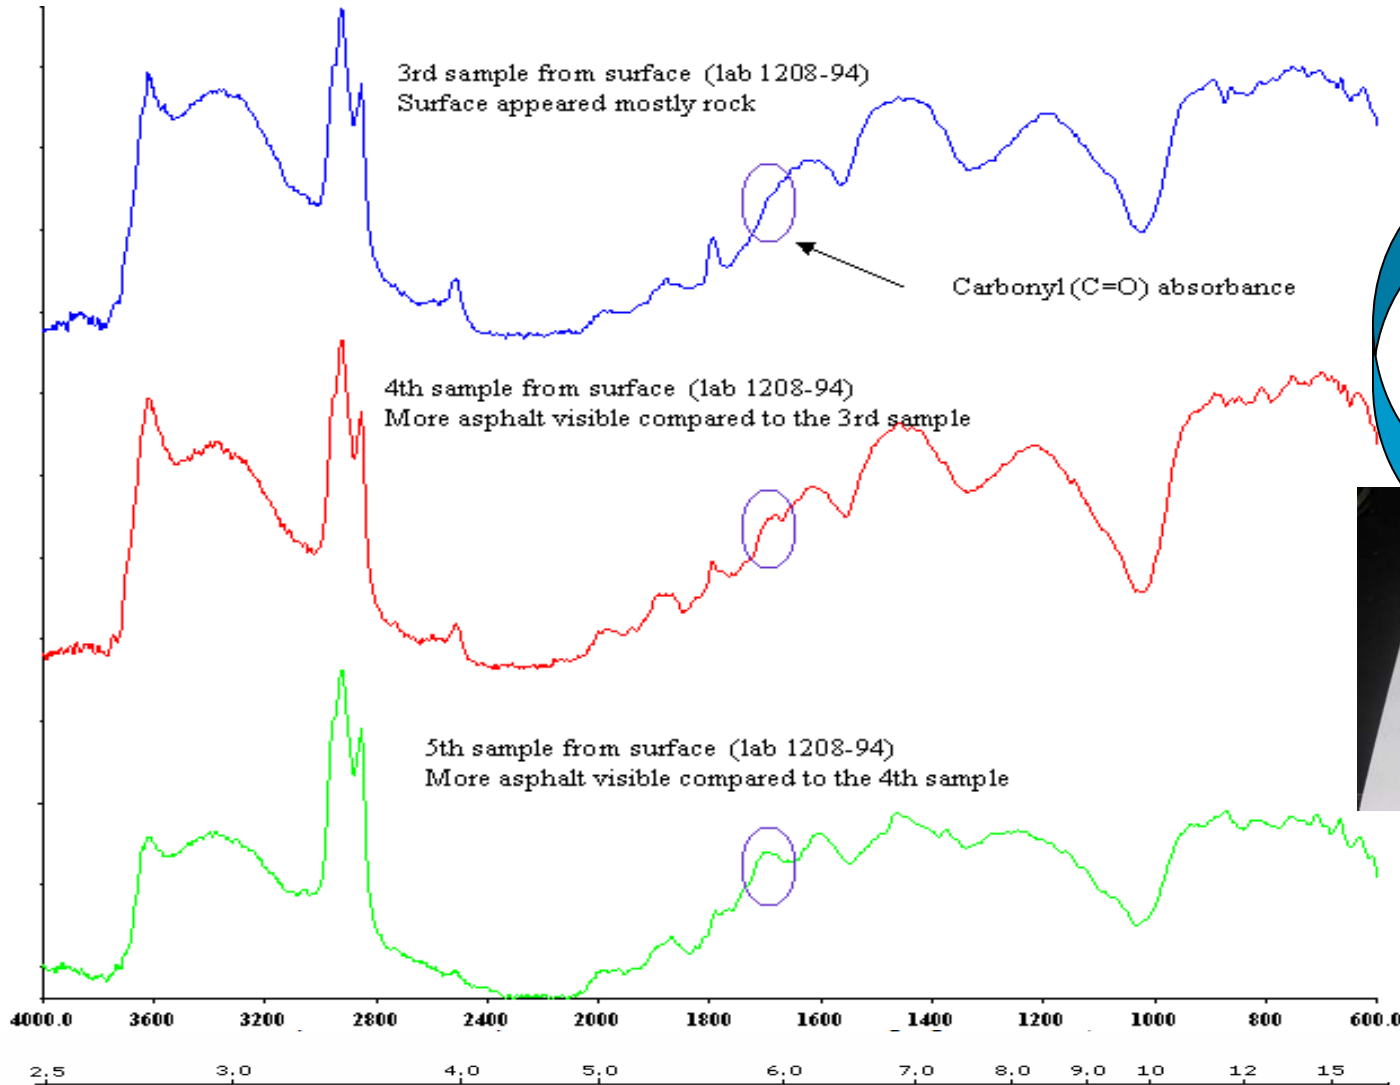
# Photoacoustic spectra – Arizona surface samples from AZ1-3b

512 co-added scans

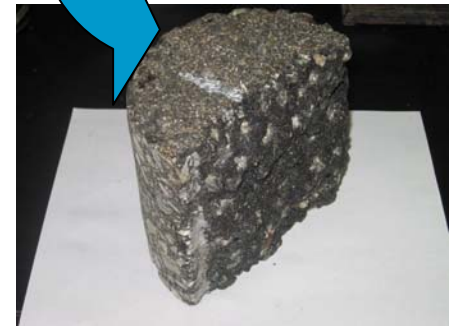
AZ1-3b core

Small (approx. 4 mm wide)  
samples removed  
from the surface
