Minnesota Airport System Pavement Evaluation 2011 Update

Ely Municipal Airport (ELO)

Ely, Minnesota

January 2012

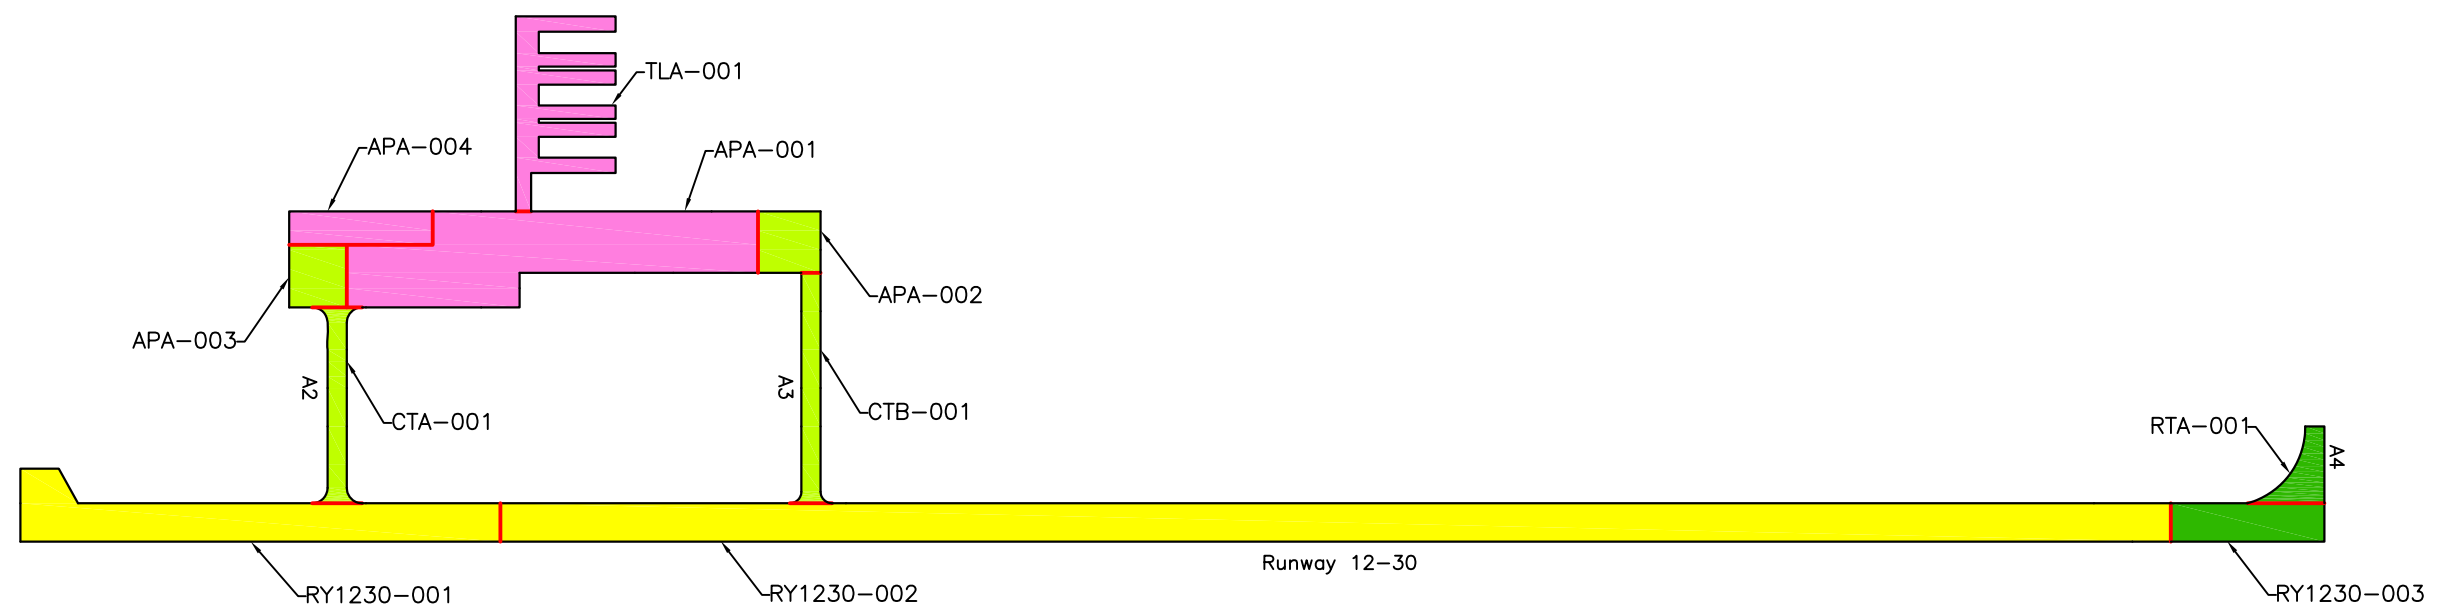
Figure 4. 2011 Pavement Condition Index Rating at Ely Municipal Airport (ELO).

The results of the 2011 PCI inspection are presented in figure 4. The overall area-weighted PCI for ELO is 62. When summarizing PCI values, an area-weighted calculation is used instead of a straight mathematical average because the area-weighted calculations eliminate the skewing of the PCI due to the disparity of the section sizes.
