Pavement Condition Report

Hallock Municipal Airport (HCO)

December 2014

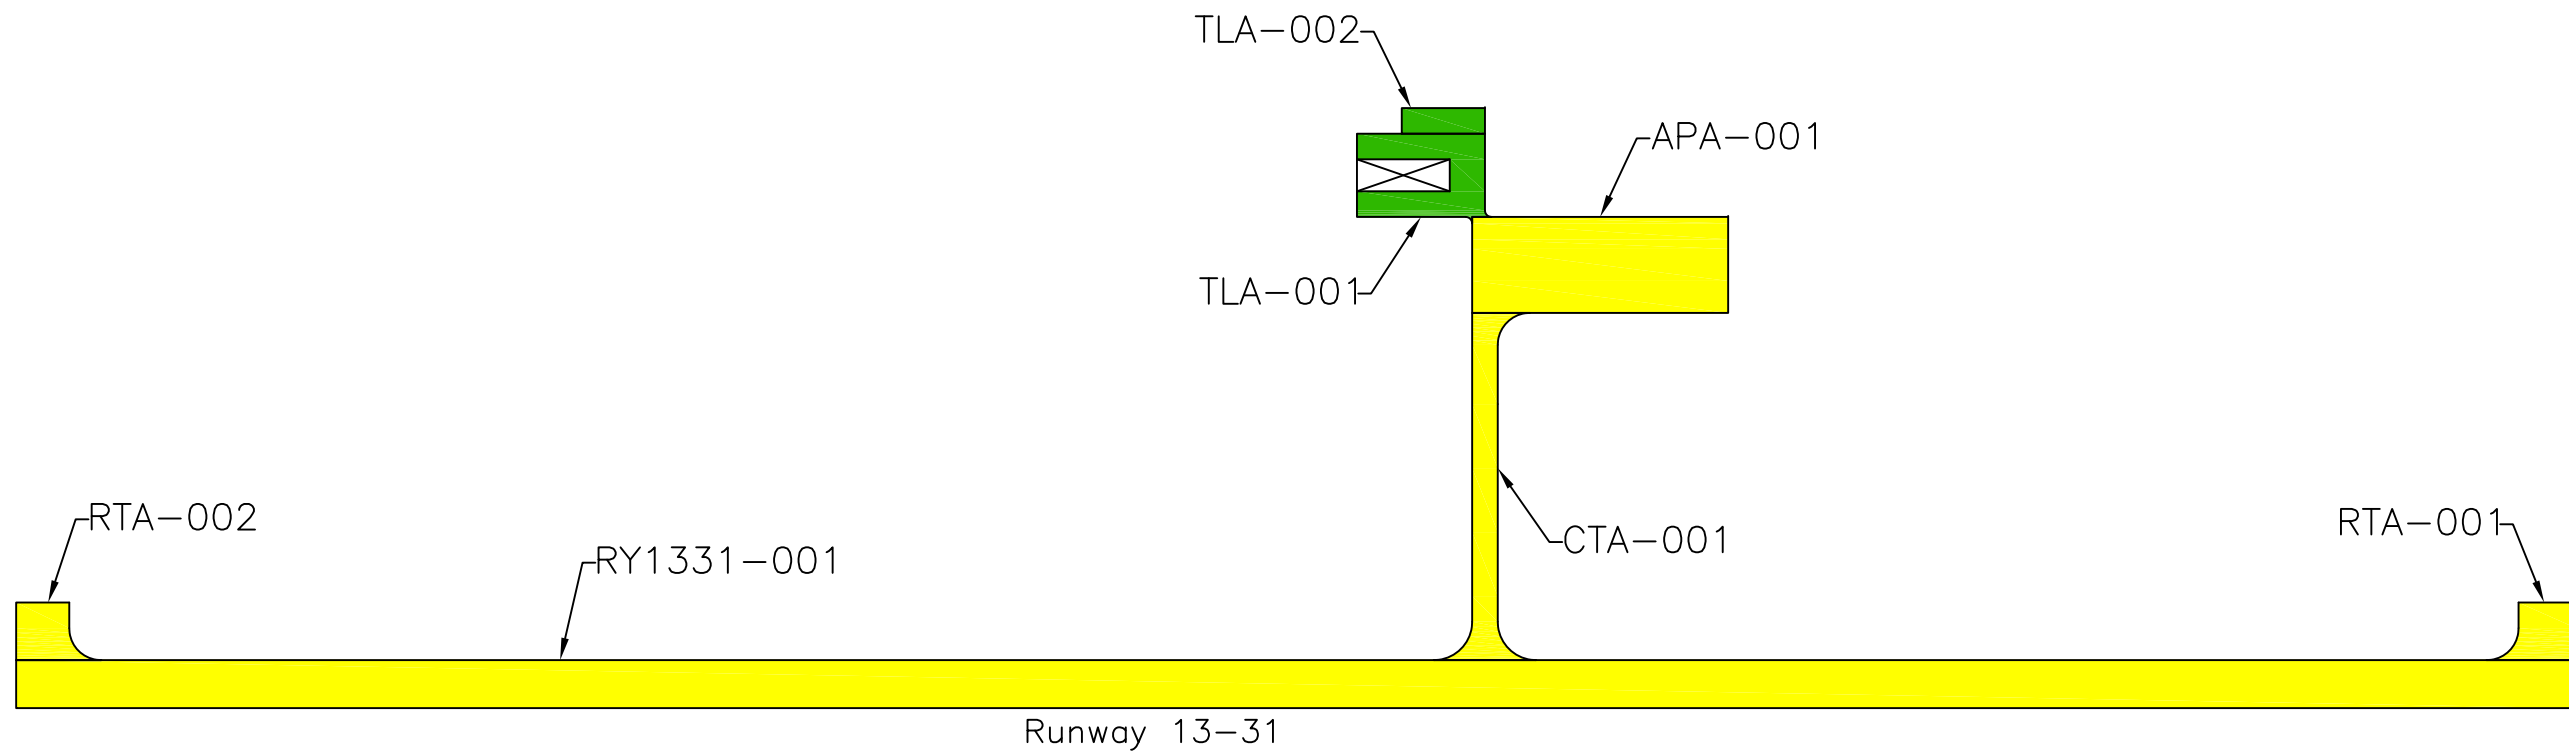
Figure 4. 2014 Pavement Condition Index Rating at Hallock Municipal Airport (HCO).

The results of the 2014 PCI inspection are presented in figure 4. The overall area-weighted PCI for HCO is 65. When summarizing PCI values, an area-weighted calculation is used instead of a straight mathematical average because the area-weighted calculations eliminate the skewing of the PCI due to the disparity of the section sizes.
