# Pavement Condition Report

## Mora Municipal Airport (JMR)

**December 2017**

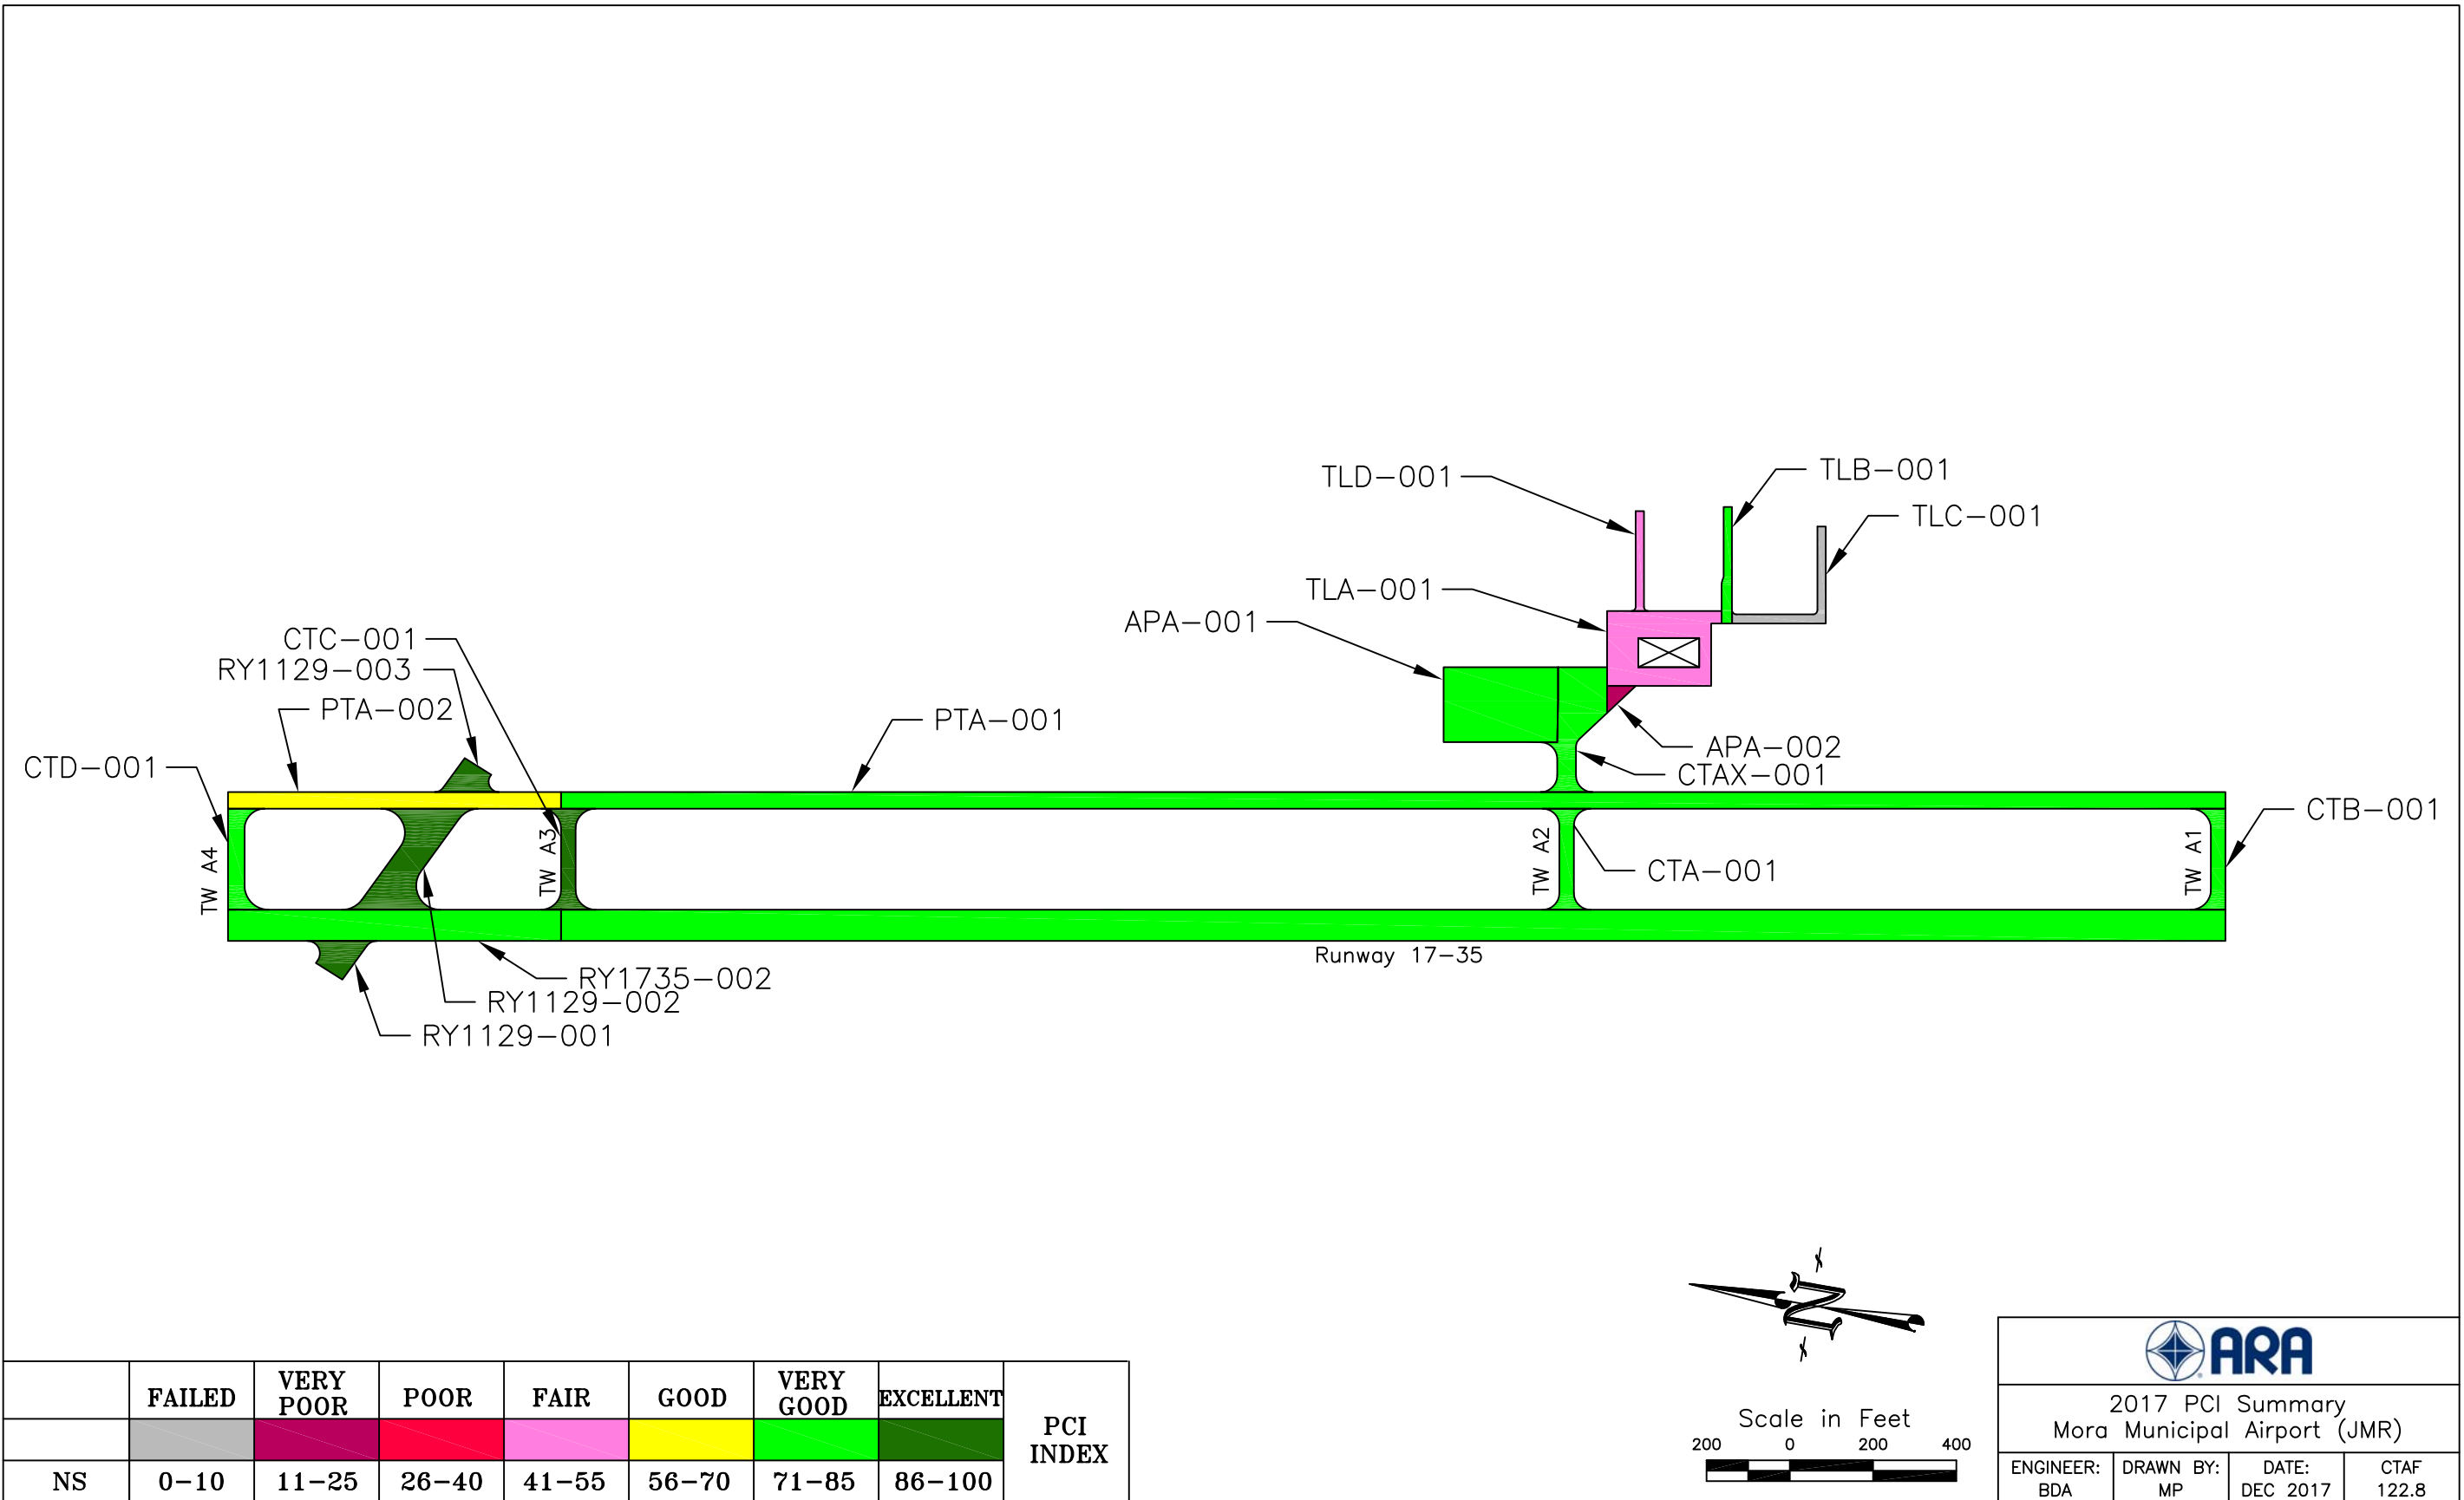
Figure 4. 2017 Pavement Condition Index Rating at Mora Municipal Airport (JMR).

The results of the 2017 PCI inspection are presented in figure 4. The overall area-weighted, inspected PCI for JMR is 73. When summarizing PCI values, an area-weighted calculation is used instead of a straight mathematical average because the area-weighted calculations eliminate the skewing of the PCI due to the disparity of the section sizes.
