Pavement Condition Report

McGregor-Isedor Iverson Airport (HZX)

December 2018

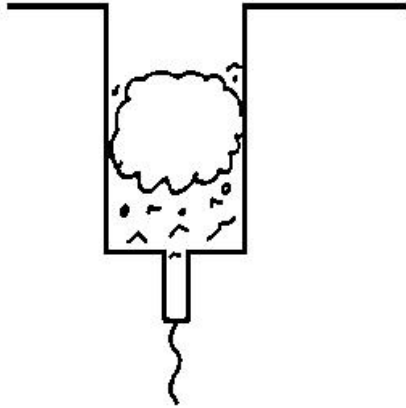
Typical joint with deficient sealant and a collection of debris & incompressibles.
