Pavement Condition Report

Owatonna Degner Regional Airport (OWA)

December 2019

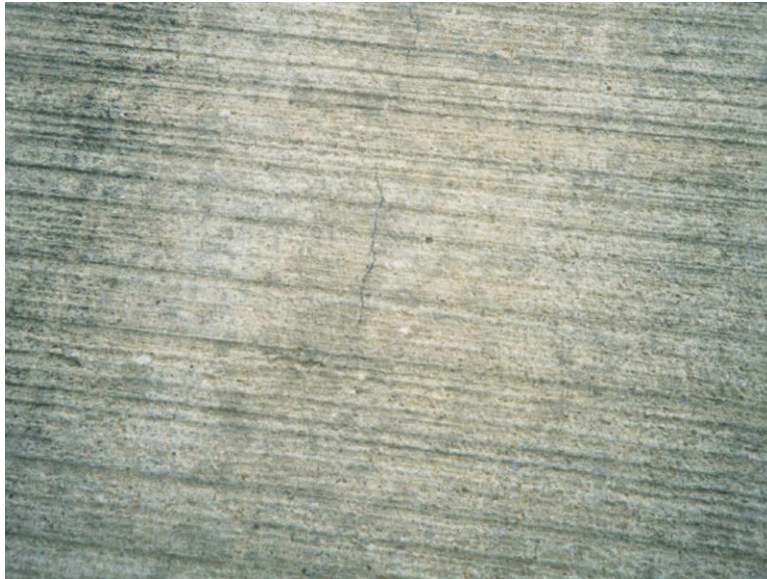
Example of Shrinkage Cracking

Shrinkage cracks are small, nonworking (no spalling along edge) cracks that are visible at the surface but do not penetrate through the full depth of concrete. Shrinkage cracks most commonly occur shortly after construction due to concrete shrinkage during the curing process. Shrinkage cracks are usually so small that they are not visible until staining or material loss at crack edges begins to take place. Shrinkage cracks do not represent a structural weakness, and no corrective action is prescribed.
