# HydInfra Inspection Manual

# Roadway Type

# Pipe Inventory

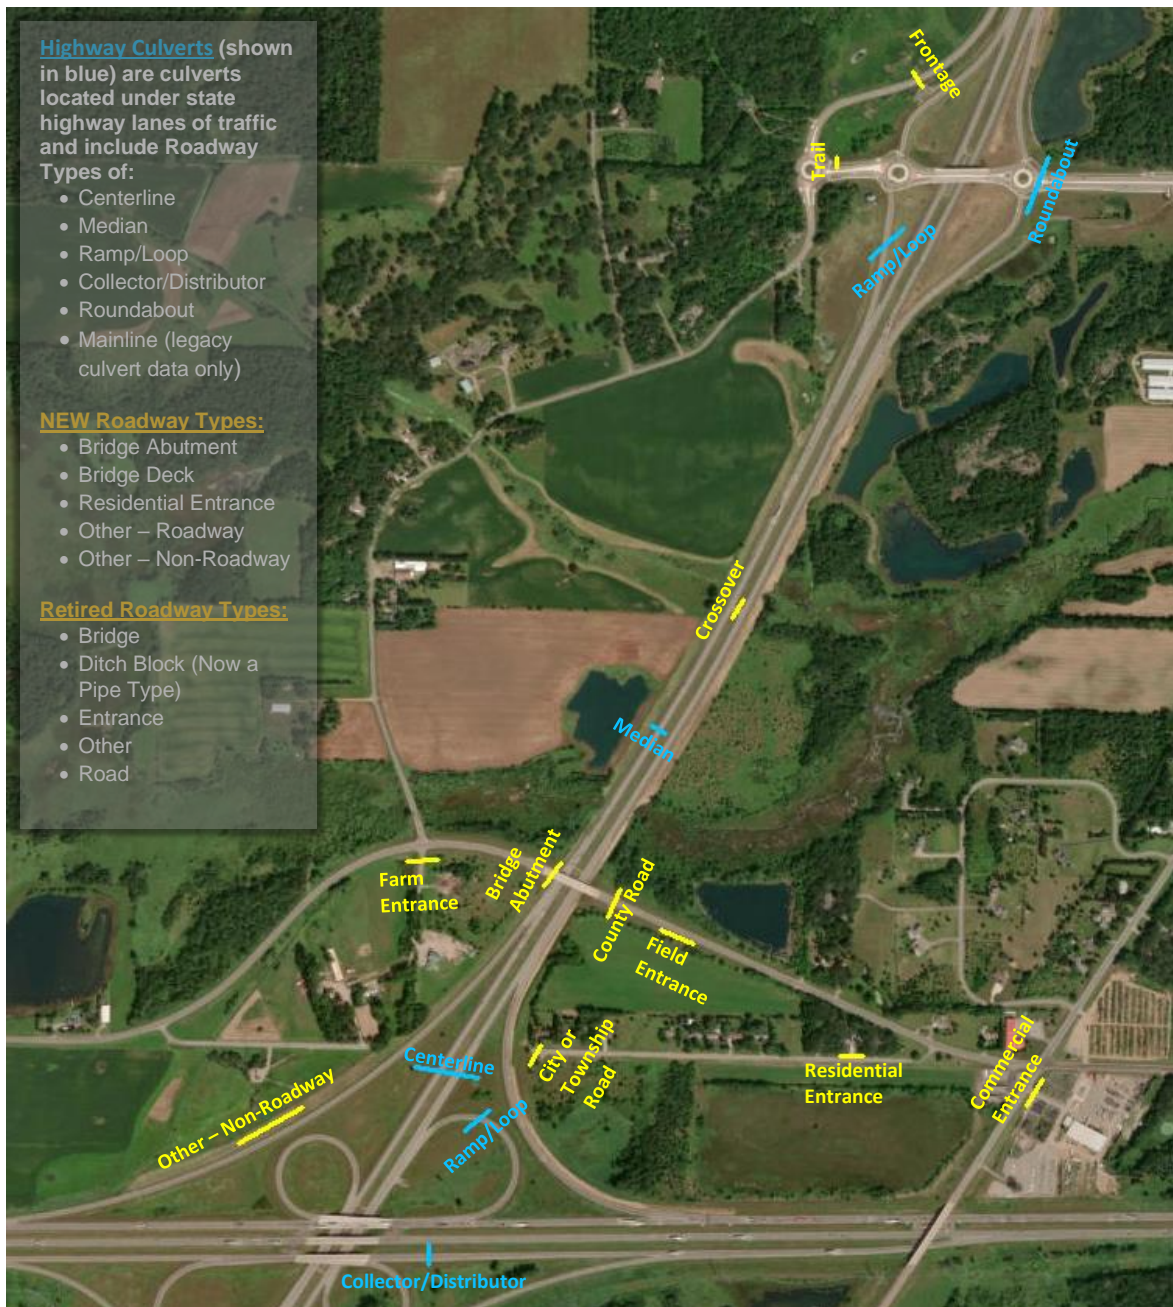
Roadway Type describes the general location and relative importance to highway traffic. For example, a "Centerline" culvert would disrupt traffic flow when replaced while a Field Entrance could be replaced with little impact to highway traffic. Categories of Roadway Types differentiate all culverts under highway traffic from other sets.

1. **Highway Culverts** are under state highway lanes of traffic. They include Centerline, Median, Ramp/Loop, Collector/Distributor, Roundabout
2. **Side Culverts** are either local road culverts or are part of state highway but not under traffic
3. **Entrance Culverts** are privately owned (but within the highway right of way they are maintained by MnDOT)
4. **Mainline** applies to storm drain, not culverts

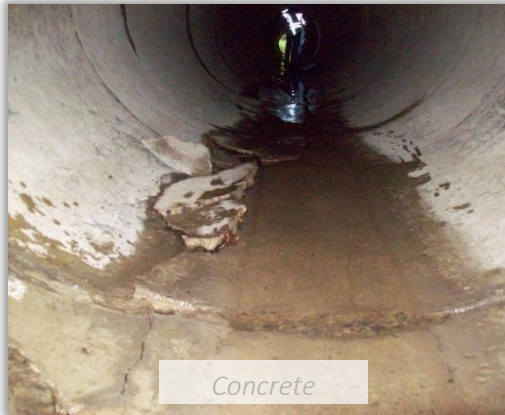
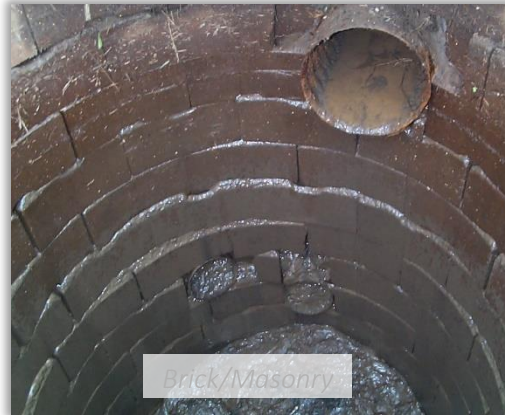
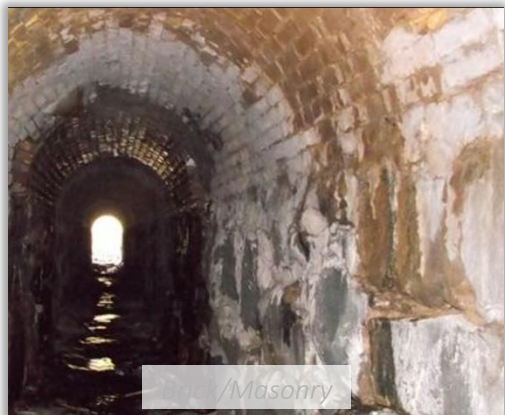
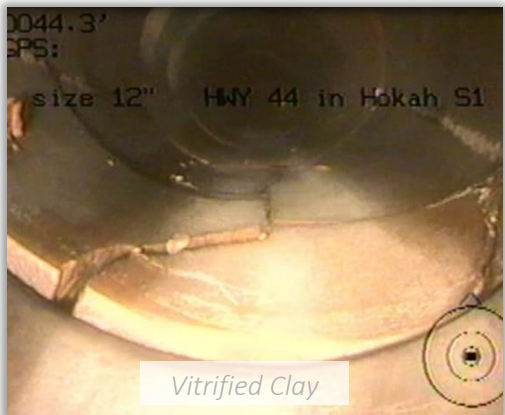
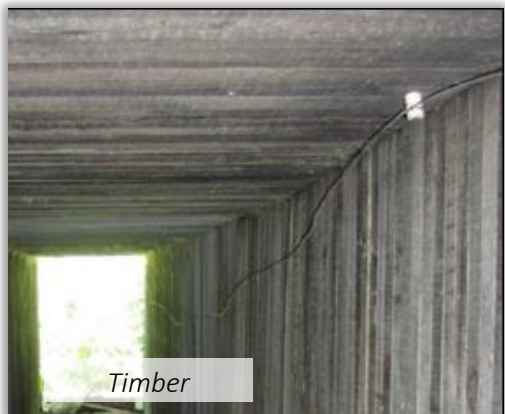
Materials shown here are used to describe Pipes or Structures in TAMS. Materials listed in TAMS-HydInfra have been found in one or more MnDOT Districts. Several of these materials are no longer installed. Material pages for steel, plastic and liners follow on the next three pages. This page shows a mixed set.

- **Concrete** is most common pipe material. About 90% of HydInfra culvert and storm drain pipes are concrete.
- **Brick/Masonry** might be used in new structures but not pipes.
- **Vitrified Clay** pipe exists in some very old systems. Look for red color.
- **Timber** culverts may still exist in small box culverts.
- **Other** is used when no other material on the list applies.

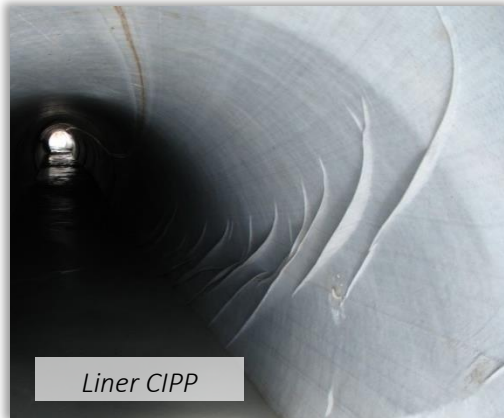
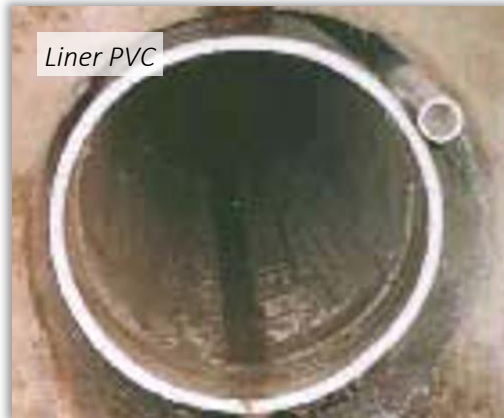
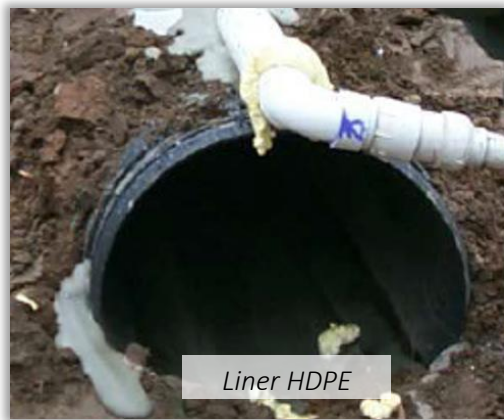
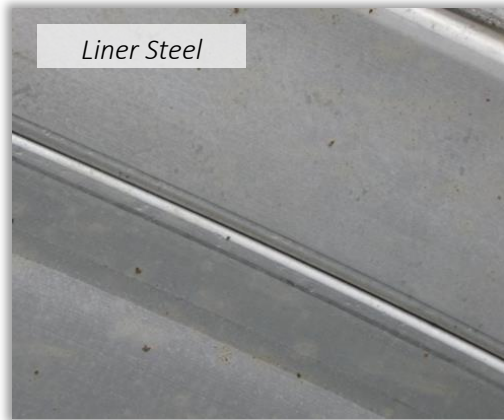
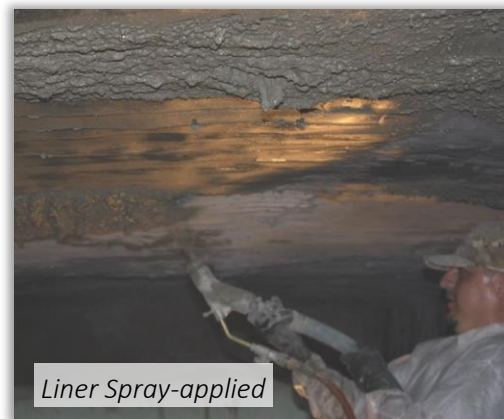
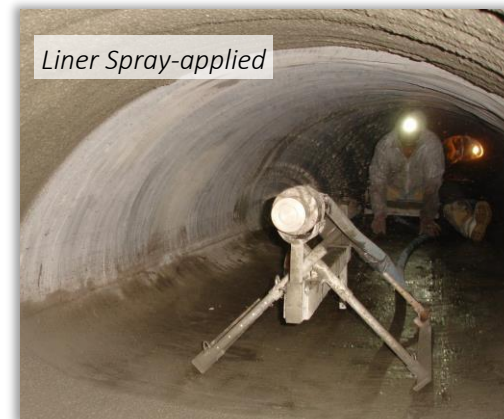
# Liner Materials

If a pipe is lined, use the material name that begins with “Liner”.

- **Liner CIPP** (Cured in Place Pipe) is a fabric liner with a resin cured by steam, hot water or UV light, looks like fiberglass.
- **Liner PVC** is no longer used.
- **Liner HDPE** is commonly used for slipliners.
- **Liner Steel** flat-seam pipe has been used for pipe liners.
- **Liner Spray-applied** can be concrete or resin cementitious material.

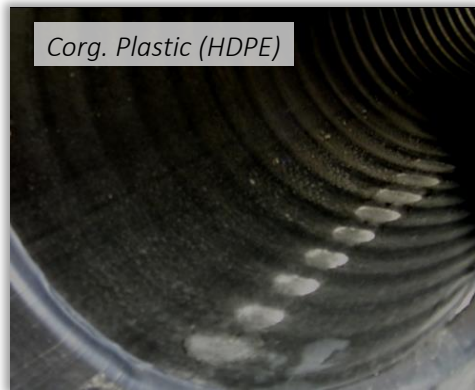
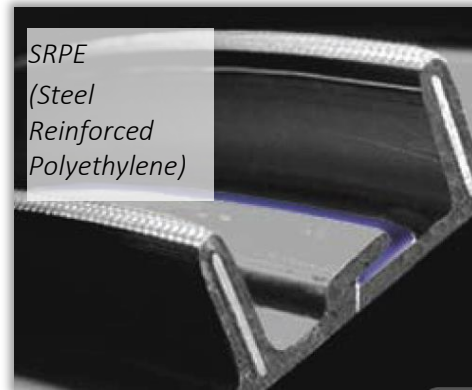
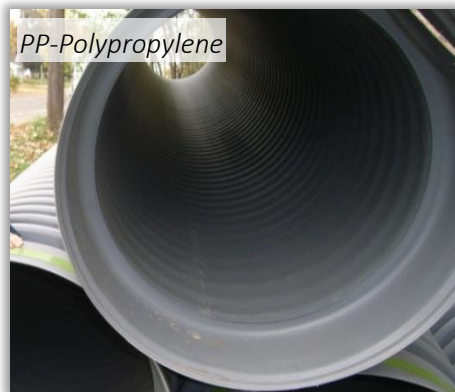
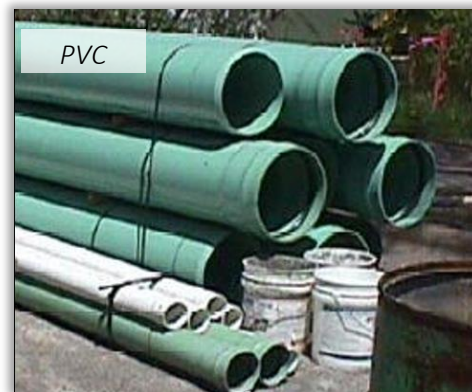
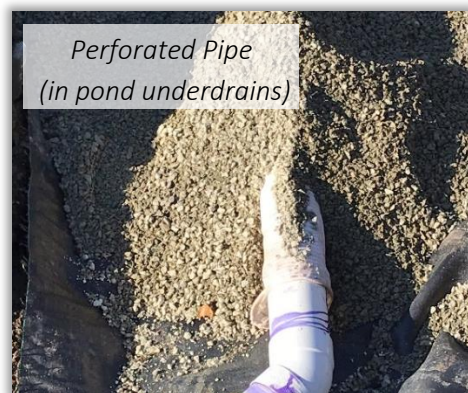
# Plastic Materials

Plastic pipe materials shown here are known to exist in one or more Districts.

- **Polypropylene** is grey but otherwise looks like dual-wall Corg. Plastic (HDPE). Polypropylene is somewhat stiffer than HDPE.
- **PVC** pipe is white or green or even light blue. It is more brittle than HDPE. It deteriorates in sunlight and should not be used for culverts.

- **Perforated Pipe** can be either PVC or HDPE single-wall pipe with holes that allow water to leak out into gravel and surrounding soil.
- **Other** is used for plastic pipe not shown on this page.

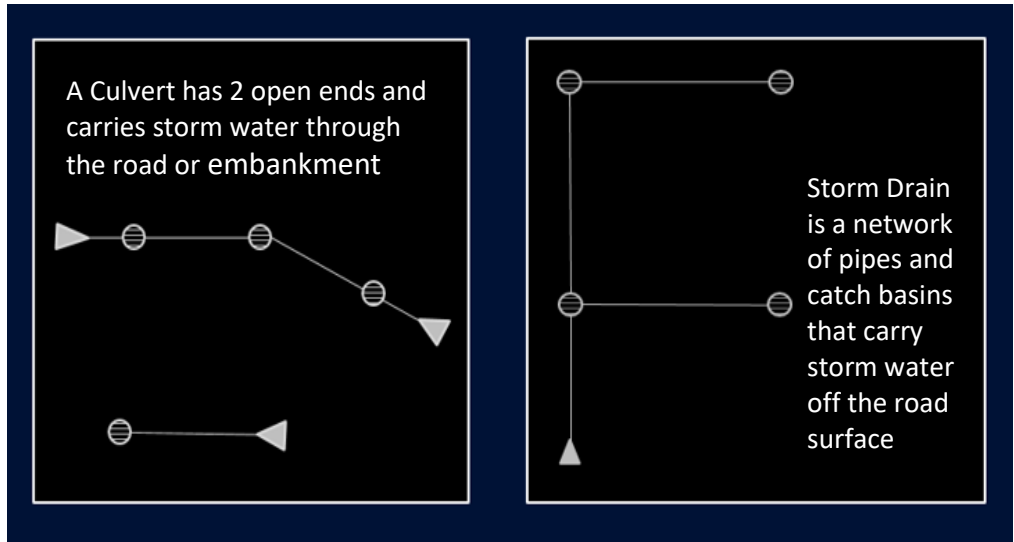
## Choose Culvert or Storm Drain Pipe

Nearly all pipes in TAMS HydInfra are Class Code Culvert or Storm Drain. Culvert pipes have two open ends, usually with aprons (End Sections) and carry water under a road or embankment. Storm Drain pipes and catchbasin or manhole structures are connected in a network that carry water off the road surface. Median drains are culverts whether they have a drop inlet or an apron capturing runoff in the median.

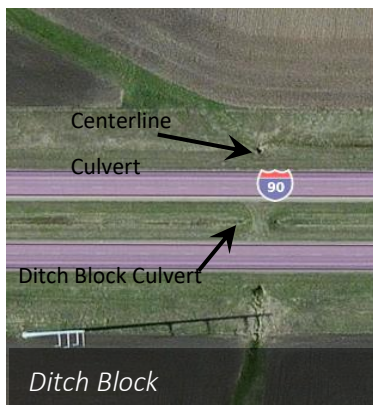
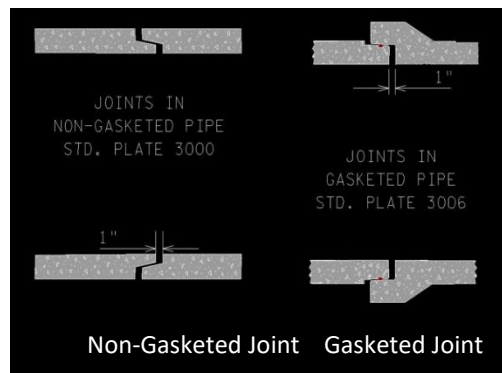
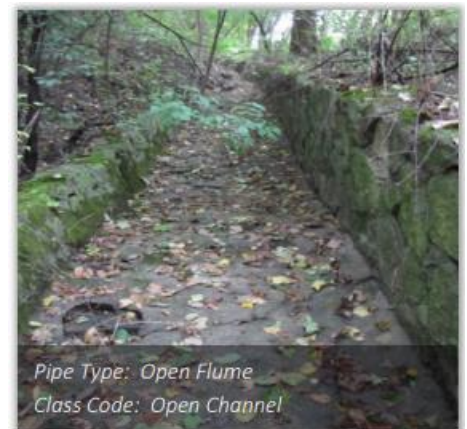
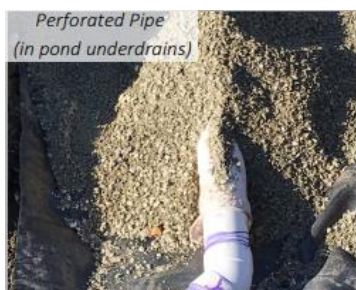
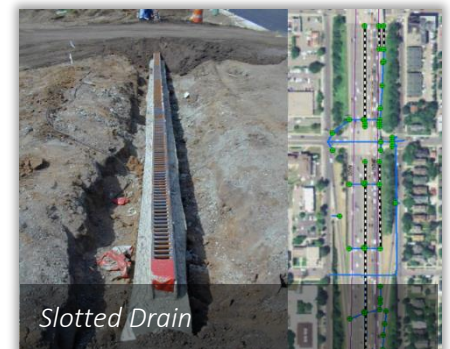
- **Ditch Block** – Pipe within a ditch block – Roadway Type would be Other – Non-Roadway
- **Gasketed or Non-gasketed** – different types of pipe joints, also known as 3006 or 3000
- **Open Flume** – hardened open channel
- **Perforated Pipe** – used for pond basin underdrains and has drainage holes
- **Pipe Flume** – Pipe used to direct water down a steep slope
- **Slotted Drain** – linear inlet with grate, usually part of a storm drain network

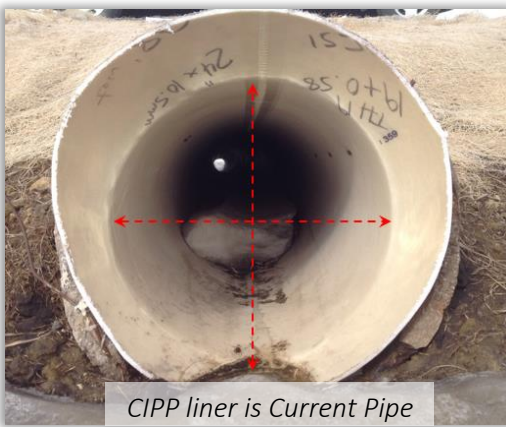
CIPP liner is Current Pipe

- **Original** – pipe **Material, Shape, Width and Height** describes the installed pipe or the host pipe if lined
- **Current** – pipe **Material, Shape, Width and Height** describes the pipe interior now. If lined these will be different from Original information. In this example, Current Material is Liner CIPP (Cured in Place Pipe liner). Arrows show Current Height and Width. Original Material is Concrete, exposed at lower left and right of pipe. Shape is Round for both Current and Original. Original concrete Height and Width are about 1 inch less than the Liner CIPP. For slipliners, the Current and Original Height and Width should be different with the slipliner being smaller in size.

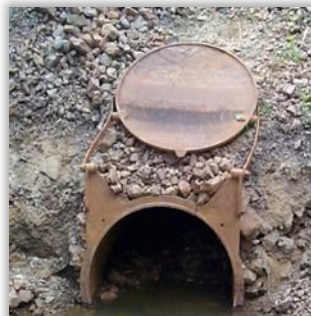
- *Flared Aprons* are wider than the pipe
- *Flap Gate* closes to prevented floodwater back flow
- *Safety Aprons* are narrow like pipe diameter, are sloped at 10:1, 6:1 or 4:1 taper
- *Box End Sections* are precast tapered box pipe sections
- *Headwall* lays flat against the road inslope
- *Headwall-Wingwall* on box culverts flare out to hold back inslope.

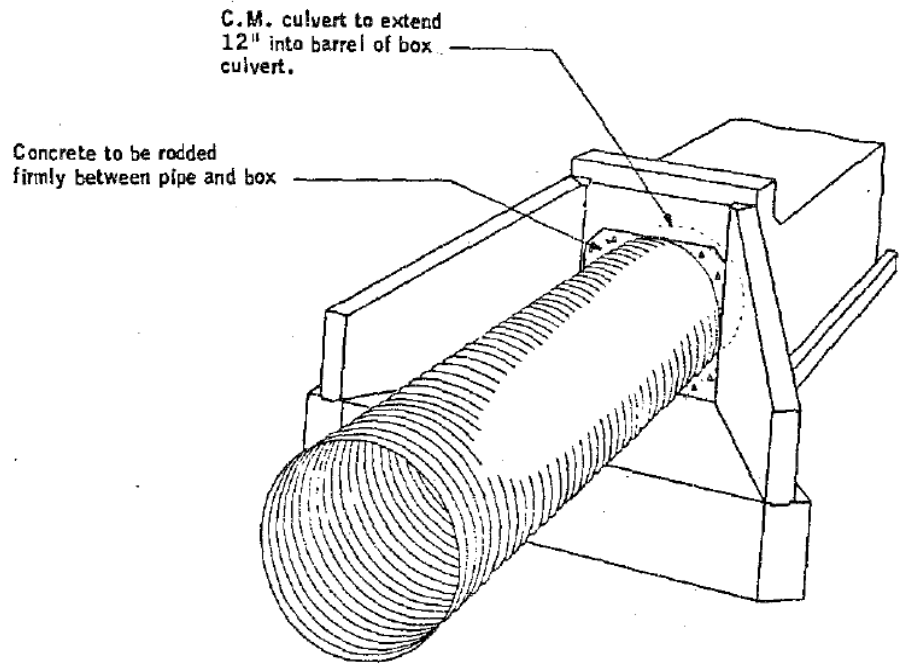
The Extensions sub-table allows a pipe to be described with multiple materials. For example, a concrete box culvert installed under the old highway may have had round corrugated steel pipes inserted on each end when the road was widened. The Extension sub-table would include a separate record for each different pipe size, shape or material.

*MnDOT Standard Plate 3066 shows how a corrugate ed metal pipe was inserted into a concrete box culvert, used when a narrow highway was widened. (Also notice the Headwall Wingwall End Section)*

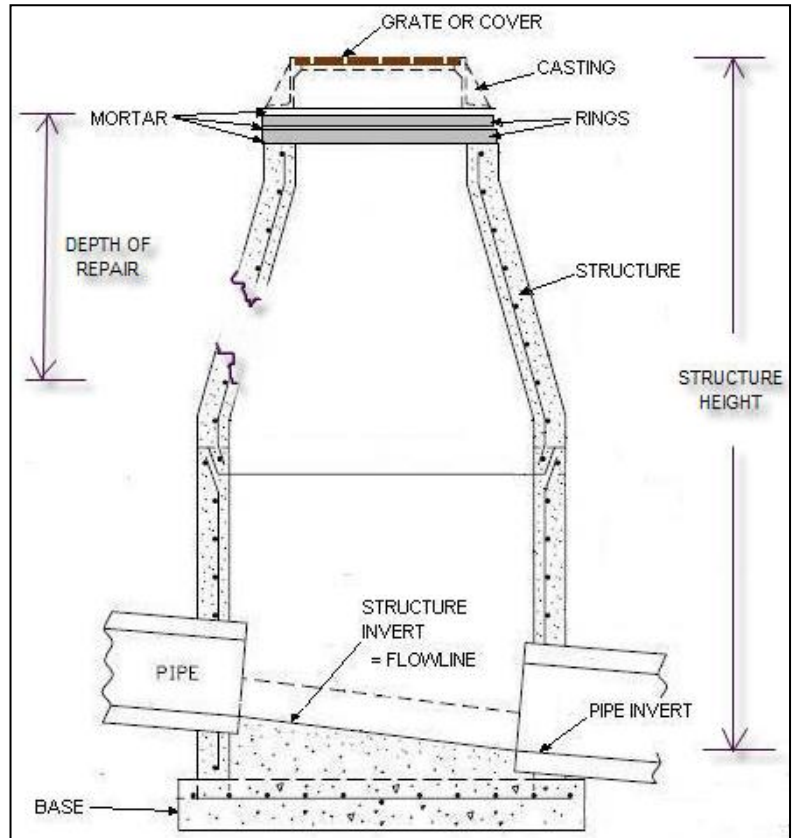
- **Structure Type** – Manhole, Catch Basin, Drop Inlet, Buried Manhole, Control Structure, Deck Drain, Diverter, Inspection Tee
- **Structure Diameter** (inches) – Width of structure (entered from Asbuilt or plans, not measured in field)
- **Structure Height** (Ft.) – Measure from top of grate to bottom of invert
- **Repair Depth** (Ft.) – (Inspection term) Measure from bottom of casting to bottom of the needed repair (gaps, cracks, holes, missing blocks or brick, etc.)
- **Connected Pipes** – Number of pipes attached to the structure
- **Sump Depth** (Ft.) – Measure from lowest pipe invert to structure invert if and record if deeper than 1 foot
- **Grate/Frame Type** – Casting assembly, see standard plates
- **Ring Material** – Concrete or plastic rings under the casting and on top of the pre-cast structure, used as vertical spacers

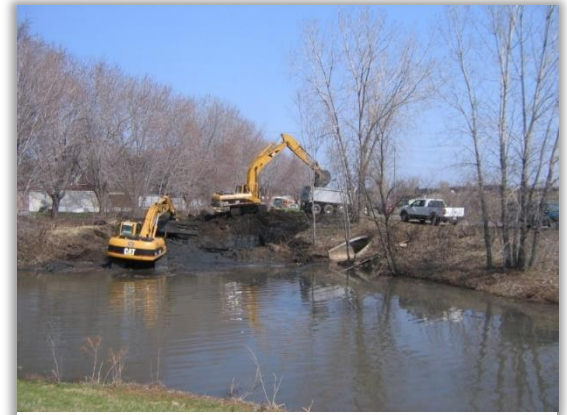
Wet Pond

- **Wet Pond** – Wet pond normally has water up to the level of the outlet structure and maintains a permanent pool of water
- **Dry Pond** – Dry pond has outlet elevation at pond bottom and drains dry
- **Mitigation Wetland** – Mitigation Wetland was built to offset wetland loss on a construction project. Look for NWC (New Wetland Credit) or PVC (Public Value Credit) or other note on plans
- **Natural Wetland** – Natural Wetland identifies a pre-existing wetland protected by Minnesota or Federal law
- **Unknown** – Unknown type is used when the type is unidentified

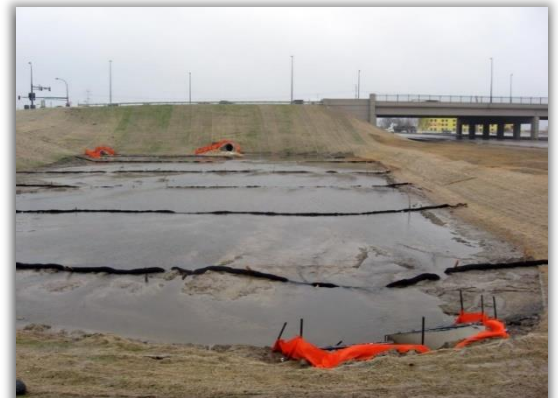
Filtration Basin

- **Filtration Basin** – Filtration Basins have perforated underdrains – Drain Tile – that allows stormwater to drawdown and dry out between rainfalls and maintain vegetation
- **Infiltration Basin** – Infiltration Basins are built with a granular or gravel substrate meant to leak into the ground until dry. They normally have living plants on basin bottom

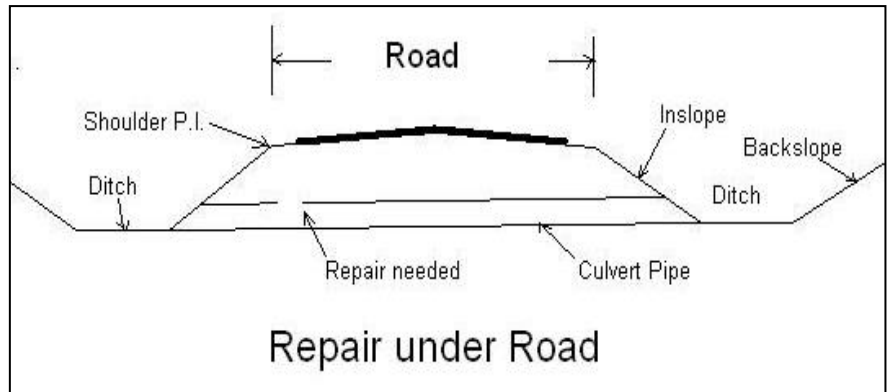
If a repair is needed and the needed repair will encroach on the road surface between the two shoulder P.I.'s then Repair under Road is marked Yes. To be valid, Needs Repair must also be "Yes". (P.I. means Point of intersection where the road surface intersects with the inslope).
